Reinforcing Coal Mine Roof with Polyurethane Injection: 4 Case Studies

Gregory Molinda

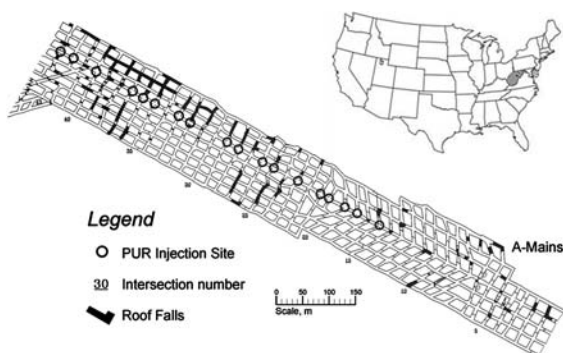
Fig. 2 Roof falls and PUR injection sites in West Virginia mine

A coal mine in north-central West Virginia was experiencing extremely difficult roof conditions in its main beltway throughout the life of the mine leading up to the autumn of 2002 (Fig. 2). The 5.5 m (18 ft.) wide belt entry was averaging 2–3 roof falls per year which resulted in costly delays due to cleanup and rehabilitation. The roof rock was extremely weak and highly moisture-sensitive clay shale. August was the worst month, with roof falls occurring almost 2.5 times more frequently than the annual monthly average. In addition, it was suspected that frequent clay veins reacted to moisture, swelled, and applied bulking pressures on the roof sequence. The roof began to unravel between bolts soon after mining, leading to a progressive upward failure and finally a roof fall. Mine-wide, 63% of roof falls occurred in intersections. In the beltway from the portal to the first submains, 15 of 43 intersections had fallen (Fig. 2).

All intersections that had not fallen in the beltway were treated with PUR injection stabilization (Fig. 2). A total of 27 intersections had PUR injected.

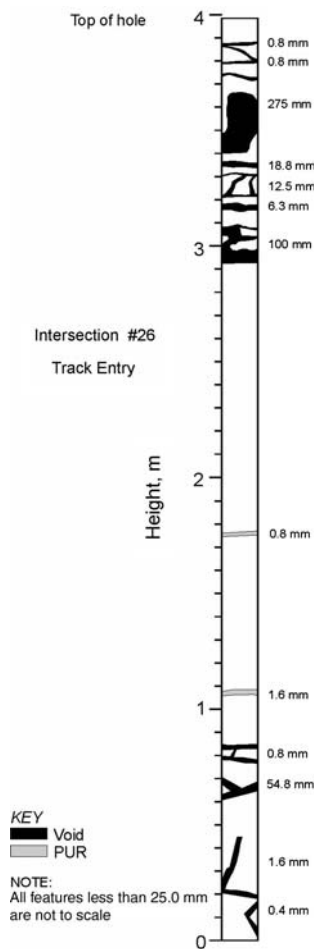
Fig. 3 Large voids detected by videoscope above bolt anchorage

Video monitoring of the first PUR injection test intersection on the track (intersection No. 26) detected large voids at 2.9–3.7 m (9.5–12 ft.) up into the roof (Fig. 3). A large void (27.9 cm (11 in.)) was detected in two test holes in the intersection at 3.4 m (11 ft.) above the roof line. A total of 48 cm (19 in.) of void space was observed in the roof. From these observations, and the lack of pump pressure, it appeared that large volumes of PUR were being lost into the voids. Video logs also revealed the condition of the roof in selected intersections along the Mains project area. Pre-pumping video logs showed significant voids in the roof at two intersections (No. 23 and No. 32) (Fig. 4). At No. 32, highly fractured roof rock was loading standing support and falling between supports (Fig. 5). Three-3.7 m (10–12 in.) of deflection on the steel beam in this intersection indicates the sum of separate fracture voids up in the roof and can be used as a de facto roof extensometer.

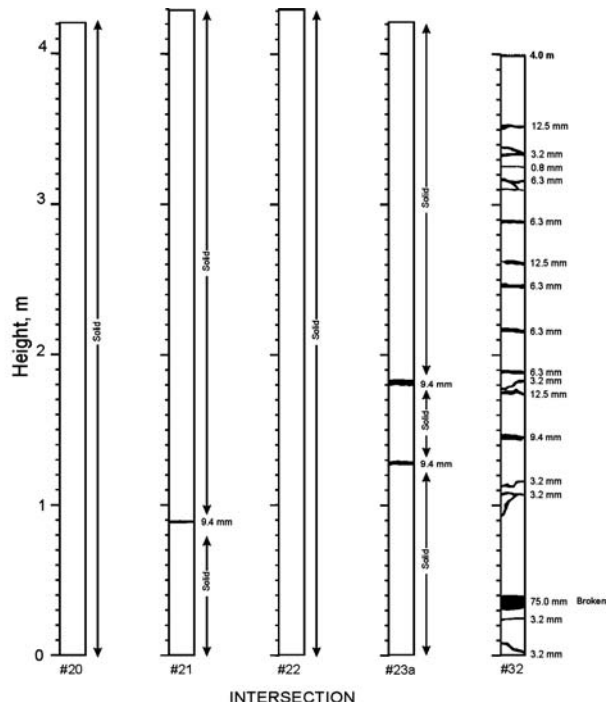
Fig. 4 Video logs of roof holes in selected intersections before PUR injection

In five intersections (Nos. 20, 21, 22, 23, 32) both pre and post-injection test holes were video-logged in order to determine which pre-existing fractures were filled with PUR (Figs. 4, 6). In intersections No. 21 and 23, all of the pre-existing fractures, in the zone of reinforcement, were filled with PUR.

In intersection No. 20 and 22 pre-injection holes showed solid roof and no voids or even separations (Fig. 4). After injection, a video log revealed that PUR was injected into a zone at 0.5 m (1.7 ft.) and from 1.1–1.2 m (3.5–3.8 ft.) into the roof in hole No. 20 (Fig. 6). It seems that in these holes PUR was injected either into weak, unseparated bedding planes or that it hydrofractured the bedding planes with injection pressures up to 12.4 MPa (1,800 psi.) Hole No. 22 showed similar evidence of hydrofracturing.

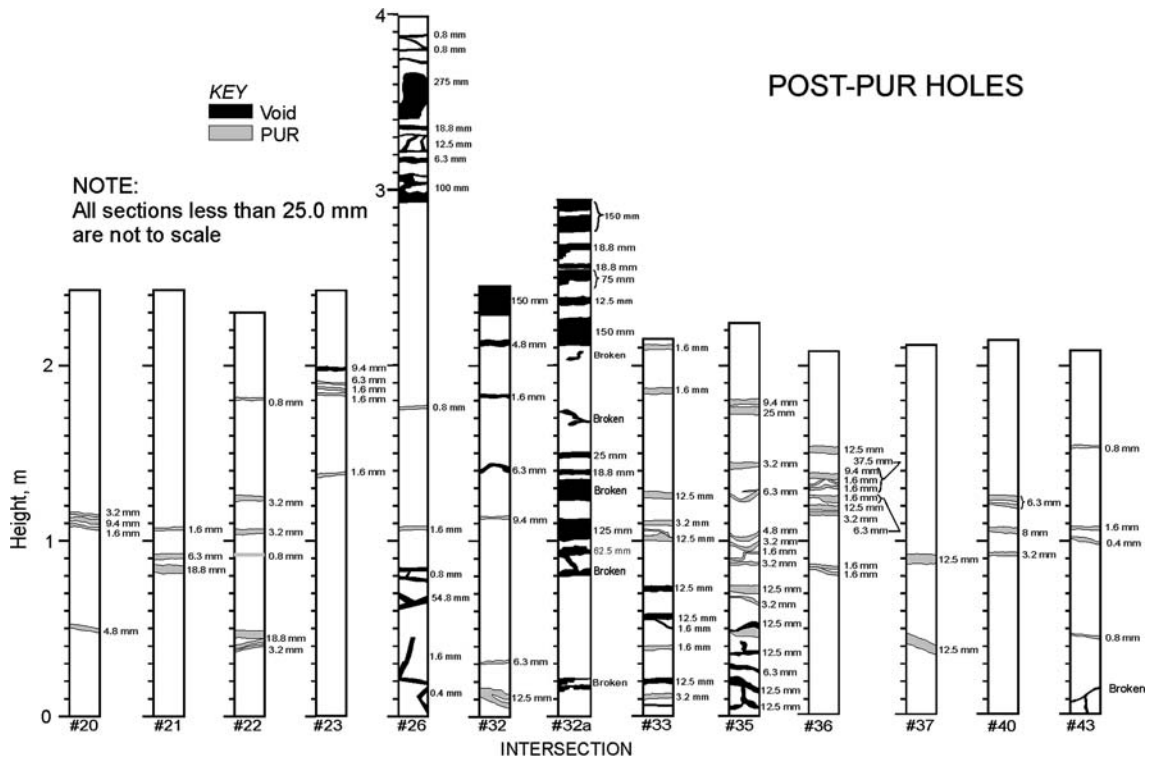
Fig. 6 Fractures filled with PUR in selected intersections after PUR injection

At intersection No. 32 PUR injection was less successful. PUR injection was stopped because no back pressures could be built up indicating flow out of the intersection. Several centimeters of void space was measured in the pre-injection pump zone (0.6–2.1 m (2–7 ft.) into the roof) (Fig. 4). No PUR was observed in one post-injection monitoring hole (Fig. 6, No. 32a), indicating loss of PUR into voids. The other post injection test hole in the intersection showed much less severe fracturing in the target zone at 0.6–2.1 m (2–7 ft.), with some PUR showing at 1.2 m (4 ft.). Several fractures in a zone from 0–0.2 m (0–1 ft.) had PUR shows. PUR shows in this zone, below the packed injection zone, indicated the extreme fracturing in this intersection. The PUR found fracture conduits below the packed zone and was seen dripping from the roof. In intersection No. 32 the one pre-injection hole and two post injection holes showed large variations in fracture location in the intersection. This indicates that additional

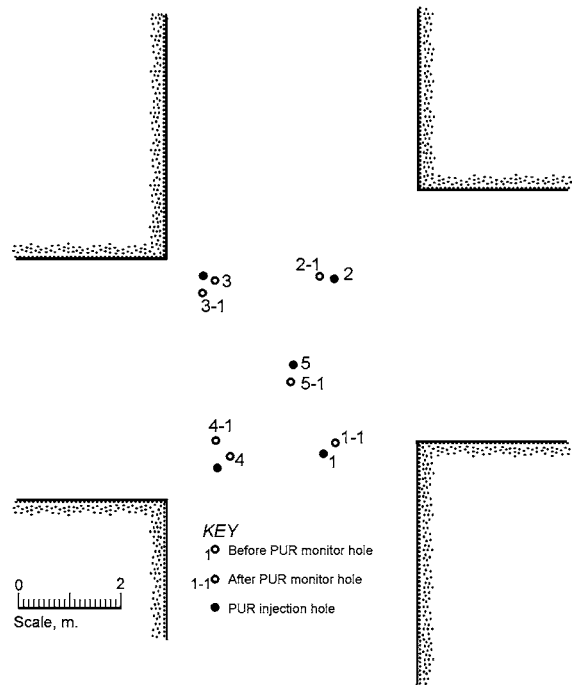
Fig. 7 Intersection holes monitored before and after PUR injection

Hole No. 2 showed a total of 2.8 cm (1.1 in.) of open void or rubbleized zones of fractured rock up in the monitoring holes which were drilled to 3.0 m (10 ft.). The individual cracks ranged from 0.15–1.28 cm (0.06–0.5 in.), in bedding separations and zones of rubble. In holes 1, 2, 3 most fractures occurred above 1.5 m (5 ft.) and in holes 4, 5 most fractures occurred below 1.2 m (4 ft.), indicating some variability across the intersection. Polyurethane was injected into five vertical holes adjacent (30–60 cm (1–2 ft.) away) to the observation holes in the intersection. The holes were packed at approximately 30 cm (1 ft.) above the roof line.

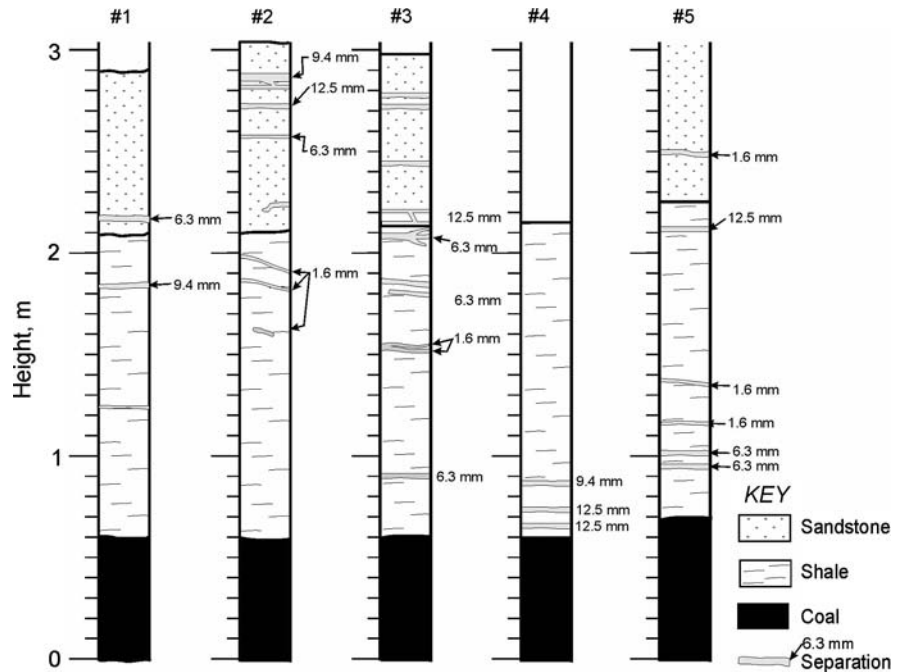
Fig. 9 Post-injection monitoring holes in the intersection

Figure 9 shows the logs of test holes drilled after PUR injection. Approximately 50% of the total

fractures were filled with PUR, while the other 50% remained open. Figure 10 shows one of the glue-filled fractures after PUR injection. Since the holes were packed at the bottom, the PUR was free to find the path of least resistance up hole. Due to the tortuous nature of the fracture permeability the PUR found pathways which filled some fracture zones and bypassed others, as observed in the post-PUR monitoring holes. From experience at the mine in West Virginia this amount of void space filling should be enough to stabilize the intersection. The mine was closed shortly after the project and no assessment of the success of the PUR stabilization project was possible. By using multiple packed zones, as was the case in the West Virginia project, the chances of targeting particular zones of significant fracturing can be greatly increased.

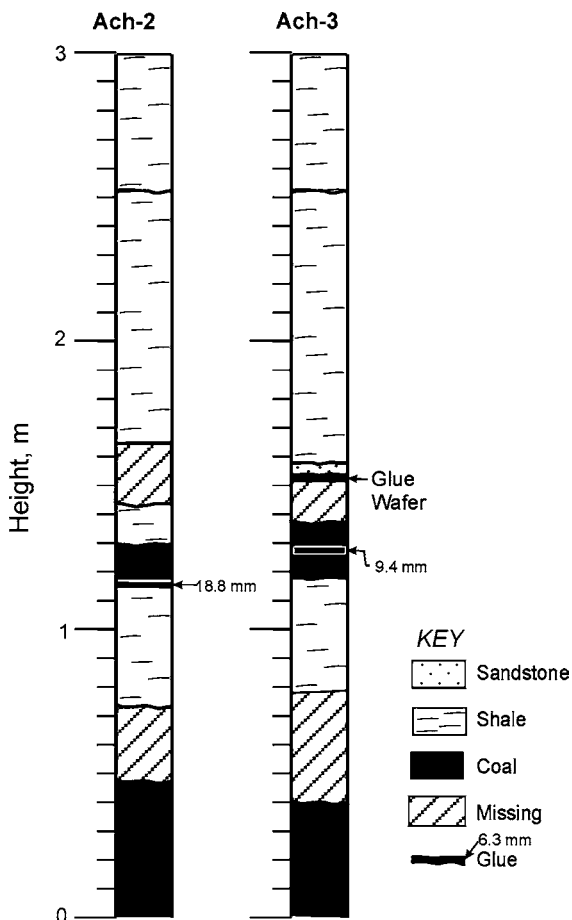
Fig. 11 Core holes drilled after PUR injection show glue injected at ≈ 1.2 m

Two coreholes were drilled after injection to determine the location of the polyurethane (Fig. 11). PUR was found injected along bedding at 1.2 m (3.9 ft.) in corehole ACH-2 and at 1.3 m (4.2 ft.) and 1.6 m (5.2 ft.) in ACH-3. This is essentially the same horizon due to small variables in the roof line. The PUR had hydrofractured the weak bedding in the second rider coalbed and left a 1.9 cm (0.75 in.) thick plug along bedding (Fig. 13). PUR was pumped into 1.5 m (5 ft.) of open hole at six locations around the intersection and the path of least resistance was the weak bedding found in the second rider coalbed (Fig. 11).

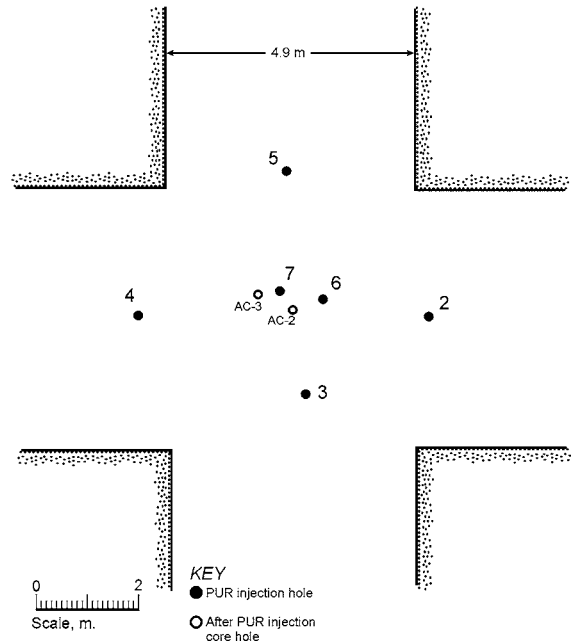
Fig. 12 Injection and monitoring holes at the Safety Research Coal Mine

coals and shale (Fig. 11). Six 2.4 m (8 ft.) long injection holes were drilled in one intersection (Fig. 12) into which a total of 477 kg (1,050 lbs) (397 l (105 gal)) of polyurethane was injected. The holes were isolated with packers located at 0.9 m (3 ft.) up in the hole, and PUR was pumped into open

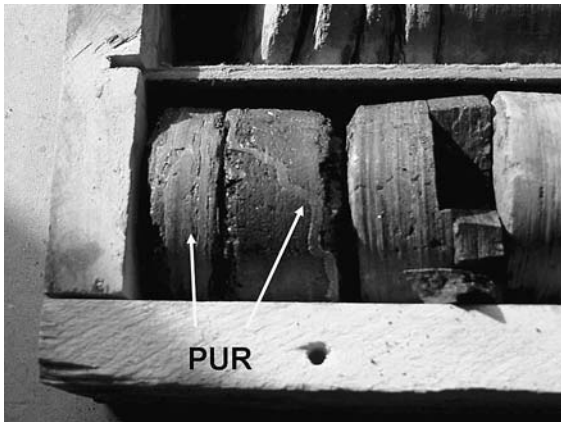
Fig. 13 Polyurethane injected into roof core Ach-2 at 1.2 m Bruceton Research Safety Coal Mine

The 1.9 cm (0.75 in.) thick layer of polyurethane injected into the Pittsburgh roof bedding at the Bruceton site cannot be considered a consistent and continuous layer, considering the variability of bedding strength. The most likely occurrence, seen at both test sites, is that the PUR will be injected on only one horizon. Similarly, in the second site at the longwall recovery chute, only one horizon was hydrofractured. This single layer cannot be expected to provide substantial resistance to thick, overlying, detached roof blocks. These results are consistent with results obtained by using the hydrofracture method to measure in situ stress (Enever et al. 1990). In this procedure, only one bedding fracture is obtained in weak rock, indicating the path of least resistance for the fluid. Once the fracture has been created and the PUR is being injected, large volumes may be pumped into the single bedding plane fracture. This additional PUR will provide little additional reinforcement as it is usually a thin wafer confined to only one horizon. If substantial reinforcement is desired in unfractured rock, that goal must be accomplished by specific design. Multiple injection zones must be isolated with packers and the reinforcement will be obtained by the sum of the strength of several layers of PUR injected into weak bedding planes.

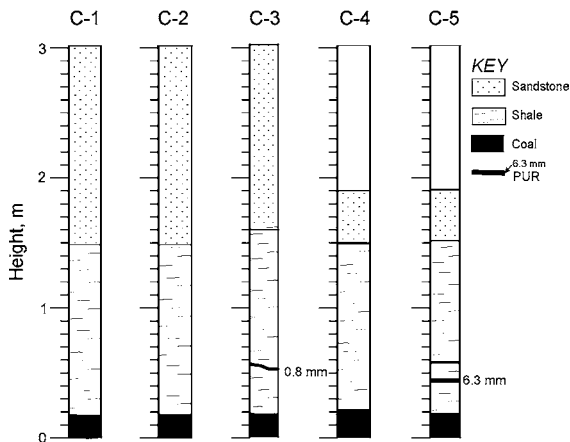
Fig. 17 Location of PUR after injection

(1.4–1.9 ft.) up in the roof in two of the video holes (C-3, 5). These shows were below the packer at 0.6 m (2 ft.). This indicates that PUR migrated below the packer and found weak bedding planes at 42.7–57.9 cm (1.4 and 1.9 ft.). Similar to the Bruceton unfractured roof case, only one zone was hydrofractured and reinforced.

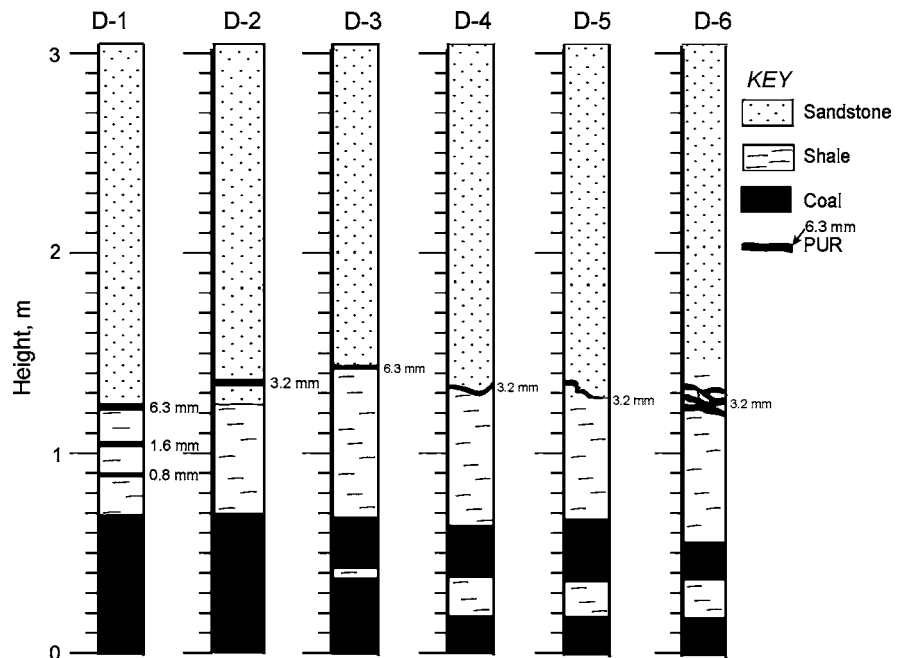
Fig. 18 Location of PUR after injection

shale contact occurred at 1.1 m (3.5 ft.). All six monitor holes showed PUR layers ranging from 0.08–0.64 cm (0.03–0.25 in.) thick right near the contact of the sandstone and shale. Clearly the weakest bedding contact was this shale/sandstone contact. The PUR that was injected into the roof of both test rooms found the bedding horizon that was the weakest and wedged it open. In only one monitor hole (D-1) was there evidence of multiple injection zones over a 0.45 m (1.5 ft.) zone.
