Bureau of Mines Report of Investigations/1987

# Analysis of Cutter Roof Failure Induced by Clastic Dikes in an Underground Coal Mine

By Eric R. Bauer and John L. Hill III

**Report of Investigations 9117**

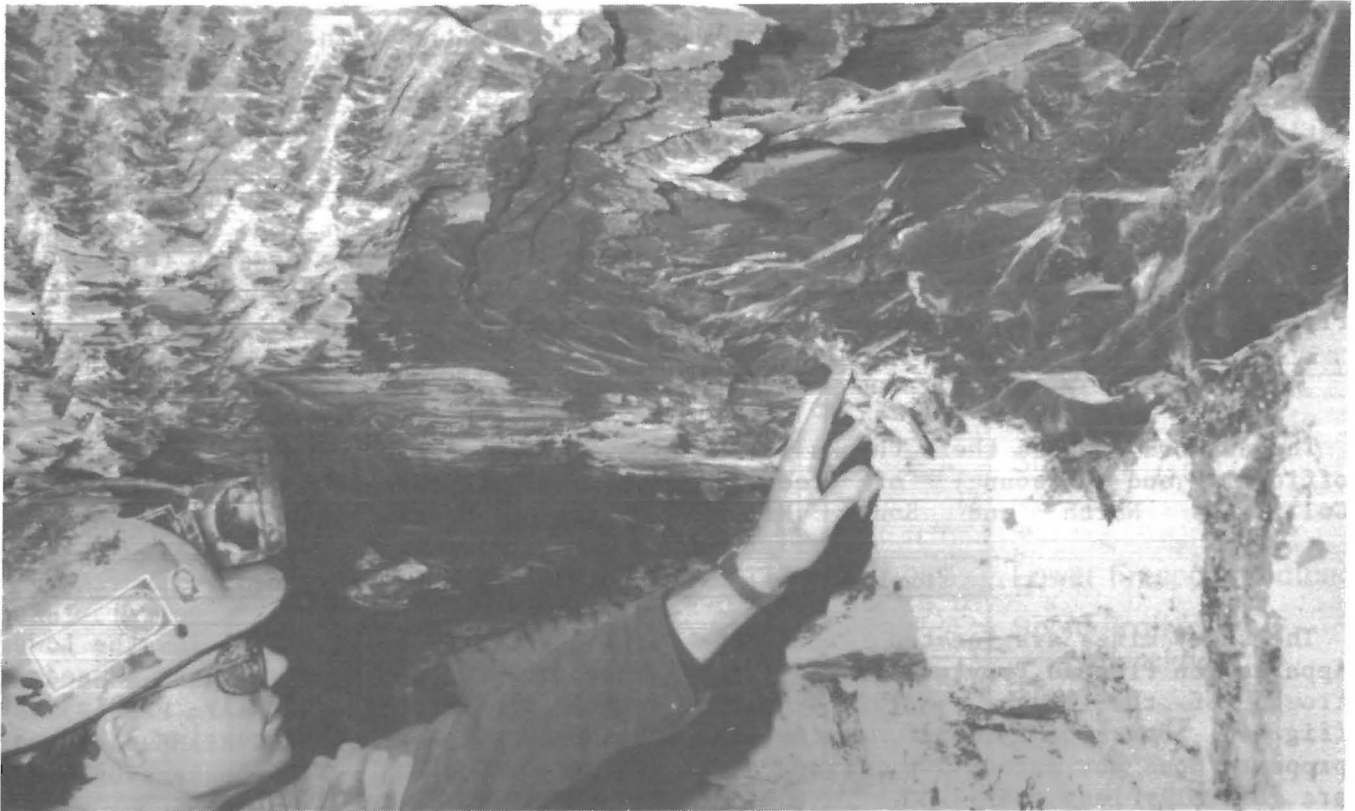
Cutter roof failure begins as a fracture along one or both roof-rib lines of an entry or crosscut and propagates nearly vertically into the roof (fig. 1). When the fracture extends above the anchor horizon of the roof bolts, or deflects along a weak bedding plane, massive roof failure may occur. Figure 2 is an example of initial cutter failure, and figure 3 illustrates the end result of such cutter development.

FIGURE 2.—Example of initial cutter roof failure.

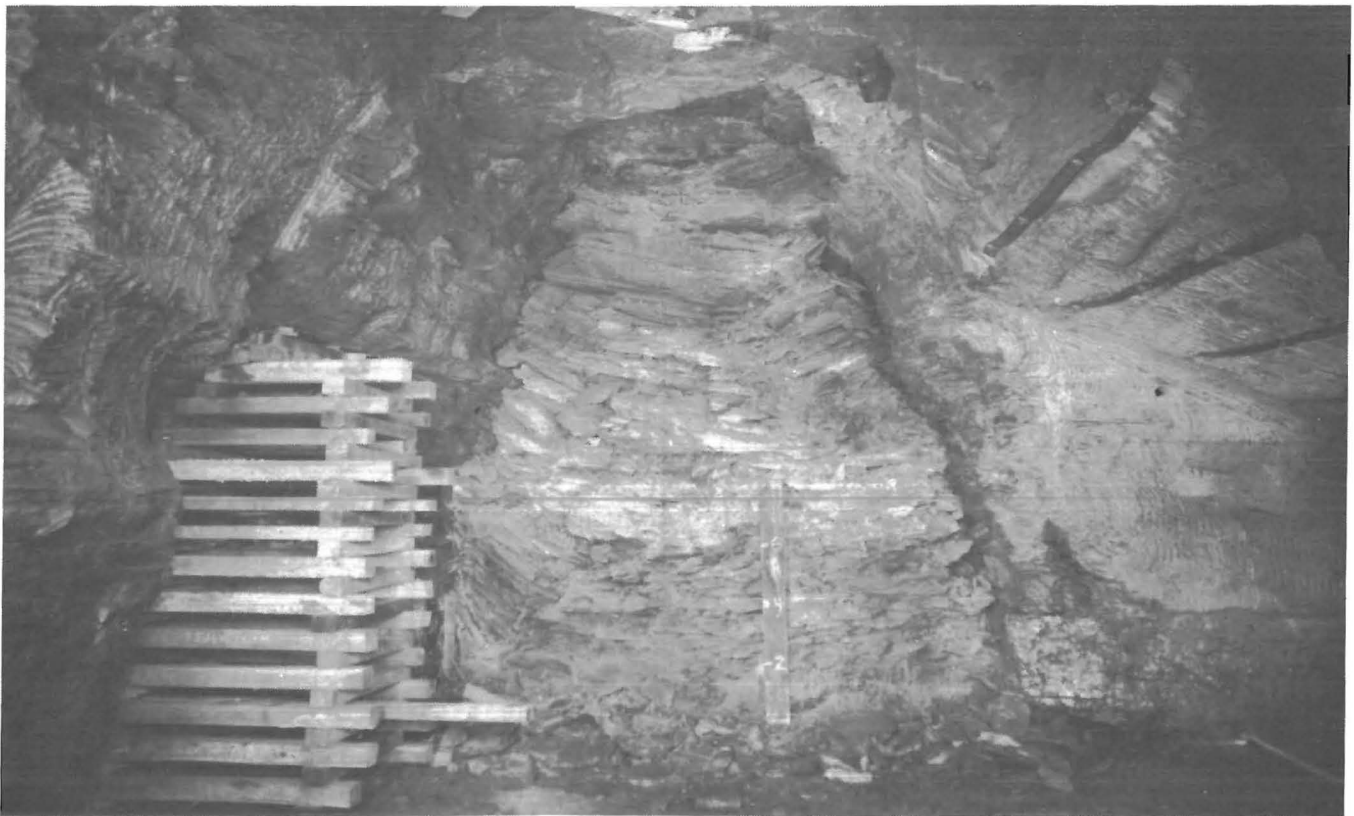
FIGURE 3.—Typical roof fall resulting from cutter failure (8).

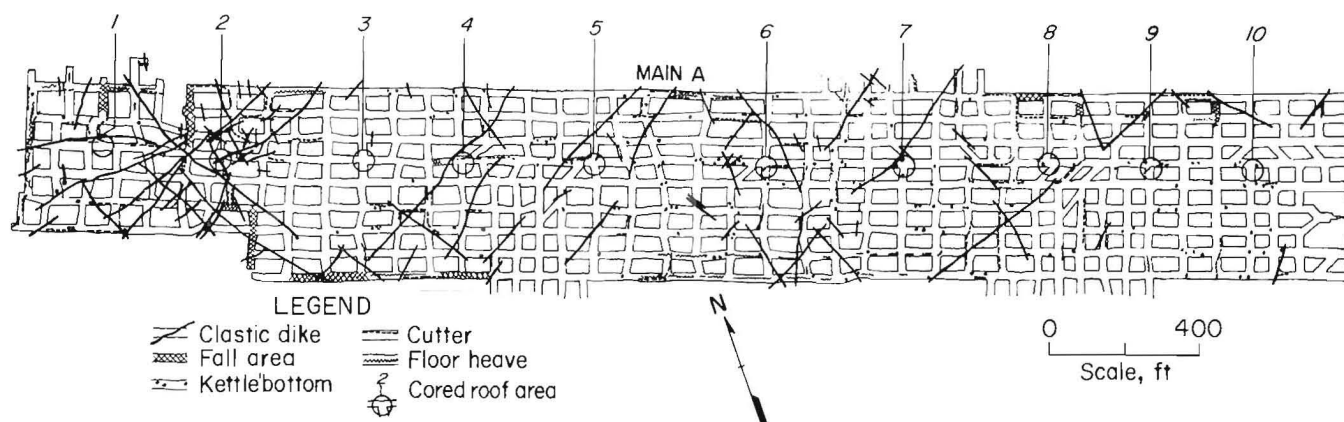
Detailed mapping of geologic features and deformation during cutter development was conducted in the Main A headings from the shaft to the face. Figure 6 is an example of the mapping and illustrates the relation of geologic features to roof failure. Clastic dikes (or clay veins), ranging in thickness from 1 ft of claystone matrix with fragments of shale and coal to a thin film of calcite or clay, are the primary roof-failure-initiating geologic features. Clastic dikes in areas overlain by channel and splay sandstones were filled with fine sand and silt instead of claystone. In some instances, infilled fractures and joints were by accident labeled clastic dikes because of similar appearance. The dikes

FIGURE 6.—Results of detailed mapping of the Main A headings (9).

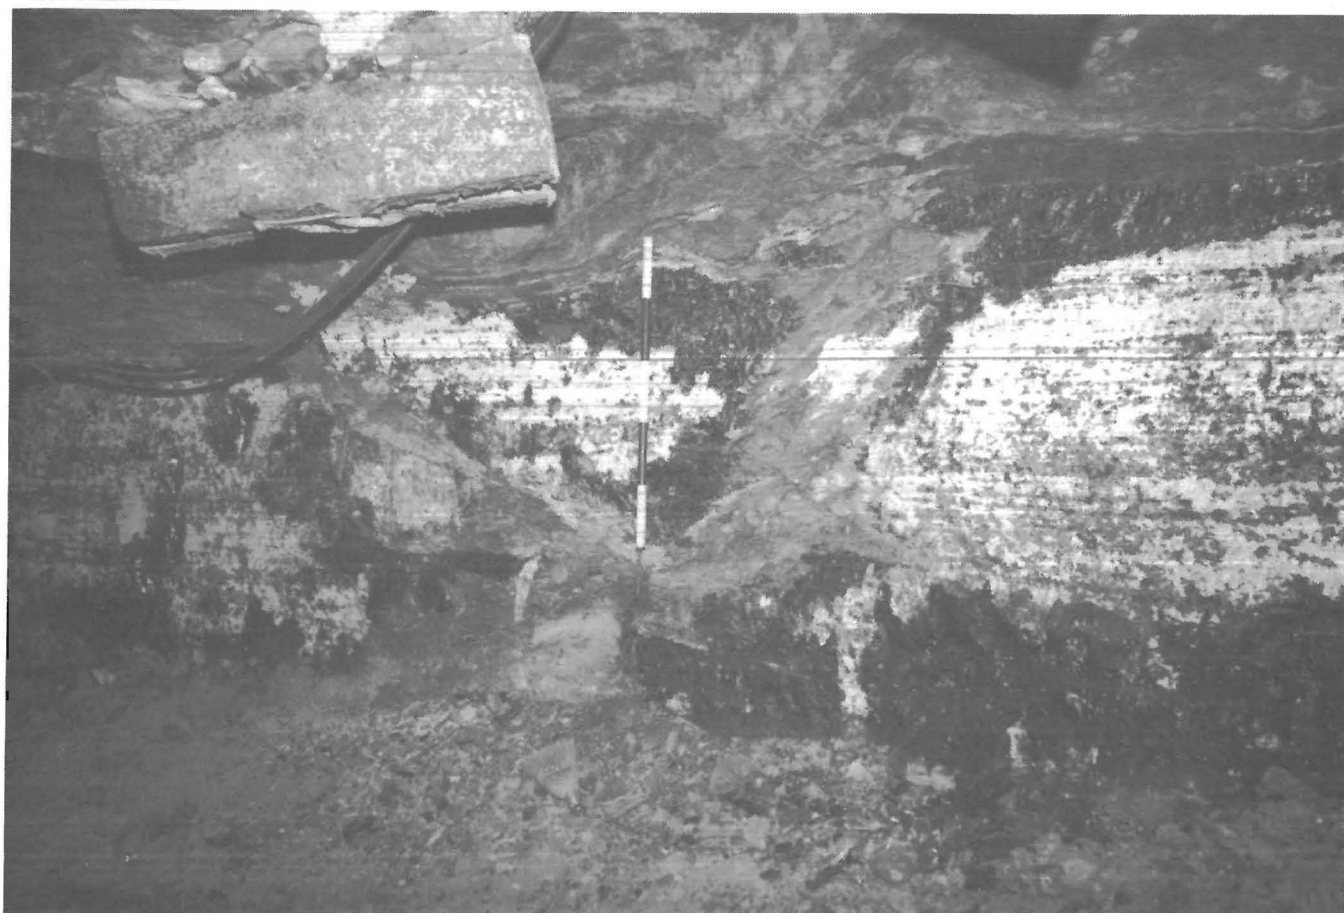
FIGURE 7.—Example of a clastic dike in both the mine roof and coal seam. (Courtesy F. E. Chase, BuMines, Pittsburgh, PA.)

exposed in roof falls extend as high as 26 ft into the roof rock and penetrate the coalbed at various angles. Figure 7 is an example of a clastic dike that has intersected both the mine roof and the coal seam. Few dikes reached the floor rock, suggesting an intrusion from above

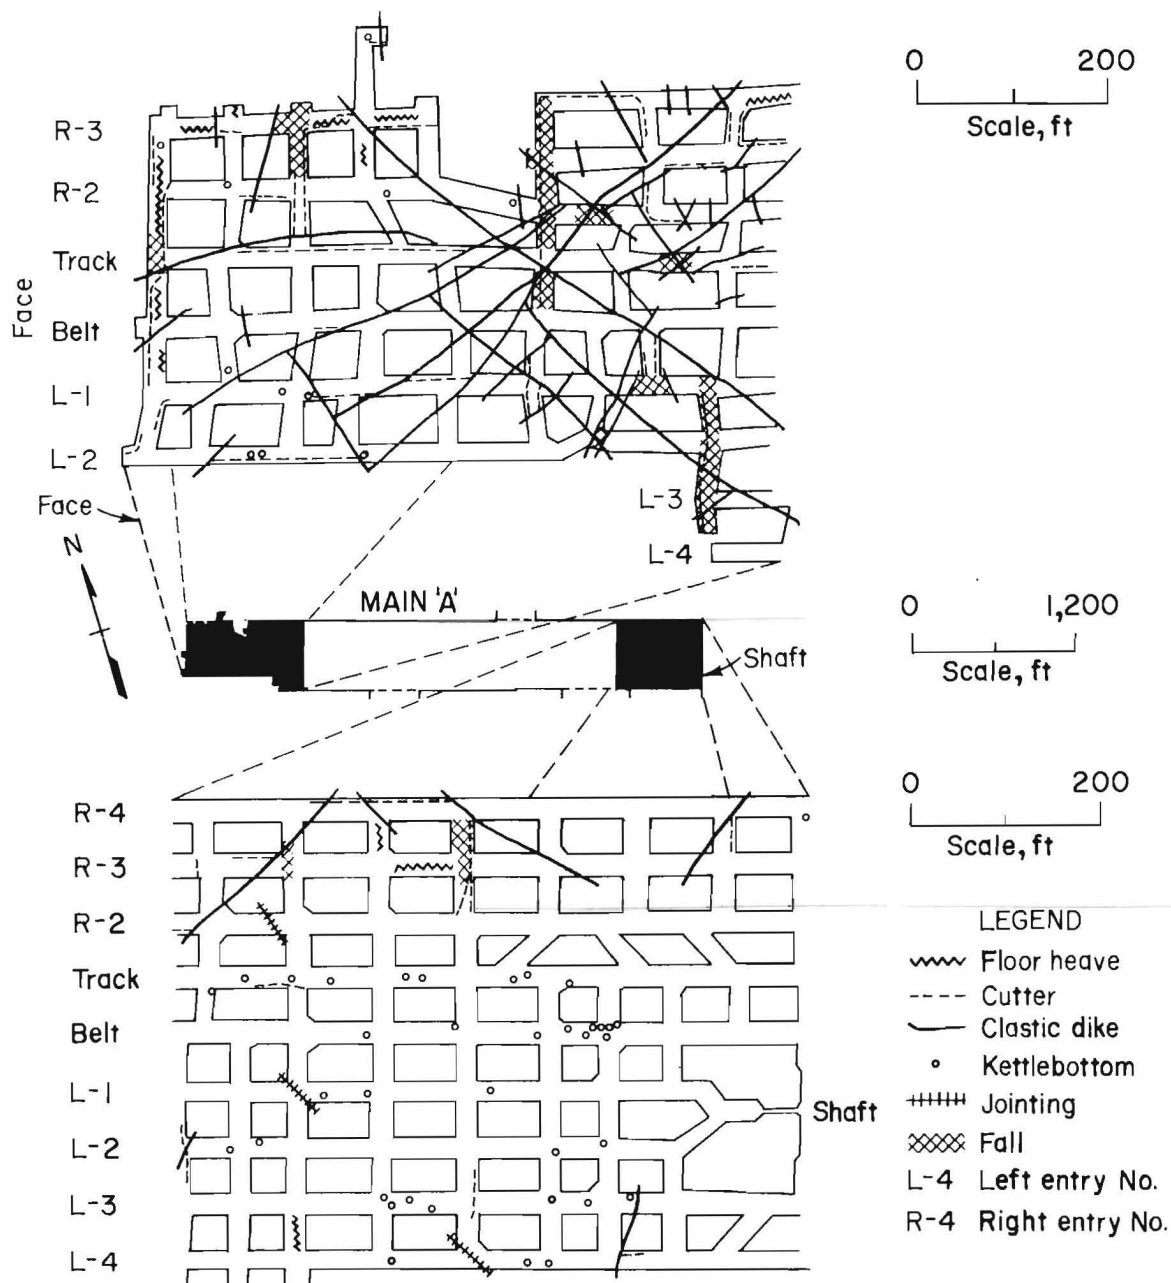
Figure 9 shows that the frequencies of clastic dikes and cutters were much greater near the face of Main A than near the shaft area. Main A was divided into seven equal areas of 87,000 ft<sup>2</sup> from the face to the shaft. The total lengths of clastic dikes, cutters, and roof falls in each area were calculated, then plotted on a histogram (fig. 10). This histogram shows that there was a gradual increase of both clastic dikes and cutters from the shaft to the face. Along with the increase in dikes and cutters is a corresponding increase in roof falls, a normally occurring and predictable trend. Also plotted on figure 10 is the total number of kettlebottoms found in each area. Kettlebottoms were found in all areas of the Main A headings, indicating that generally similar environmental conditions were present during coal formation of the entire area. The entirety of the mapping suggests that the stresses were greater in the area of the present mining face at some point in time, possibly due to the formation of the syncline causing more fissures and eventually, through infilling, more clastic dikes.

FIGURE 9.—Comparison of the geologic and deformational features in the face area and shaft area of the Main A headings (8).

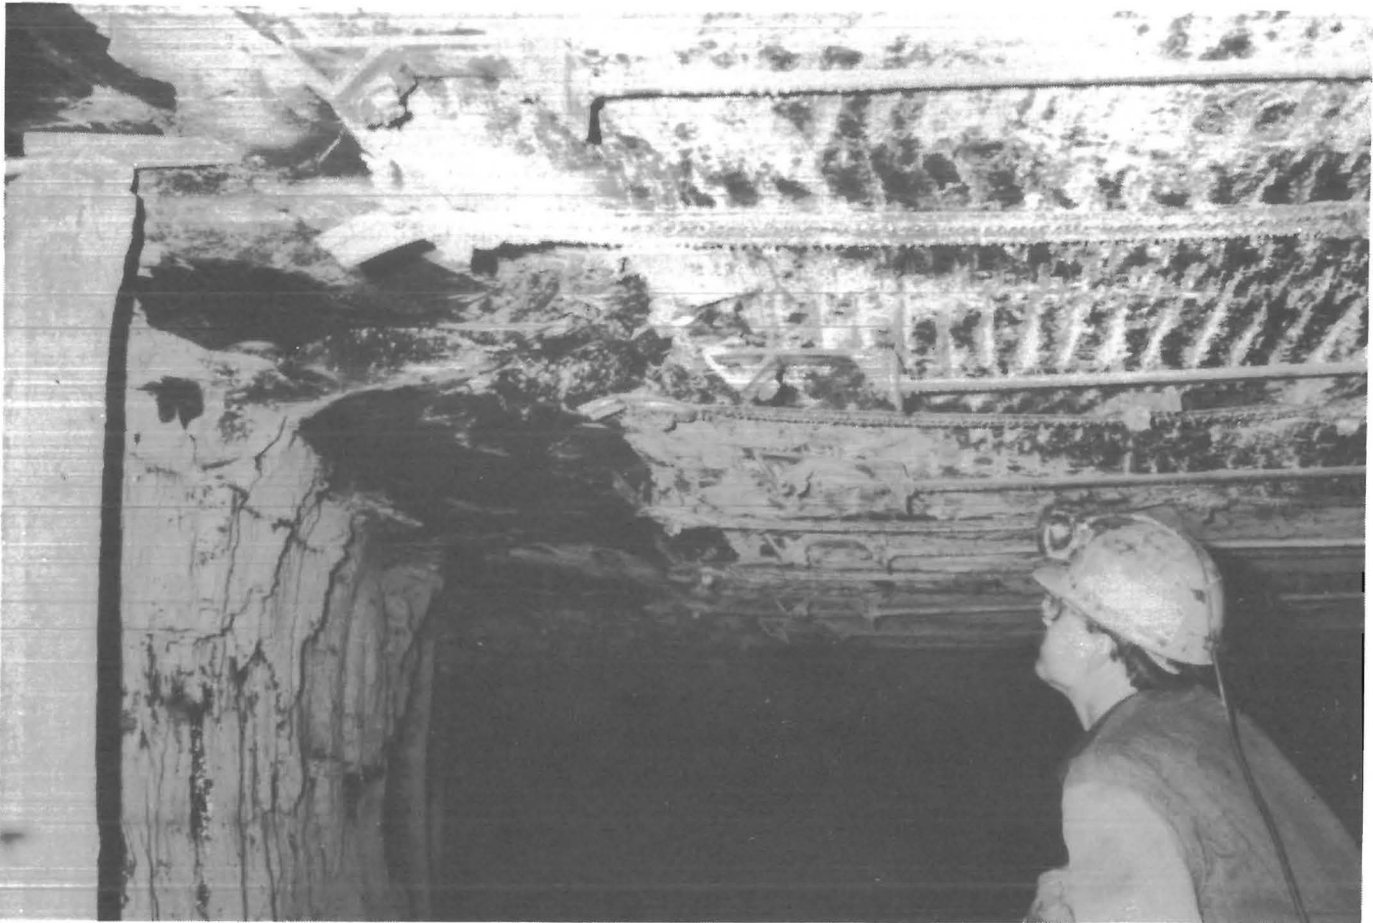
In the next area (fig. 15C) trusses were being used on a regular basis and had been successful in deterring the formation of cutters. Shortly after this cut was mined, some rock did fall from the clastic dike in the roof, but this activity ceased once trusses were installed. Figure 21 shows the total loading seen by each U-cell across the entry.

FIGURE 19.—Example of roof trusses supporting cutter roof.

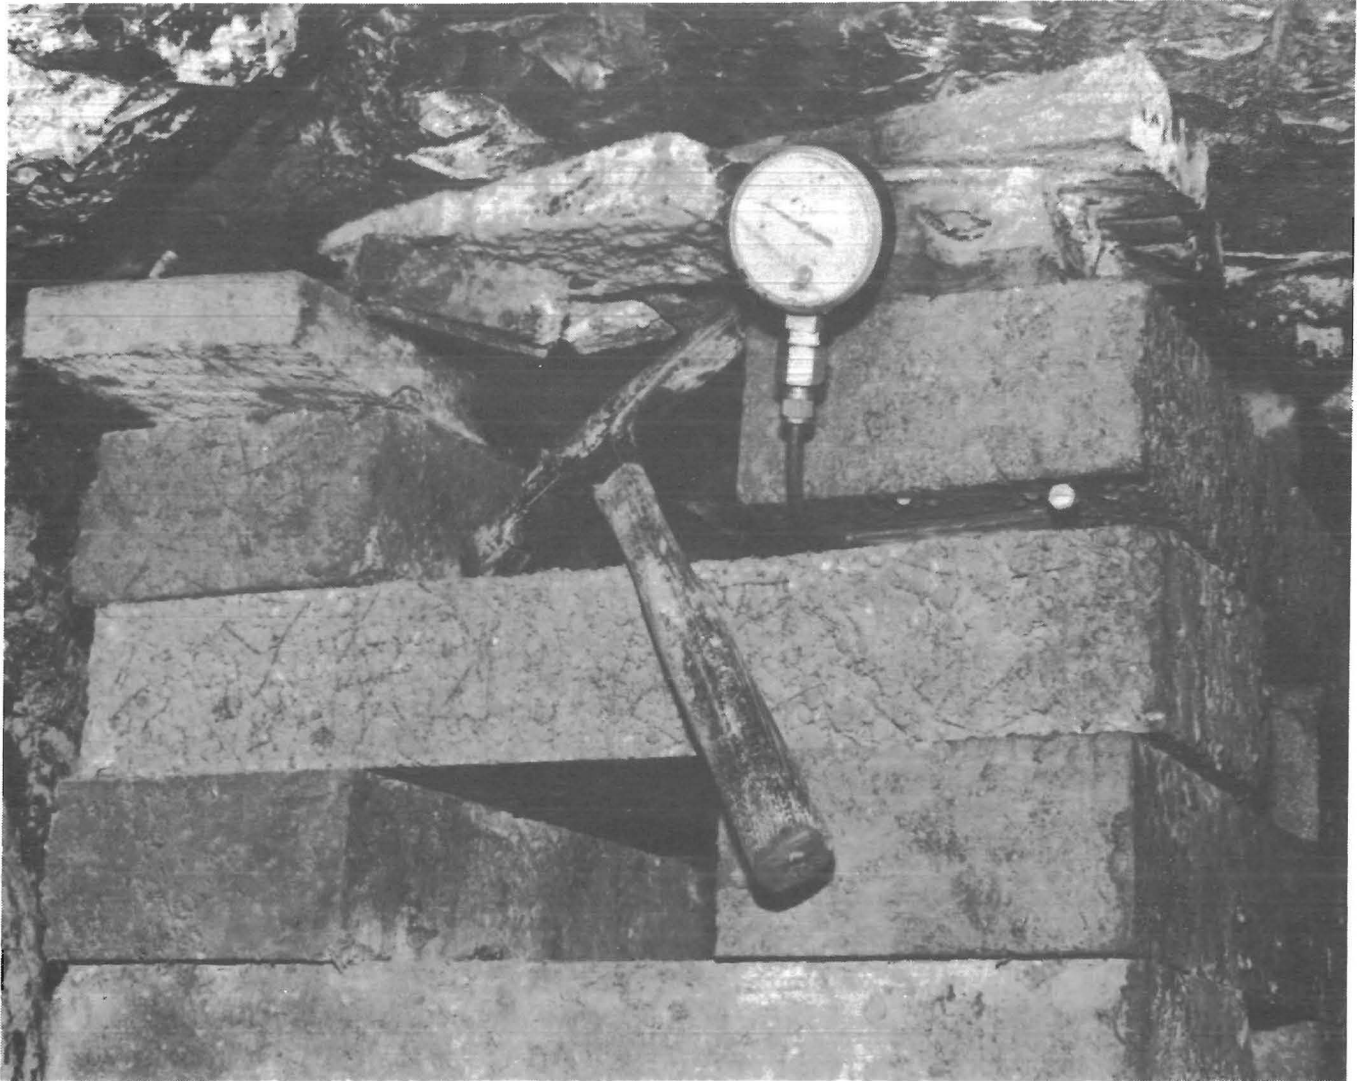
FIGURE 23.—Flat hydraulic cell monitoring loading on a steel-fiber-reinforced concrete crib.
