REPORT OF INVESTIGATIONS/1989

Effects of Structural Faults on Ground Control in Selected Coal Mines in Southwestern Virginia

By Gregory M. Molinda and David K. Ingram

BUREAU OF MINES

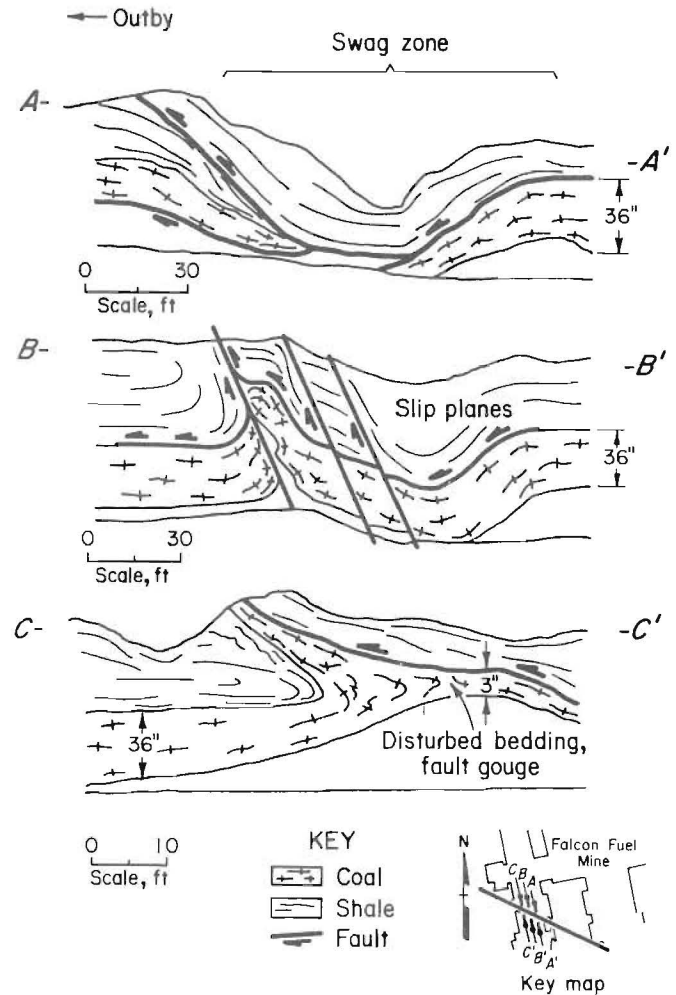
Figure 6.—Series of cross sections of Pistol Gap Fault exposed in Falcon Fuel Mine.

At cross section B-B' (only 50 ft away), the nature of the disturbance is different (fig. 6). Here, the compressive forces have dragged the coalbed into the roof and partially severed it. A series of three main faults have isolated two fault blocks, which have been uplifted as horsts. The coalbed and adjacent strata have been severely disturbed

Figure 6 (cross section B-B') also shows that the fault zone is accompanied by a swag zone up to about 75 ft wide where the coalbed is downbuckled approximately 8 ft. This feature is characteristic of compressional stress fields in both these cross sections and may serve to warn miners that they are approaching a fault. Figure 11 shows an interpretation of events in the formation of bedding plane faults at the site of the existing Pistol Gap Fault. Section A is the coalbed with the existing strike-slip fault; sections B-D are subject to increasing lateral compression until complete failure in section E. Section B shows the development of the swag, which precedes bedding plane failure in section C. In sections C and D, the severed coalbed is telescoping past itself as the thrust fault shears upward into the roof. The strike-slip fault plane is also deformed. Continued compression also warps the coalbed in the vicinity of the vertical failure.

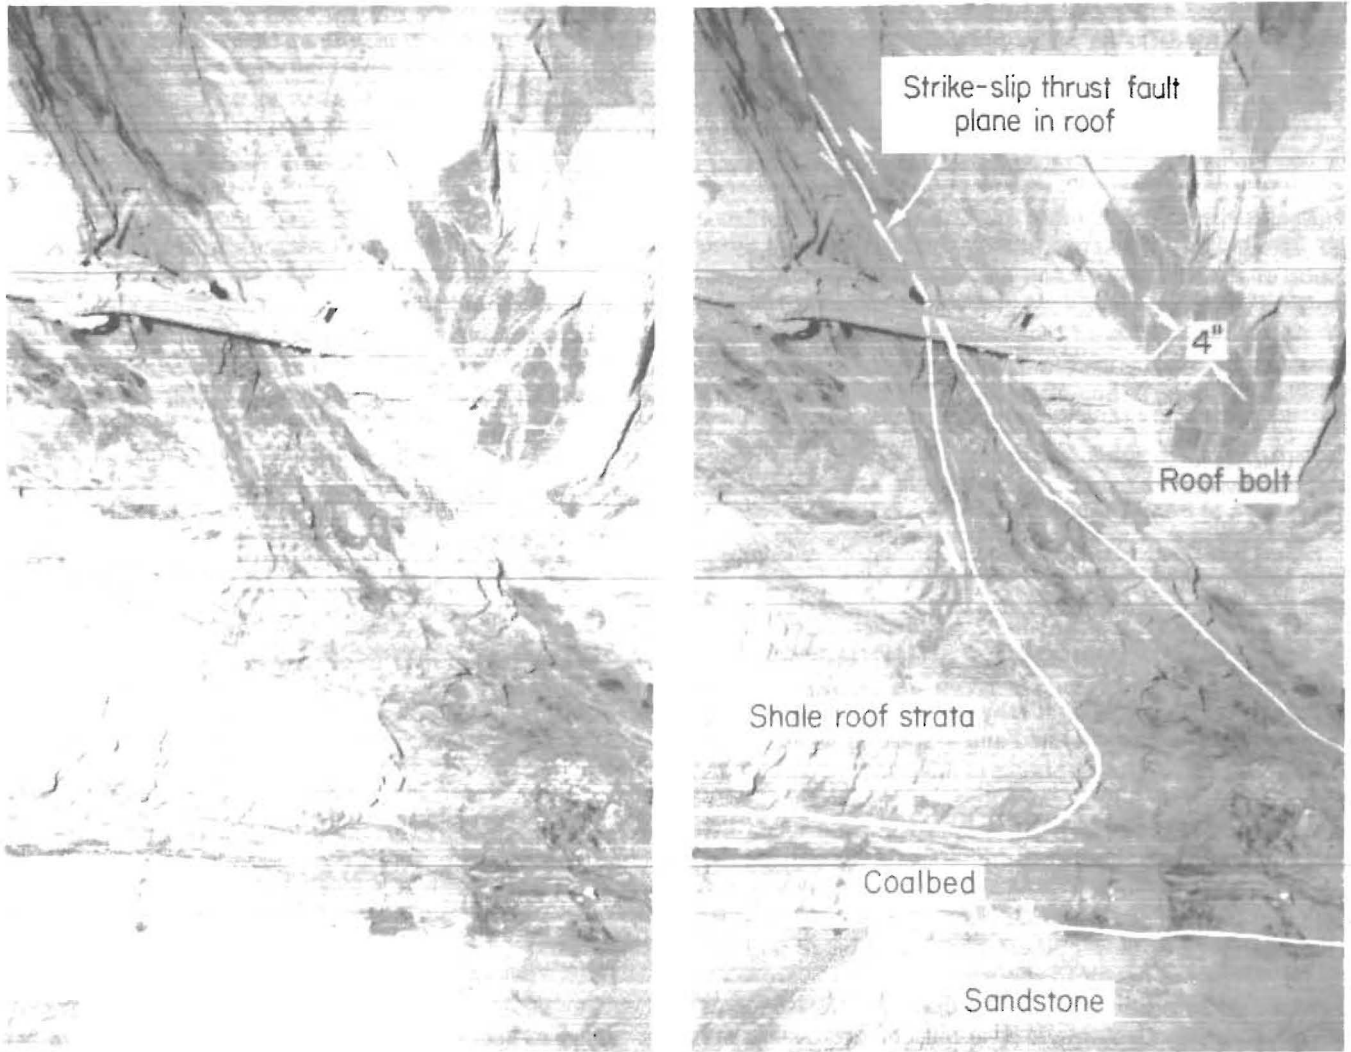
between the fault planes (coal fragmentation, fault gouge, and cleat rotation). The mine operator notes that roof bolts have been sheared in the vicinity of the fault, indicating active bedding plane movement since bolt installation. The movement, which has caused bolts to be sheared, appears to be mining induced and not the result of active tectonic compression. The entire mine is above drainage and therefore not subject to farfield horizontal stresses. In both cross sections A-A' and B-B', the Jawbone Coalbed has been overturned because of compression. Also, at all three places where the fault is exposed, horizontal (strike-slip) movement is indicated by slickensides. Roof conditions in the three accessible entries were poor for nearly 200 ft, with falls averaging 8 ft high and extending up to 20 ft high (fig. 10). Supplementary roof support included heavy crossbar sets, posts, I-beams, and resin bolts longer than 8 ft.

Figure 7.-Severe strata deformation and unstable roof caused by Pistol Gap Fault. Coalbed overturned and dragged upward.

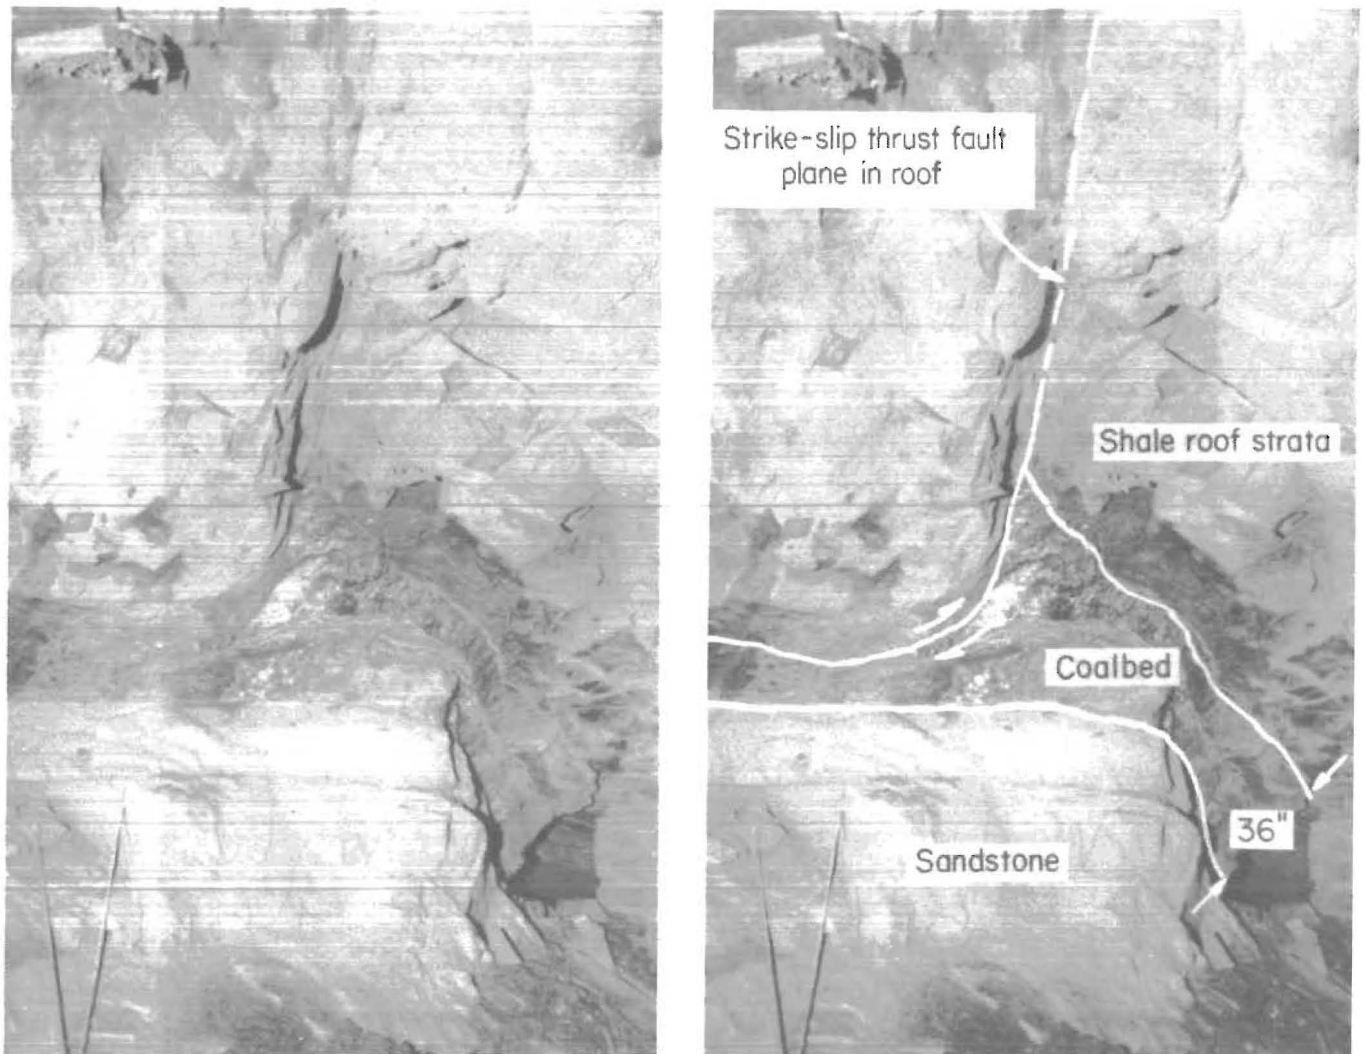
Figure 8.-Coalbed paralleled by bedding plane fault, which then shears into roof, causing roof fall.

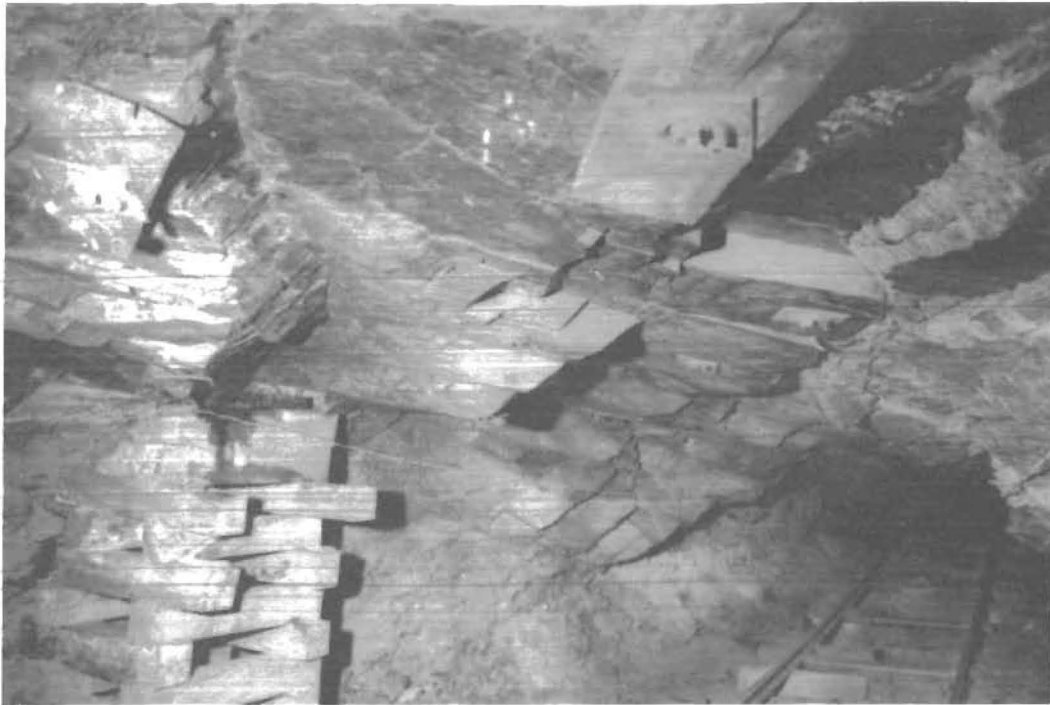
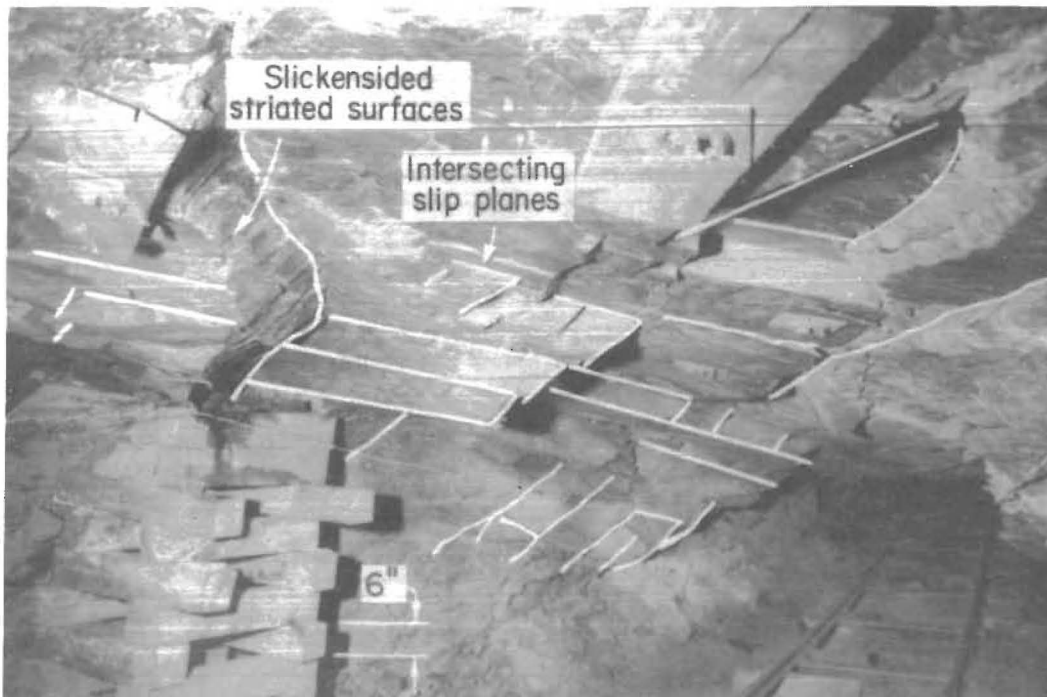
Figure 9.—Bedding plane fault exposed at coal-roof interface. Vertical fractures isolate hazardous roof blocks.

In a number of cases where the fault was mined through, the intersection of two or more opposite-dipping bedding plane faults caused the roof to drop out in blocks. These blocks should be supported by angle bolts, roof trusses, or straps to prevent arching falls. In all cases, the coalbed and surrounding draw slate and roof shales are severely disturbed. This disturbance is caused by compression and crushing of rock. Fault gouge is found along bedding plane faults and also vertically where the coalbed is dragged into the roof. This crushed rock has very low strength and should be avoided as a sole anchor for roof bolts.

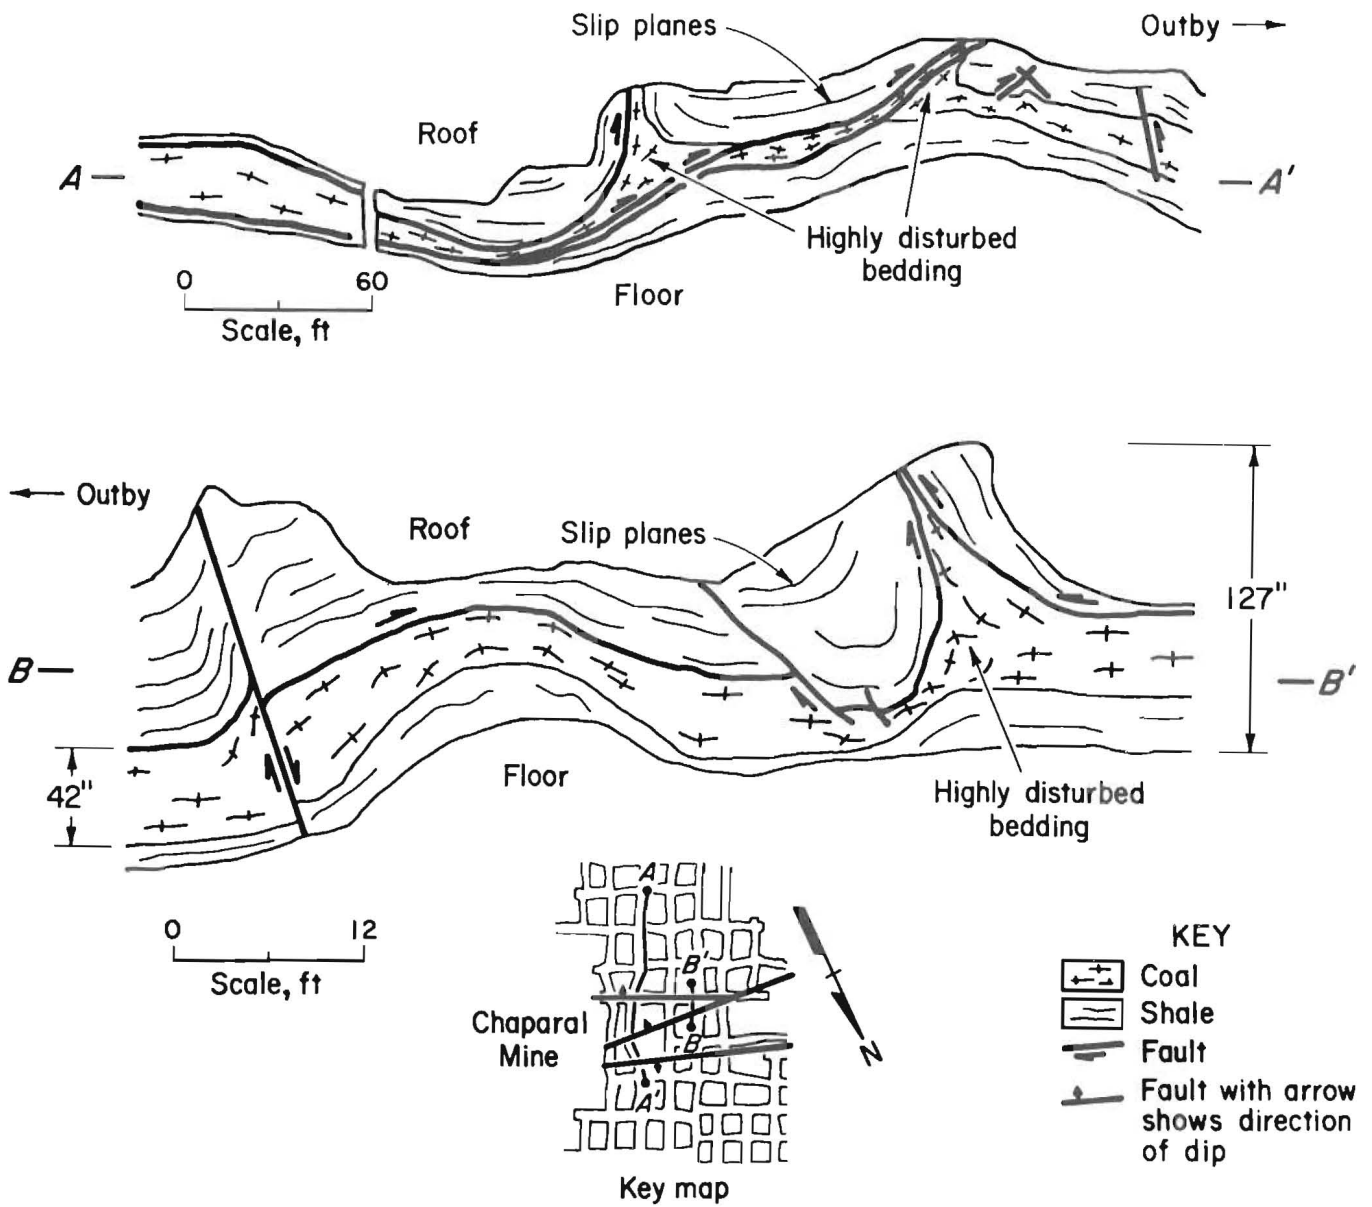
Figure 12.-Cross sections of Pistol Gap Fault exposure in Chaparal Mine.

The Chaparal Mine is another contract mine to United Co. This drift mine works the Jawbone Coalbed and has intersected the Pistol Gap Fault while driving a south-western development (fig. 4). Figure 12 shows two cross sections through the fault zone. Cross section A-A' shows a large swag zone (approximately 230 ft wide) inby the fault zone. The Jawbone Coalbed has been buckled down 4 to 5 ft before returning to normal elevation outby the faults. As in the Falcon Fuel Mine, compression that oriented northeast-southwest caused a swag to the southwest of the fault zone. The coalbed failure is evident because a bedding plane fault exists at the coal-roof interface and between the roof and floor (fig. 13). This bedding plane fault then ramps up into the roof, causing a roof fall. The coalbed has been smeared out to only several inches thick. Also, there is a well-defined fault gouge zone that marks several of the fault planes within the coalbed. The coalbed has also been rippled, as seen on the outby side of cross section A-A' (fig. 12). This local "thin skinned" rippling is a common compressional feature.

Cross section B-B' shows the same failure reaction to compression. The outby block has been buckled up and the inby block has been split by the outby block (fig. 12), causing upward thrusting of the coalbed into the roof and an overturning of the fault plane (fig. 14). The coalbed and the roof strata are highly disturbed between the fault planes. The coalbed also thickens to over 93 in owing to compression. This thickening seems to be characteristic of thrust faulting in this area.

To minimize production loss and hazardous roof conditions, the operators were forced to narrow the development in order to cross the fault. In addition, fewer crosscuts were turned, which made pillars over twice as long as normal. Again, the narrow development causes restrictions to ventilation. Roof conditions were very poor in the 100- to 150-ft-wide fault zone. Most of the entries crossing the fault were inaccessible because of dangerous roof. Several falls were over 15 ft high and had to be supported by elaborate terraced cribbing (fig. 15). Within the fault zone, numerous intersecting fault planes broke the roof into blocks and made rock bolting ineffective.

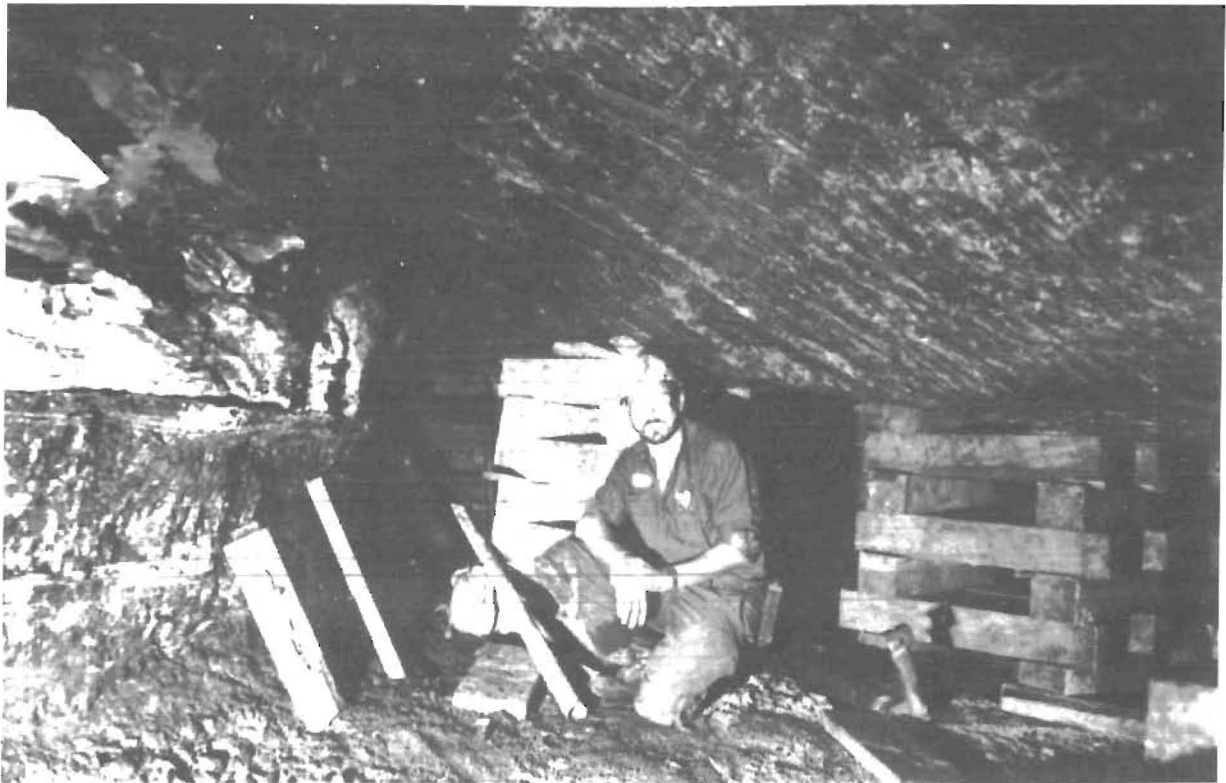
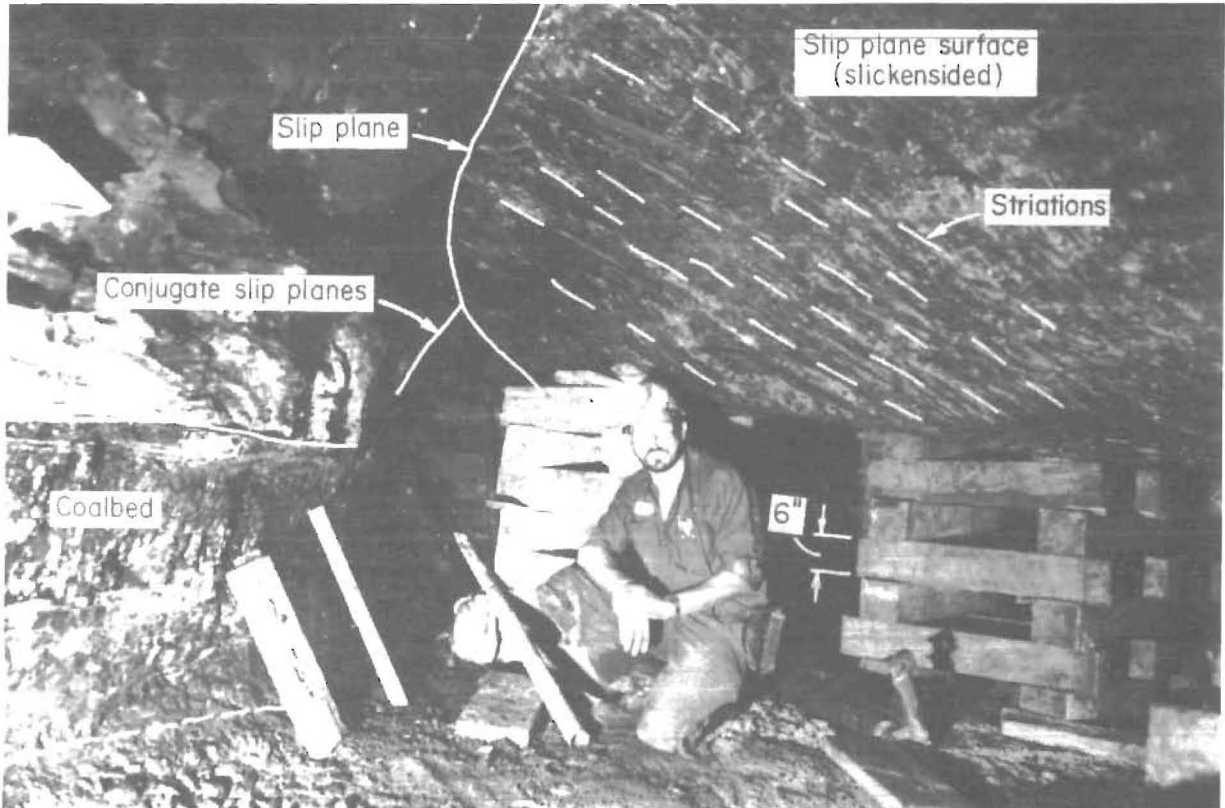
Figure 13.-Bedding plane fault rising into roof, showing roof fall caused by section of roof spalling away from fault plane.

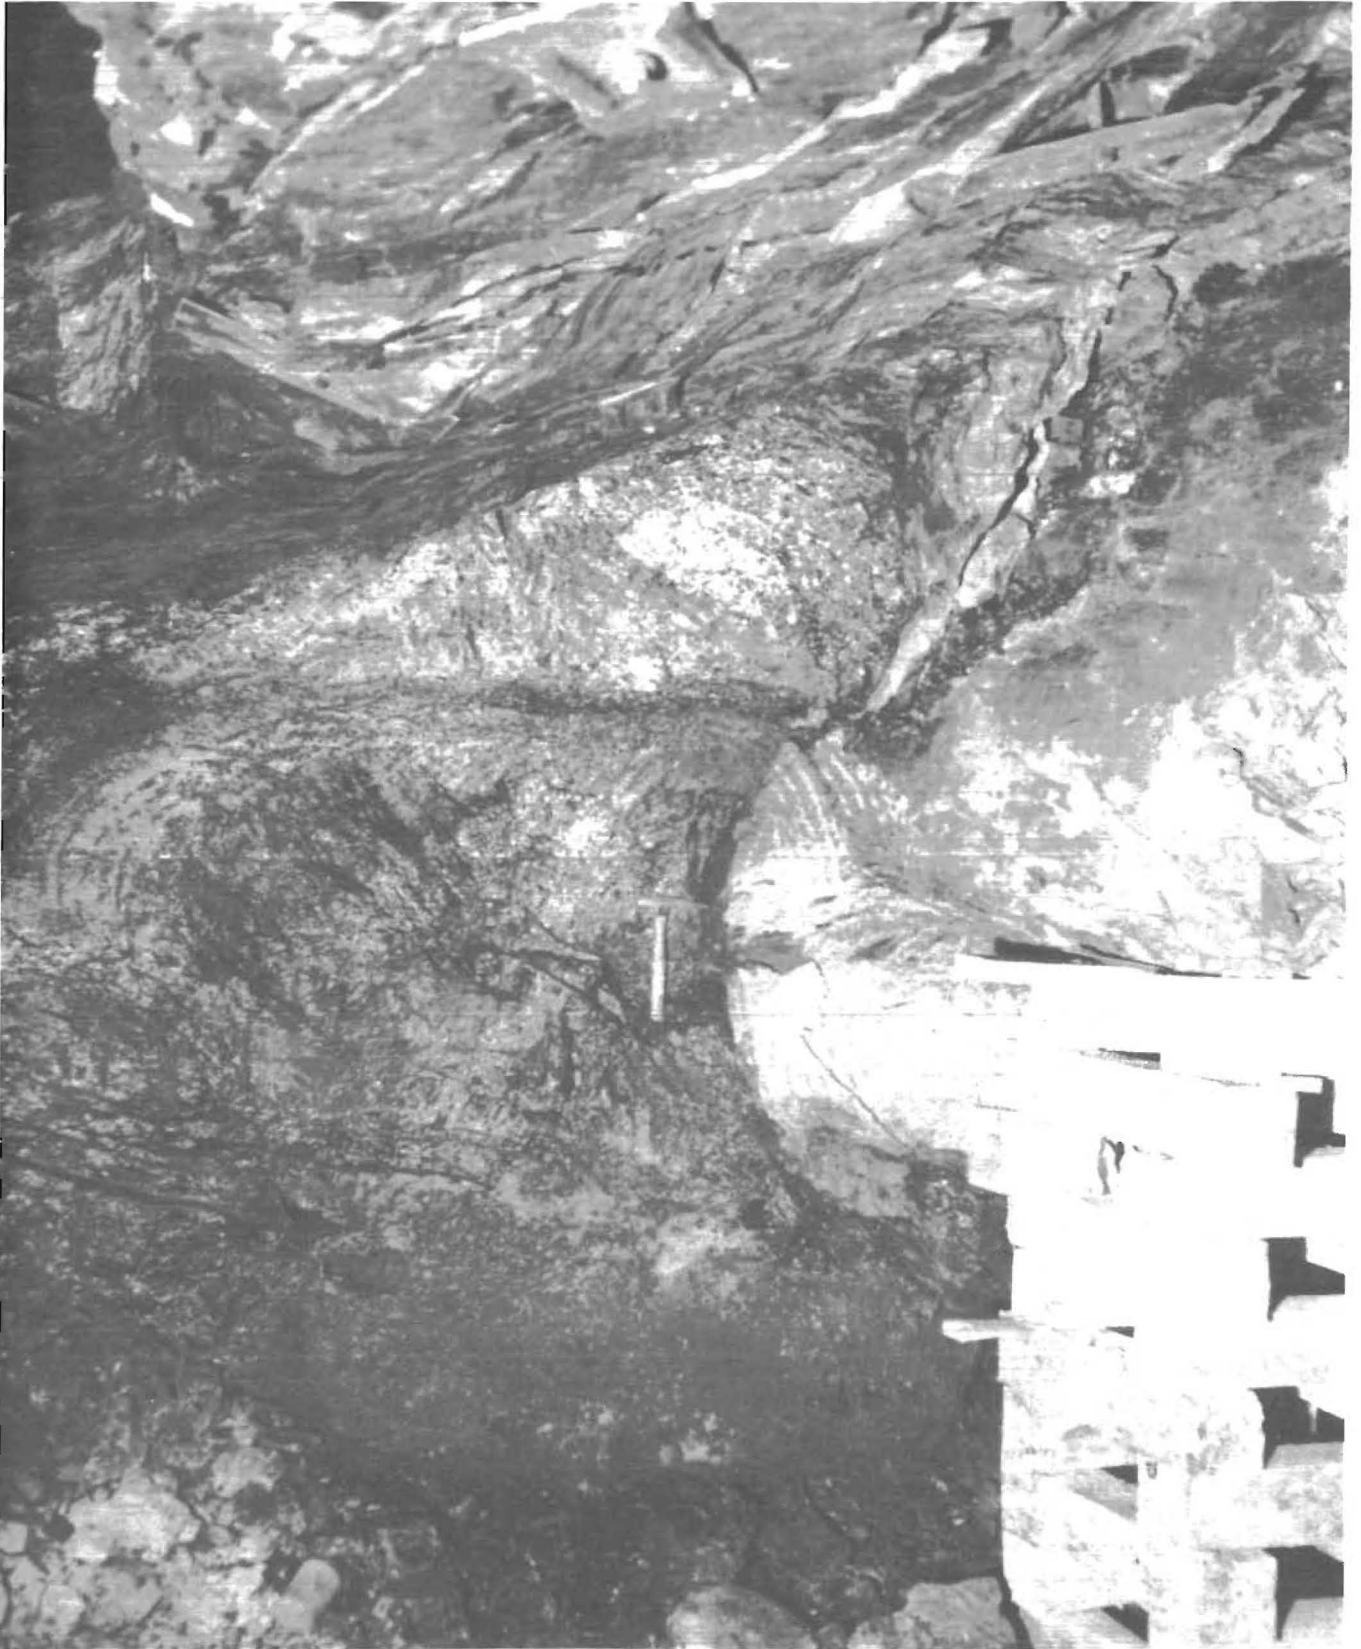
Figure 14.—Jawbone Coalbed split by compression along Pistol Gap Fault, with top half riding up into roof and bottom half pushed into floor.

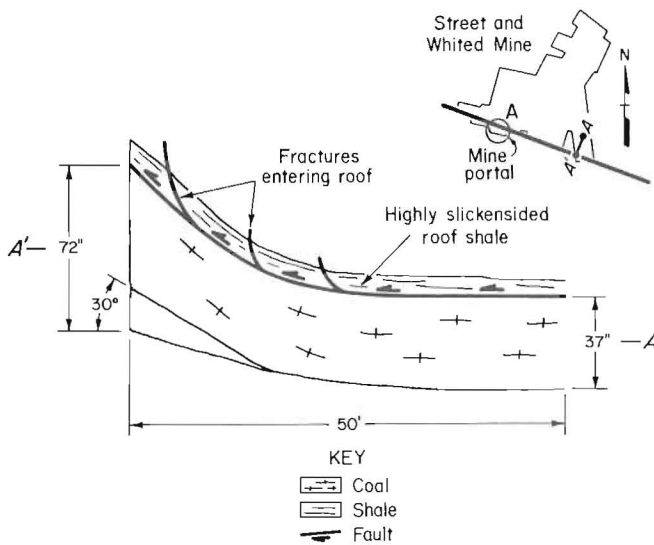
Figure 16.—Cross section of mine entry intersecting Pistol Gap Fault at Street and Whited Mine.

The mine intersects the fault in two places (figure 16, location A and cross section A-A'). A southern driving, seven-entry section intersected the fault at cross section A-A'. The operators tried to cross the fault with two entries, but the coalbed pitched upward into the roof at a 30° angle. The mining machine was unable to mine at such a steep angle, and production was halted. Roof conditions began to deteriorate in the two advancing entries, with large roof falls developing. A bedding plane fault is evident at the roof-coal interface. A series of small thrust faults also splinter off the bedding plane fault and enter the roof shales. These fractures indicate compressional failure.

There is no swag zone on the northeastern side of the fault as was seen at the Chaparal and Falcon Fuel Mines. Also, unlike the other mines where the coalbed rises abruptly into the roof, the coalbed at Street and Whited Mine rises on a gradual 6-pct grade. The coalbed also maintains its full 42-in height and has not shown signs of thinning or thickening. Possibly, if the fault had been further exposed, these features may be seen. Because of limited reserves on the southwestern side of the fault zone, the operators have decided not to attempt to cross the fault zone. The other location where the mine intersected the fault is in the main entry just inby the mine portal (figure 16, location A). Here, the disturbance is limited to merely a 6-in normal type of offset and a rippled coalbed.

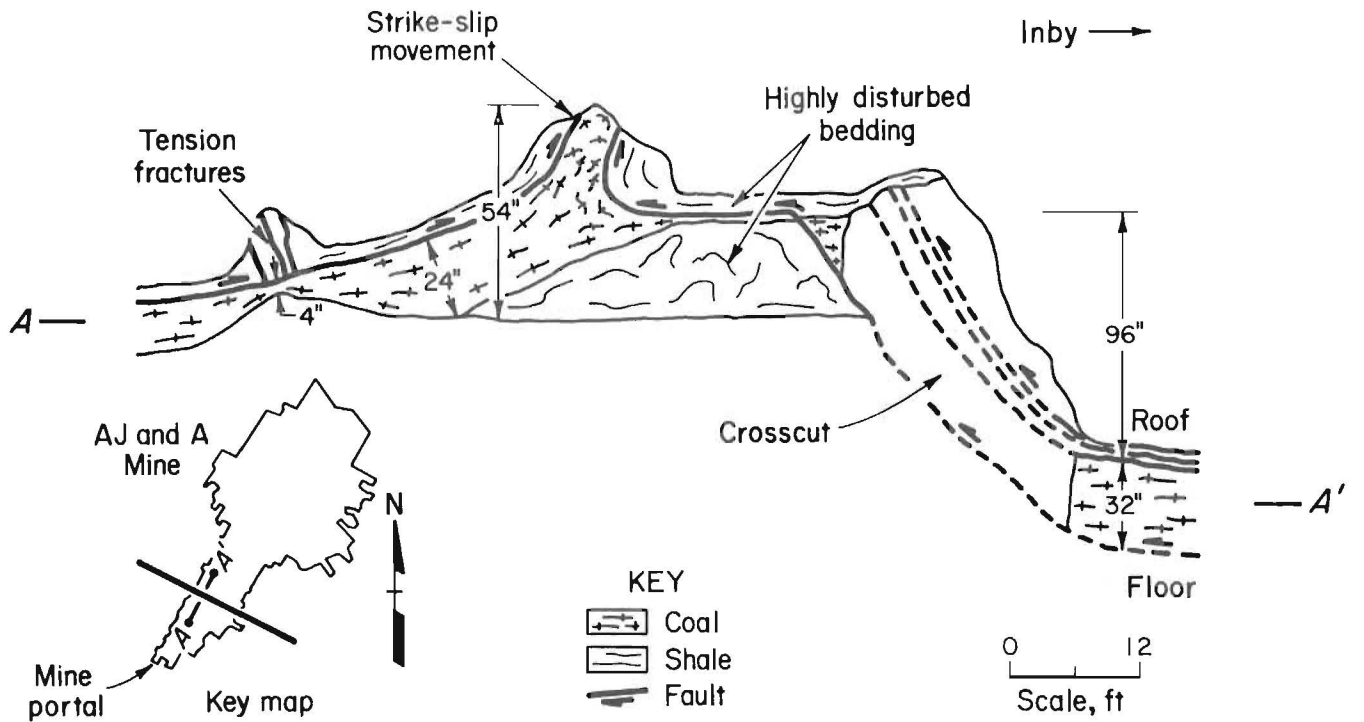
Figure 17.—Cross section of Pistol Gap Fault at AJ and A Mine.

Figure 17 is a cross section of the Pistol Gap Fault as it is exposed by mining. The total offset of the coalbed is 96 in. This apparent offset is due mainly to the coalbed being downbuckled in the inby direction because of compression. After downbuckling, the coalbed was sheared off by a bedding plane fault running along the floor, which then cut upward through the coal. The fault runs along the top of the coalbed, smearing the coal to 2 in thick before cutting up into the roof and overturning (fig. 18). Parallel thrust faults are also seen in the inby roof shales. Another opposite-dipping thrust fault is seen on the outby side of the fault zone (fig. 17). This fault flattens to a bedding plane fault and runs along the coal-roof interface. The overlying roof shales are highly contorted and disturbed as though dragged along above the fault plane and resisted by the coalbed. The presence of two opposite-dipping bedding plane-thrust faults shows failure on both sides of the fault zone. The coalbed itself shows signs of slippage and disturbance, and becomes overthickened as the fault enters the roof. On the southwestern side of the fault, there is an area where the floor is buckled up, causing the overlying coal to thin. The roof shows tensional fractures where the coalbed is squeezed (fig. 17). The affected zone is 50 to 75 ft wide and was accessible in only one entry. Where the coalbed sharply rises, there is a roof fall about 7 ft high. Numerous vertical roof slips are present that do not disturb the coalbed. At this mine, failure has occurred along bedding from both the southwest and the northeast. The AJ and A Mine, which is stratigraphically higher than the other study mines, intersects the fault directly in line with its linear trace (fig. 4). This indicates that the Pistol Gap Fault plane is vertical and planar.

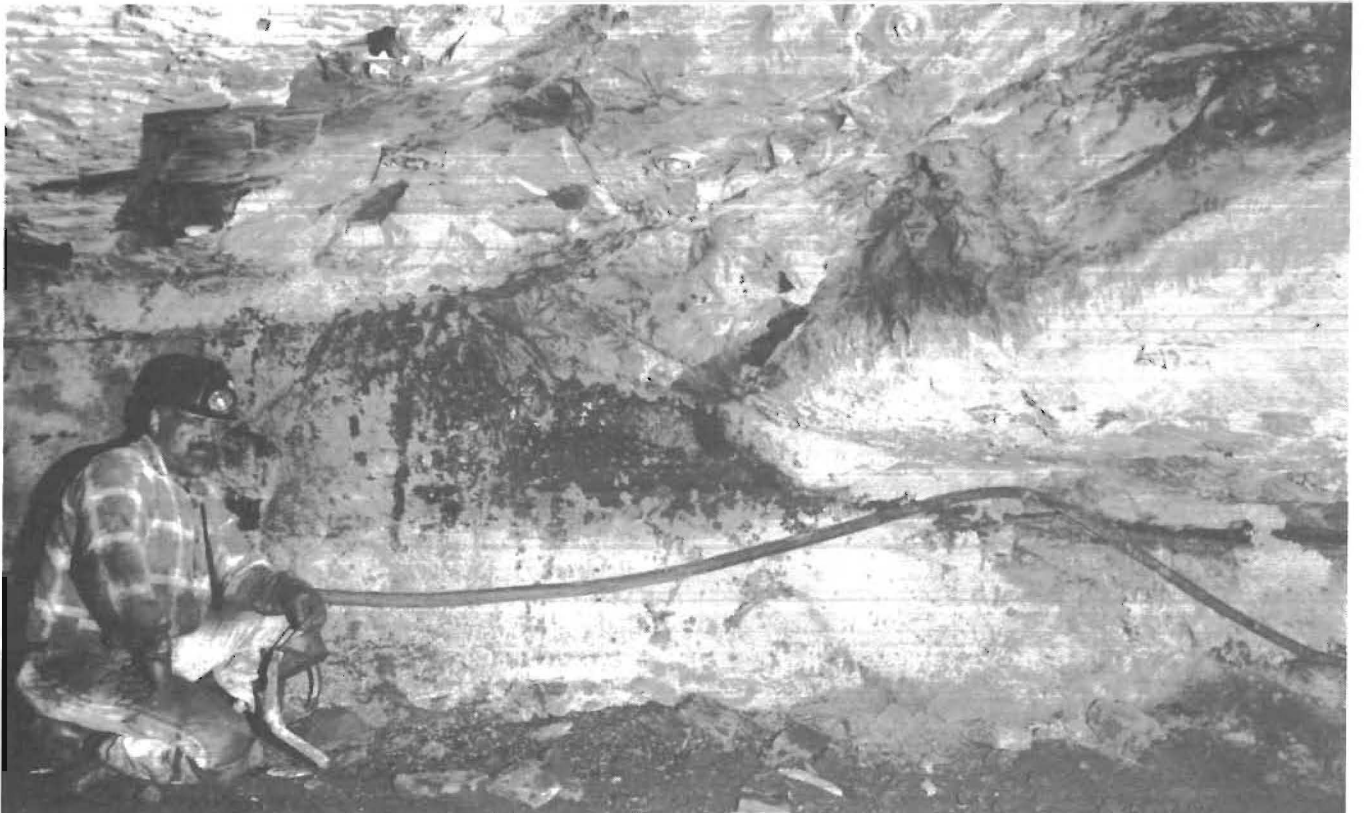
Figure 18.—Pistol Gap Fault exposed in rib at AJ and A Mine.

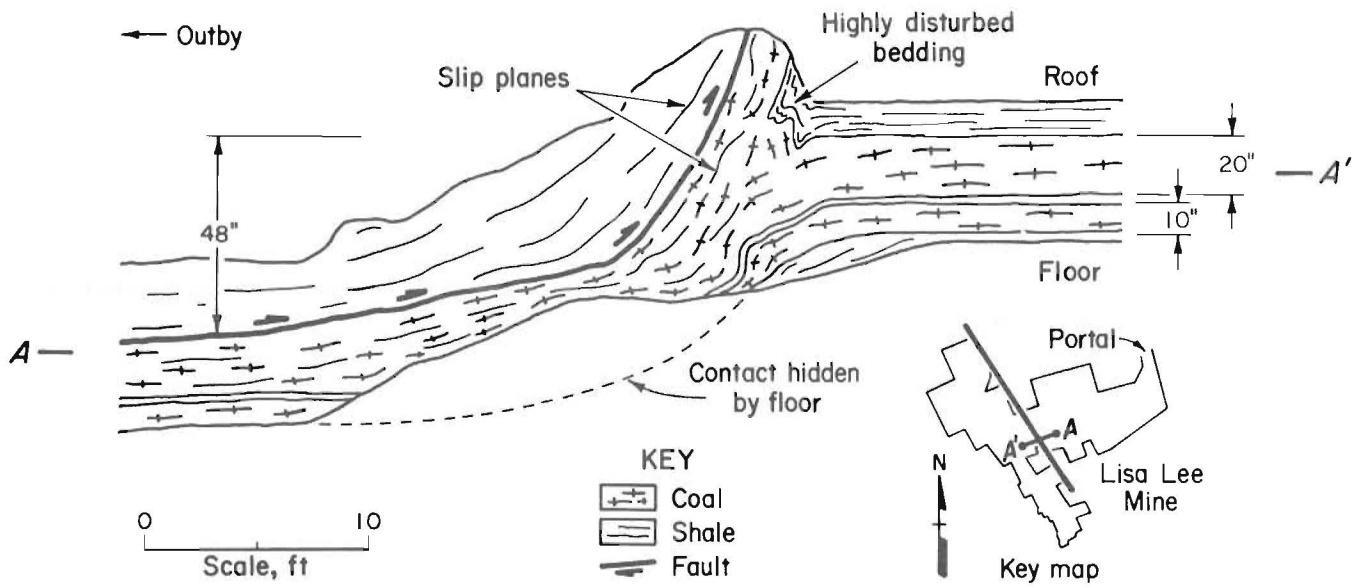
Figure 20.—Cross section of mining exposure of Keen Mountain Fault at Lisa Lee Mine.

At location D (fig. 19), the Keen Mountain Fault intersects mains, which provide access to the western side of the mine. Here, an eight-entry development was necked down to three entries to cross the fault zone. The effects of the fault were mapped in detail at this crossing. Figure 20 shows part of the fault zone in cross section at location D. The zone is approximately 200 ft wide and consists of a bedding plane thrust fault and numerous roof fractures, which do not offset the coalbed, and a large coalbed swag. The main coalbed offset is 48 to 51 in, and the bed is downbuckled to the northeast. The main fault runs along bedding on the northeastern side of the offset for an

undetermined distance until it abruptly enters the roof (60°), causing a 3-ft-high fall of roof. Figure 21 shows the bedding plane fault and the associated roof disturbance. Numerous horizontal slickensides and polished surfaces indicate extensive slippage between the coal and immediate roof shales. Compression in a northeastern-southwestern direction has caused the coalbed to be dragged up into the roof and locally thickened (over 72 in). Slippage within the coalbed is apparent, and bedding is highly disturbed. The adjacent roof shales are also highly distorted. Failure occurred along the roof-coal interface and also along the bedding planes within the coalbed (fig. 21).

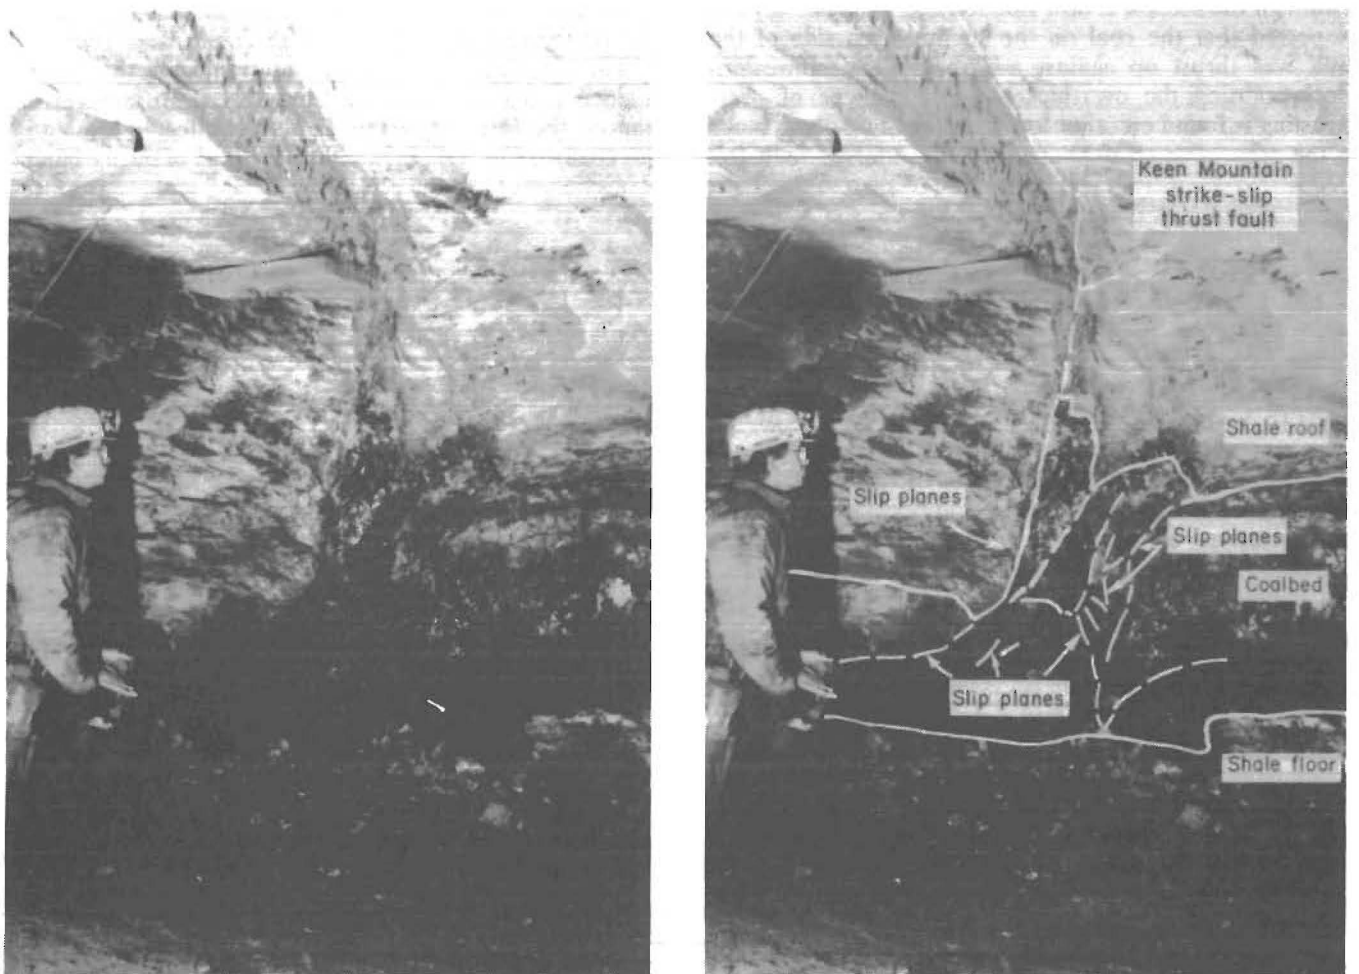
Figure 21.—Exposure of Keen Mountain Fault zone in Jawbone Coalbed, showing disturbed coalbed with fault plane entering roof.
