RI 9267

REPORT OF INVESTIGATIONS/1989

Hillseam Geology and Roof Instability Near Outcrop in Eastern Kentucky Drift Mines

BUREAU OF MINES

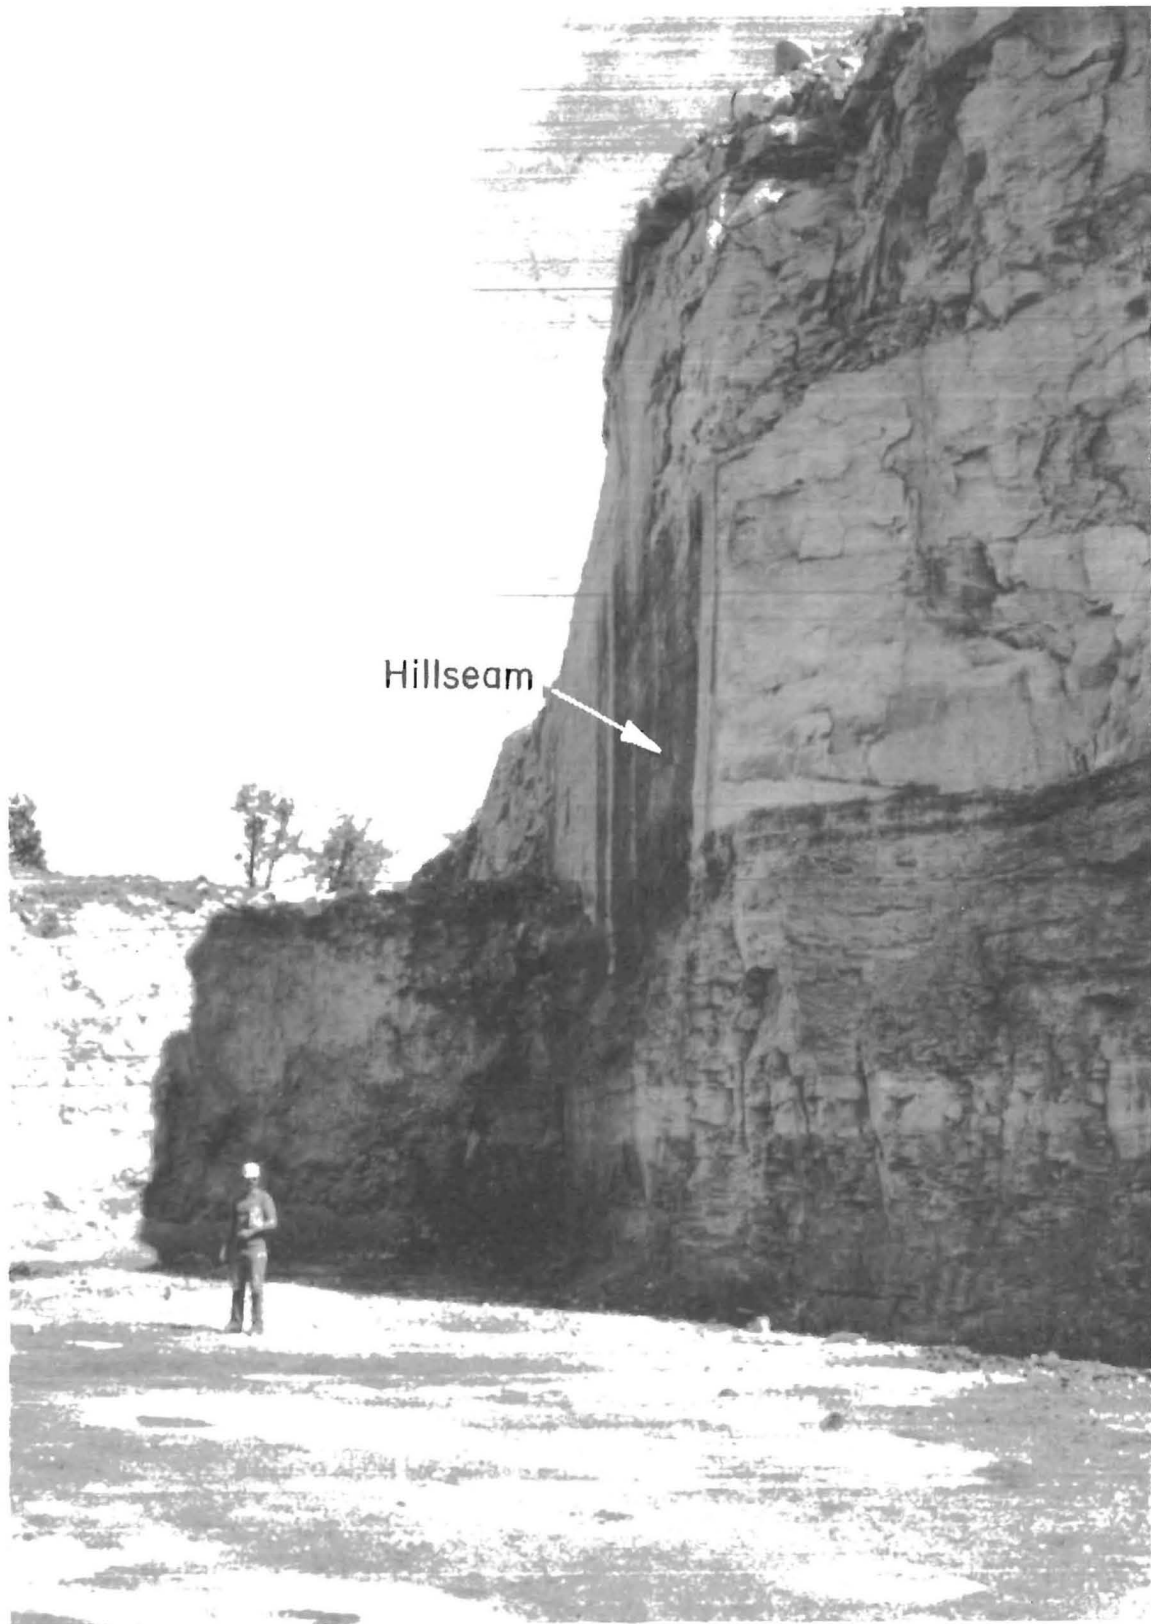
In addition to hillseam-related roof falls in underground coal mines, strip mine highwall stability is, to a large degree, adversely affected by the presence of hillseams. Figure 2 shows a nearly vertical strip mine highwall formed by one of several large, parallel hillseams. While hillseams may facilitate highwall removal, they can also be extremely hazardous, forming undetected, freestanding slabs or wedges of rock that can topple forward or slump into the excavation without warning.

Figure 2.-Hillseam in strip mine highwall.

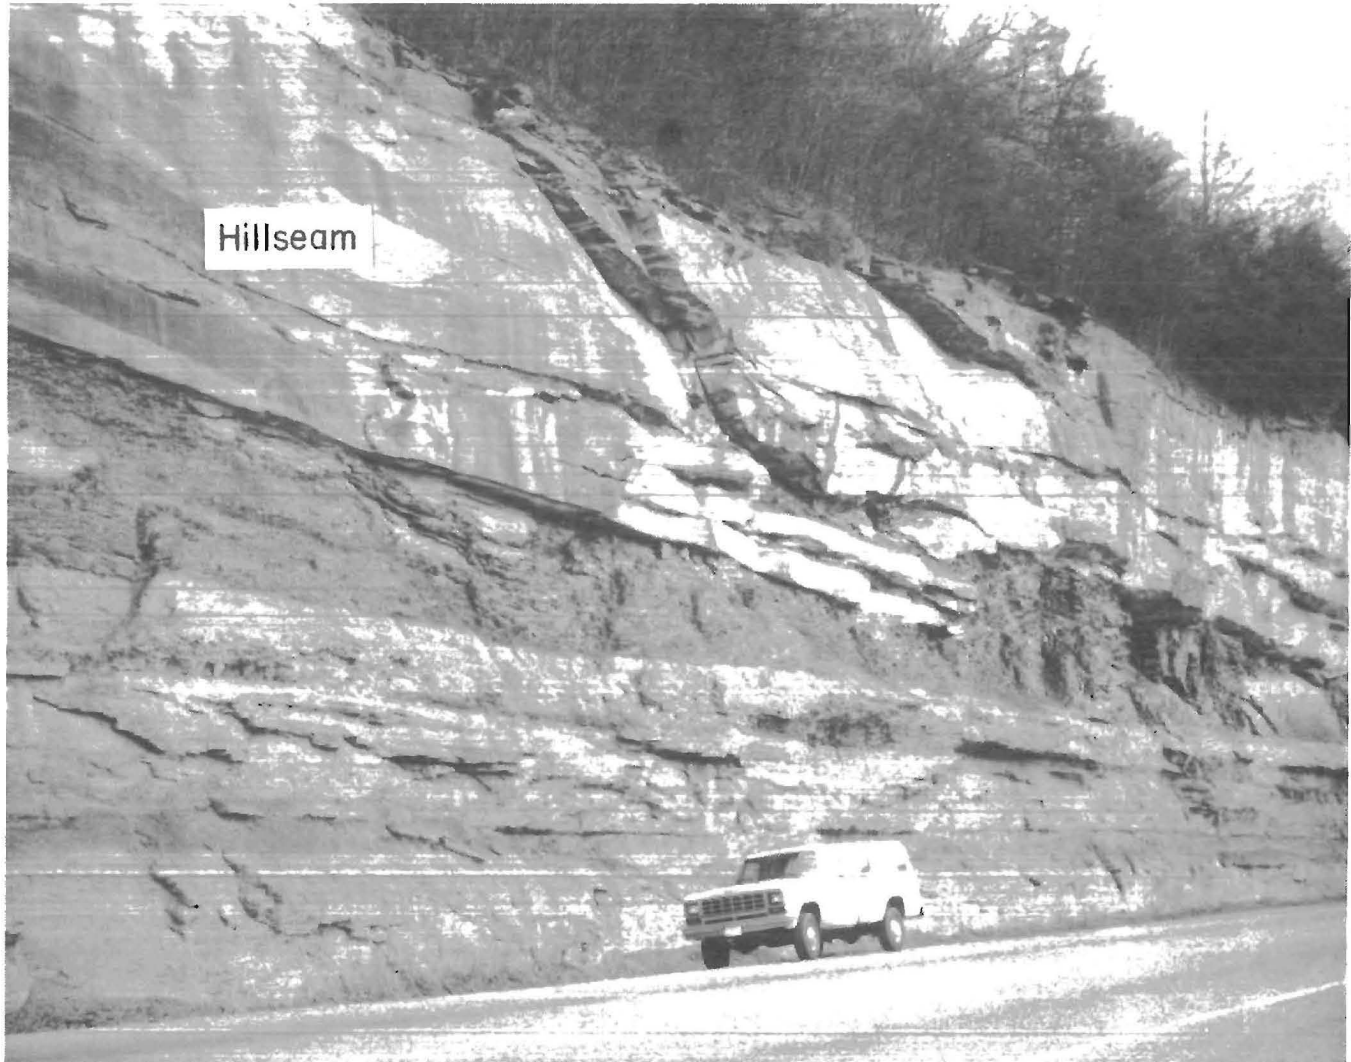
Hillseams also constitute a hazard in deep roadcuts that parallel surface contours. While deep-seated rockslides are rare (7) they typically involve excavated slopes in which large wedges of rock, separated from the valley walls by near vertical stress relief joints (hillseams), slide or hinge over into the excavation. Figure 3 shows such a situation in which a large wedge of rock, separated from the wall of a roadcut by a hillseam, is unsupported and may slide or topple towards the pavement without warning.

Figure 3.—Hillseam in wall of roadcut.

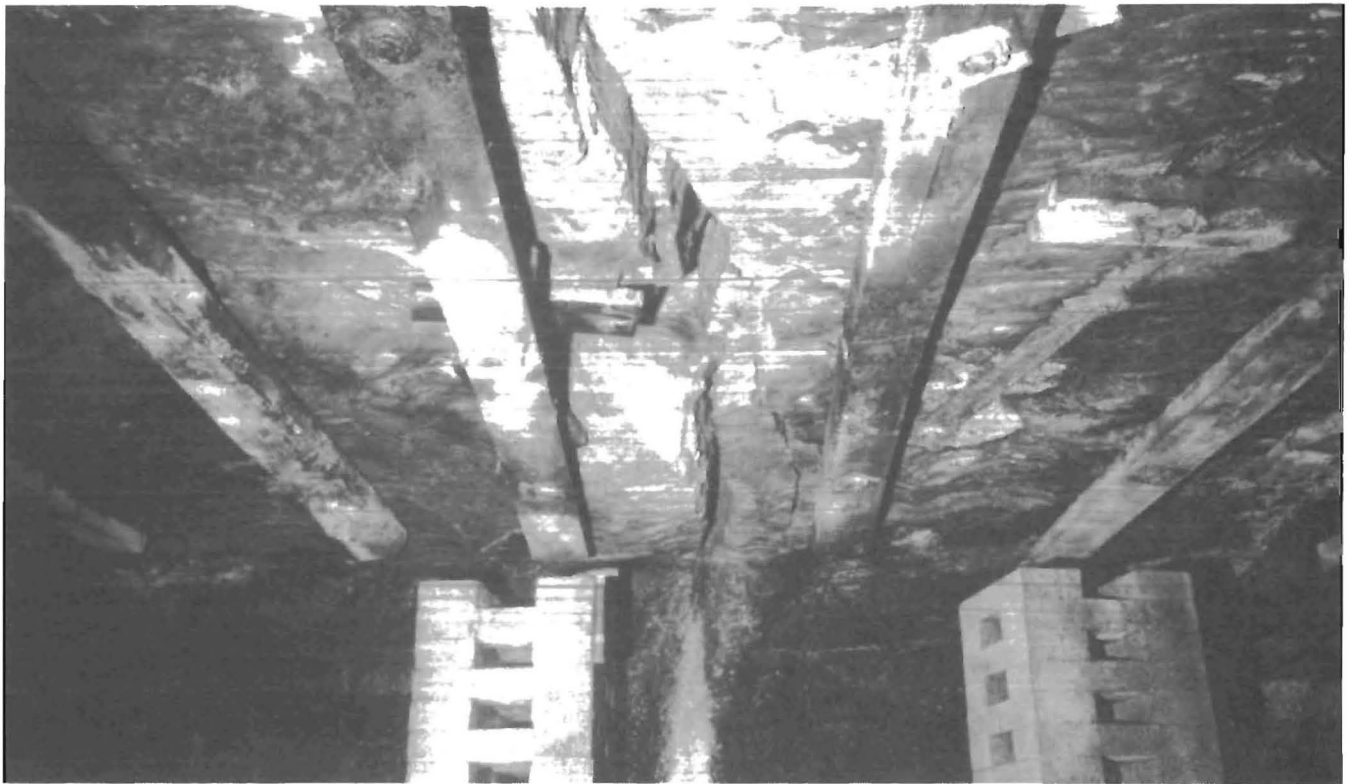
Figure 7.—Rib stained by ground water channeled by hillseam.

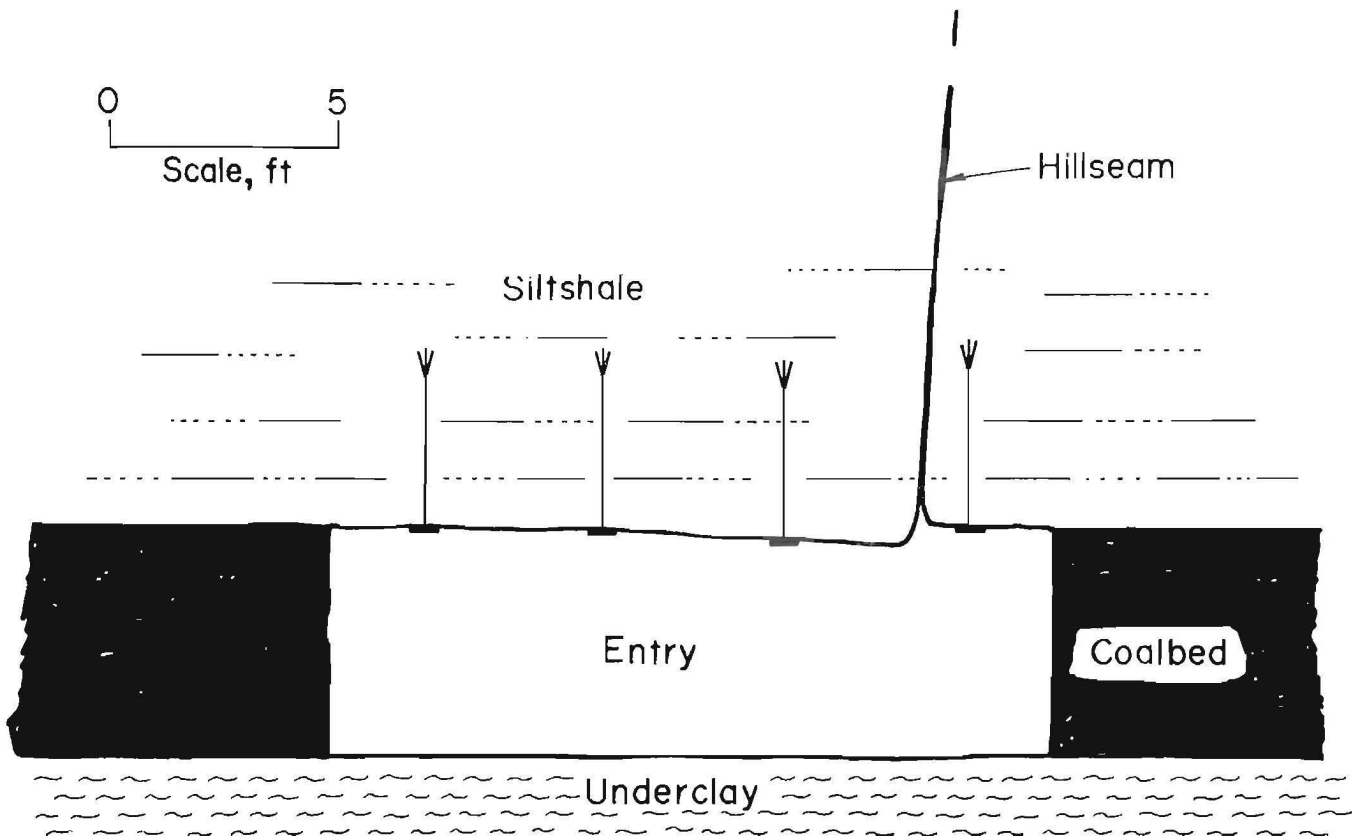
Hillseams that parallel openings create a serious hazard by interrupting the beamlike span of roof that normally supports the overlying rock, leaving a cantilever (fig. 18). This situation calls for detailed observations, immediate judgment, and remedial action in terms of supplementary support, especially when the hillseam may be heavily weathered and broken just beyond the face.

Figure 18.-Cantilevered mine roof formed by hillseam paralleling entry.

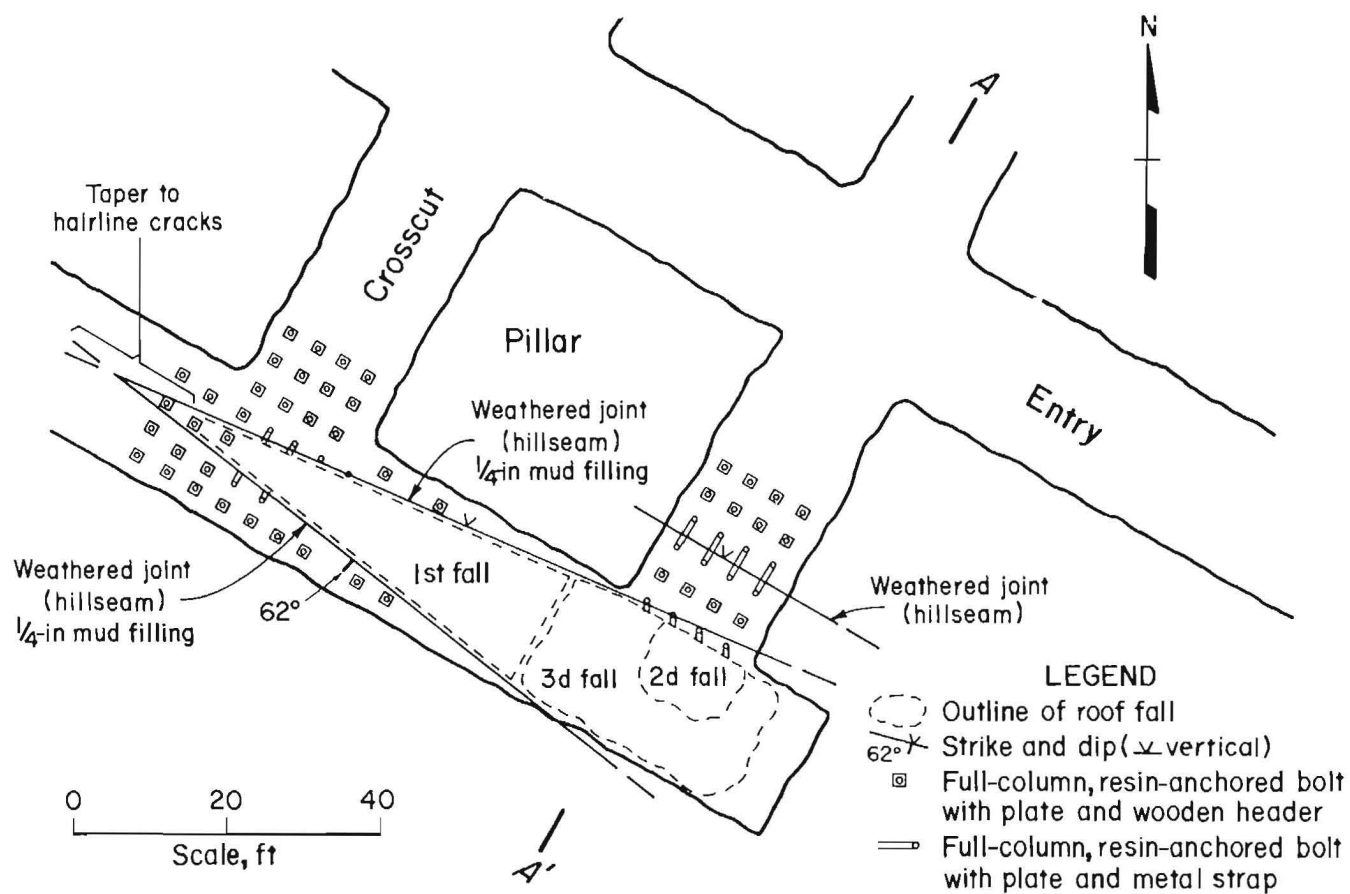
In one area of the mine, the outer entry of the mains was adjacent to the 100-ft-wide outcrop barrier. Hairline cracks in the roof were the first indication of roof support problems. As the entry was advanced, the cracks gradually increased in width and intensity of weathering until two intersecting hillseams were exposed that followed the trend of the entry and the contour of the ridge.

Figure 21.—Roof falls in example 1 mine.

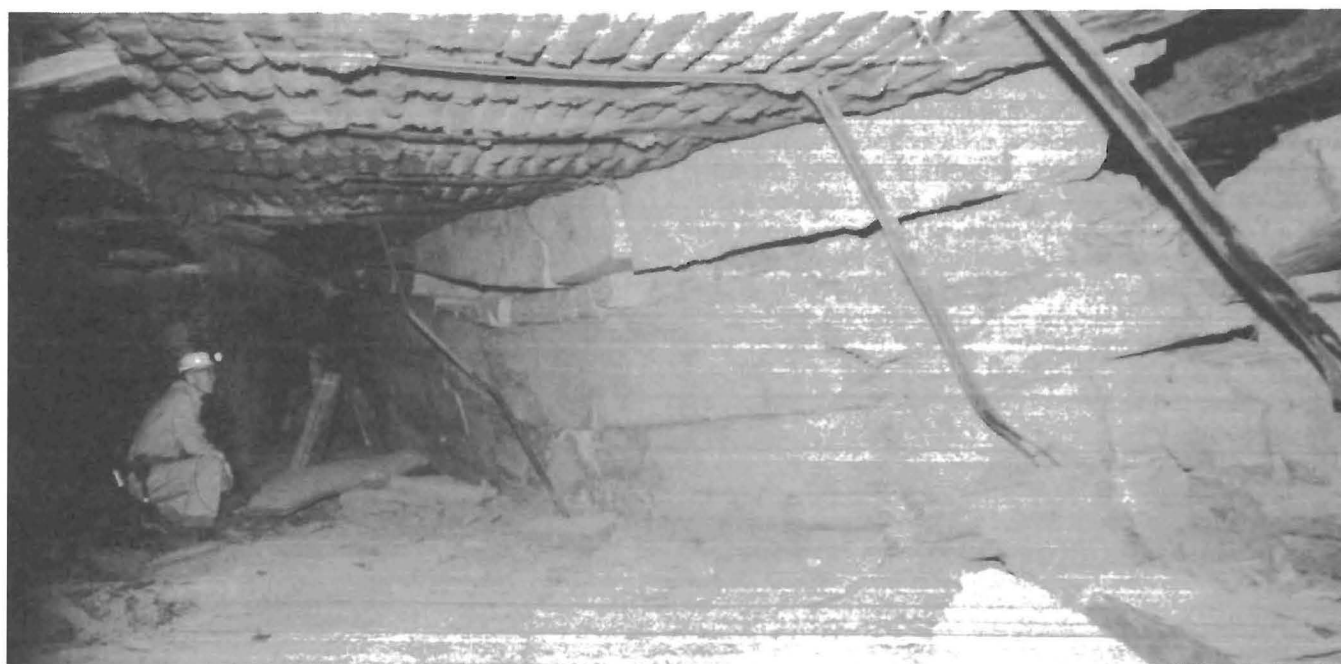
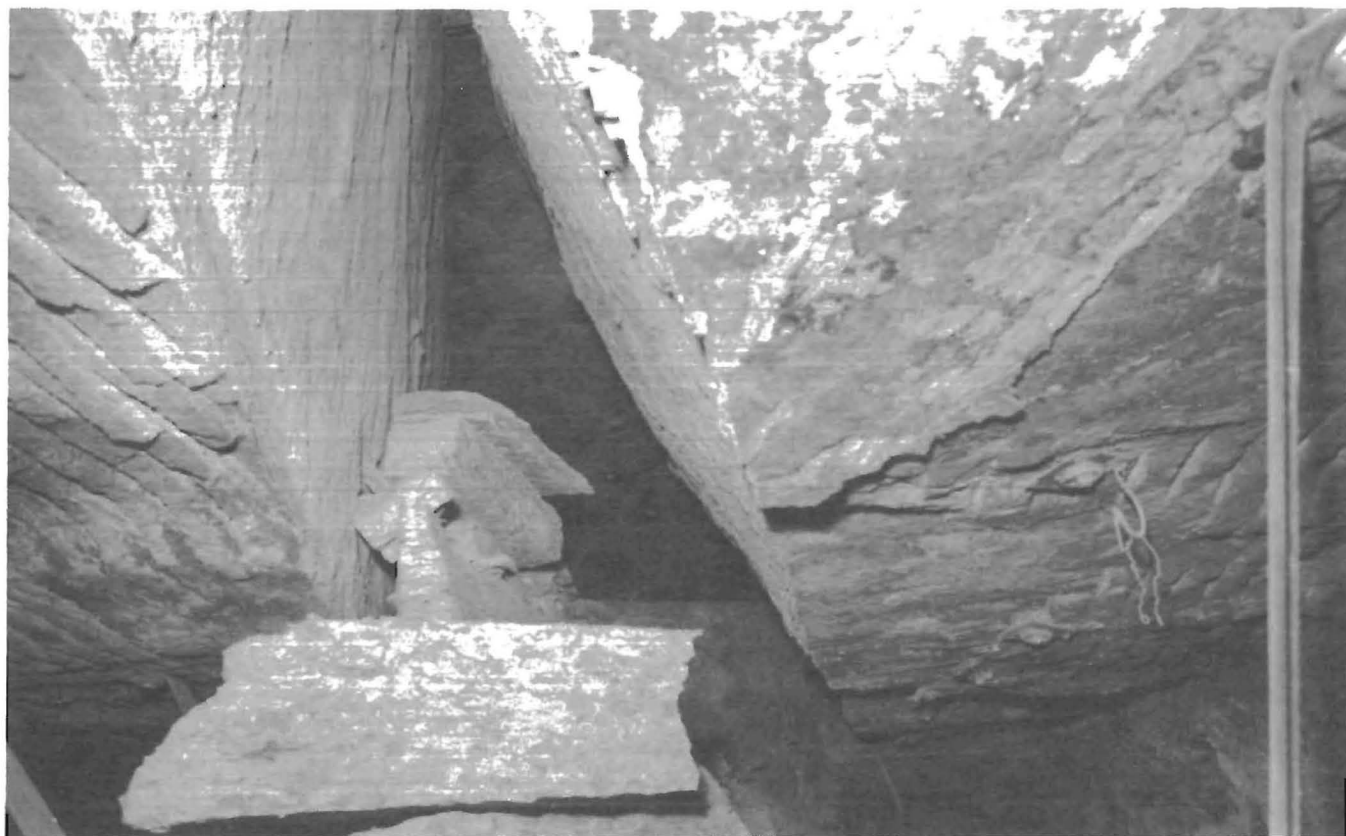
The entire wedge-shaped fall of roof between the intersecting hillseams was estimated to consist of 5,139 ft³ of rock weighing 385 st. Figures 22 and 23 show two views of the fall. This weight over an entry length of 50 to 80 ft far exceeded the support capacity of the installed bolts and straps. If the magnitude of the fall could have been anticipated by a greater awareness of the roof structure, additional supplementary support could have been installed.

Figure 22.—North side of roof fall in example 1 mine.

Figure 23.—Apex of roof fall in example 1 mine.

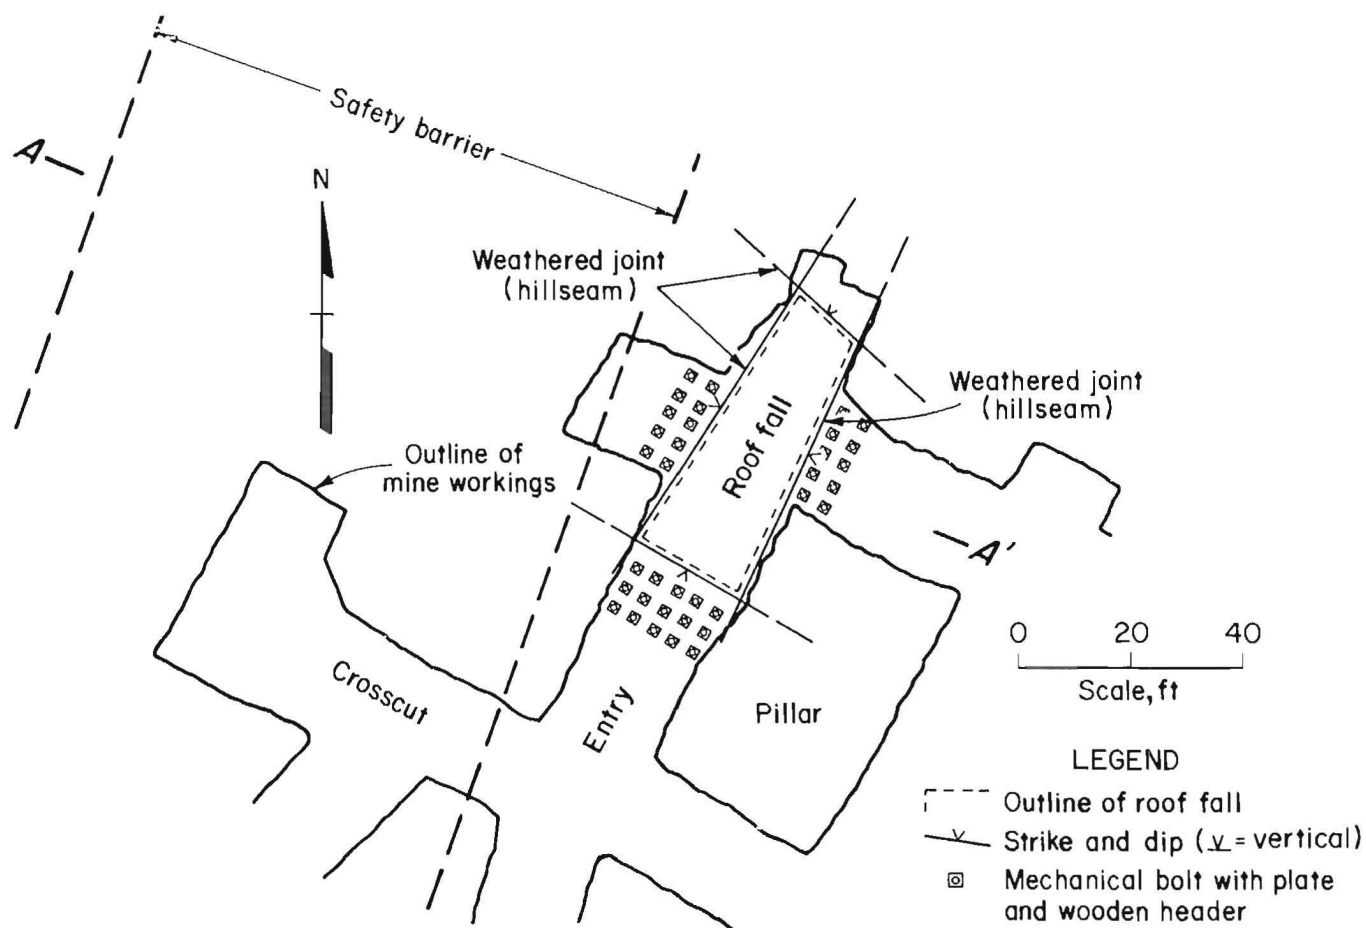
The entire rectangular-shaped fall of roof between the intersecting hillseams was estimated to consist of 13,500 ft³ of rock weighing about 1,000 st, far in excess of the support capacity of the bolts and straps.

Figure 26.—Map of roof fall site in example 2 mine.

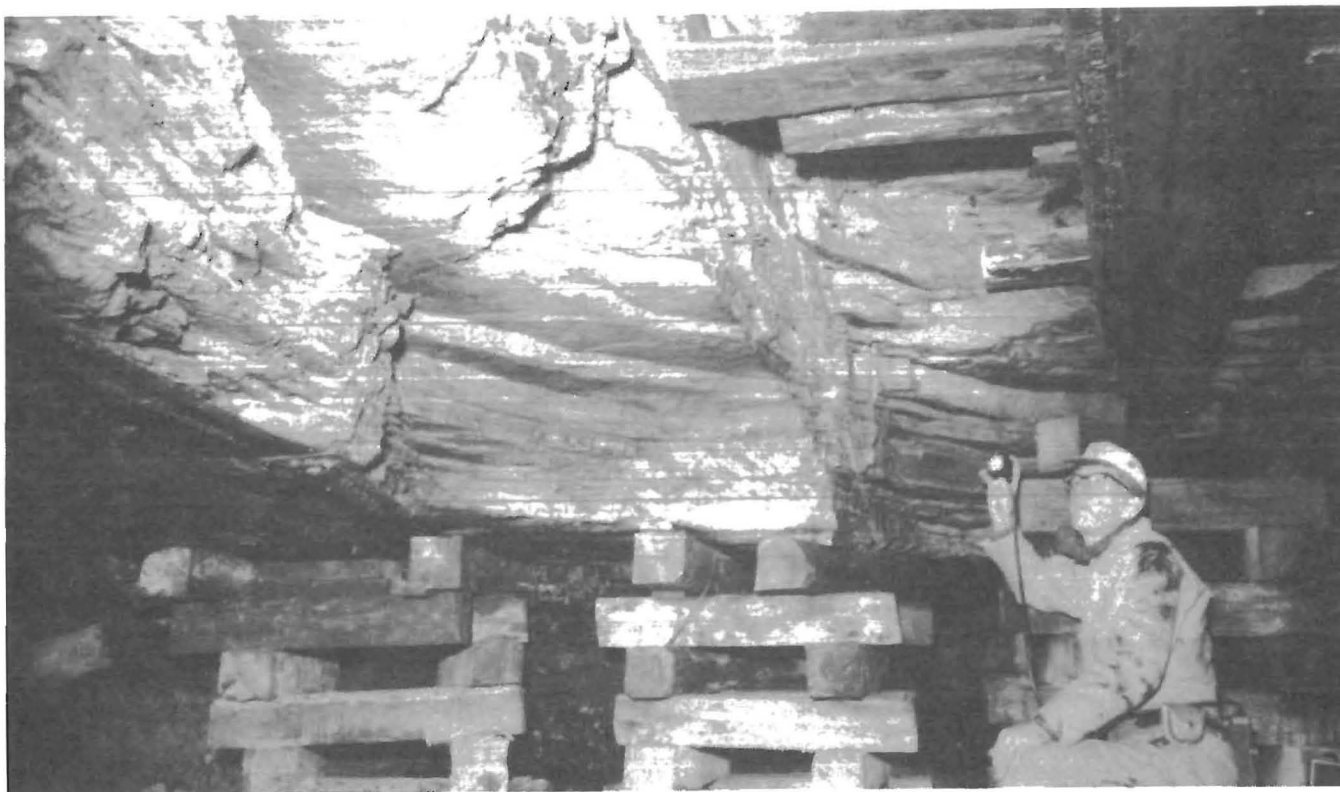
Figure 31.—Unstable roof in example 4 mine intersection.

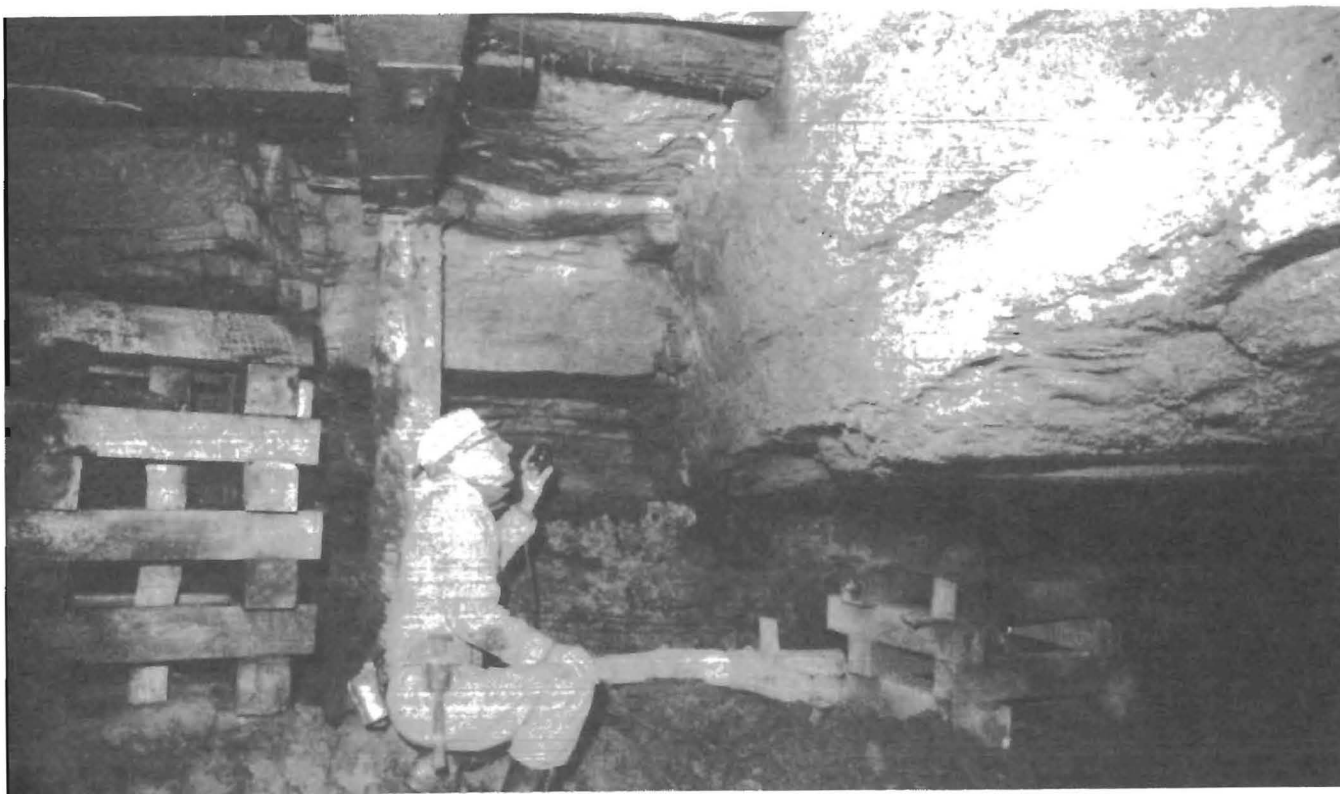
Figure 32.—Hillseam-related roof fall forming roof brow.
