Principal Horizontal Stress Contributing to Massive Roof Collapse at the Subtropolis Mine

Nicole Evanek

NIOSH, Pittsburgh PA

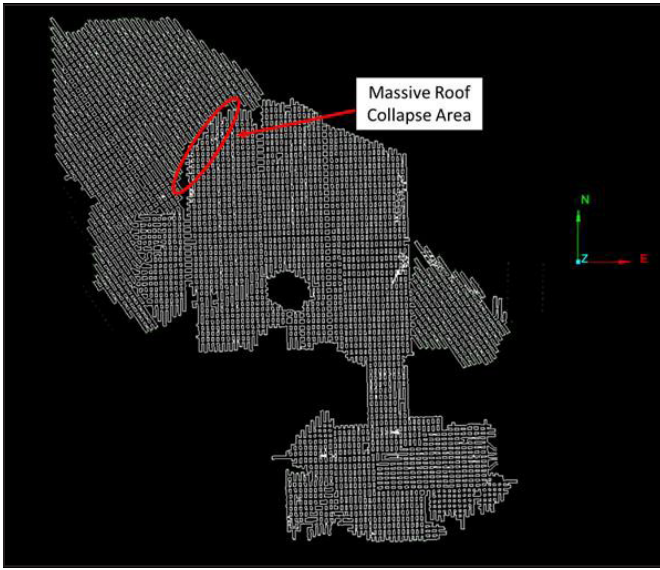
The massive ground collapse at the Subtropolis Mine in Petersburg, OH, is also defined as a massive roof collapse. The failure of the roof began in late 2015 and has slowly developed over time and now encompasses several entries in the north-central part of the mine (Figure 2). The Subtropolis Mine, which is a room-and-pillar mine that extracts the Vanport Limestone, has a long history of reacting to horizontal stress damage in the roof. Since the mine opened in 2005, the operators have changed the orientation of the mine several times in order to alleviate the detrimental effects of high horizontal stress and to determine the principal horizontal stress direction (Figure 3).

Figure 2. Subtopolis Mine Map with massive roof collapse area circled in red

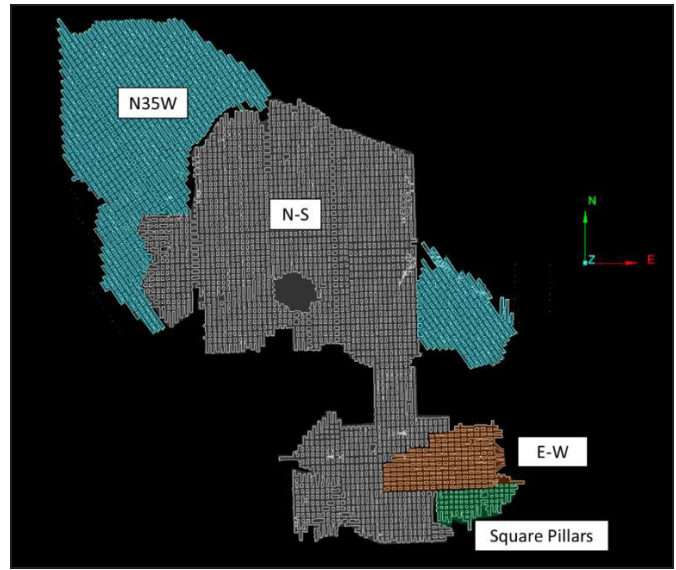
Typically, a mine will find the orientation of the principal horizontal stress at or near to the regional horizontal stress. At the Subtopolis Mine, the principal horizontal stress differs from the regional horizontal stress and can even differ across the mine itself. Evidence to support these changes in the principal horizontal stress direction come in the form of cutter roof failures and oval-shaped roof falls oriented in different directions in specific areas of the mine. The principal horizontal stress direction at this mine tends to be generally N35W.

Figure 3. Subtopolis Mine Map with varying heading orientations

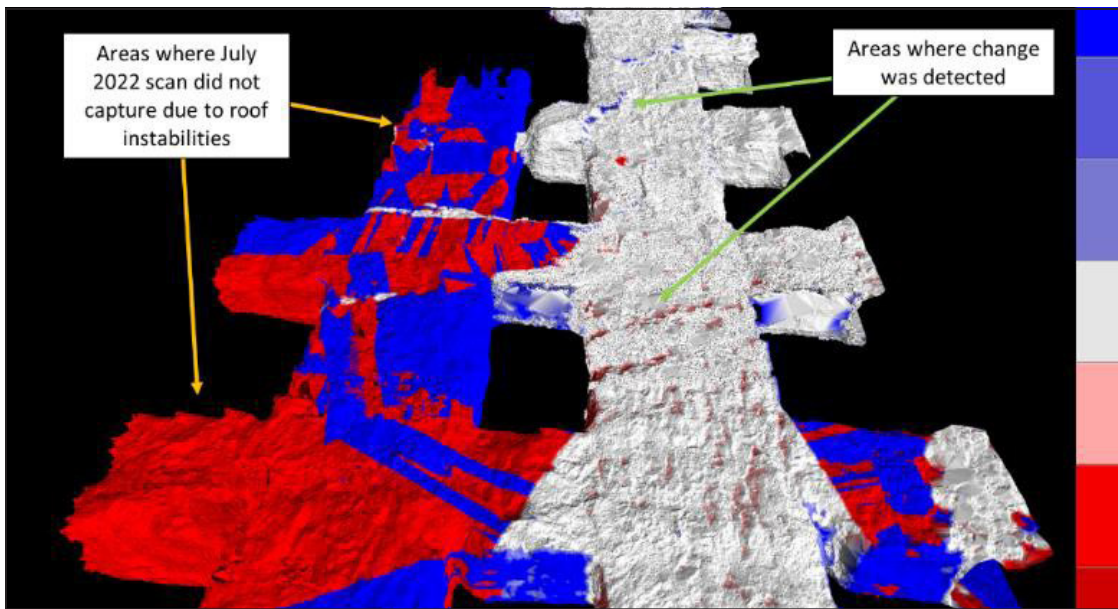
Therefore, July 2022 scans could be compared to June 2019 scans in entry N3N2. Changes were detected in the roof of N3N2 at an angle perpendicular to the principal horizontal stress direction as shown in Figure 12.

Figure 12. Ariel view of N3N2 changes over time from June 2019 to July 2022 (Red represents material removed and blue represents material added)

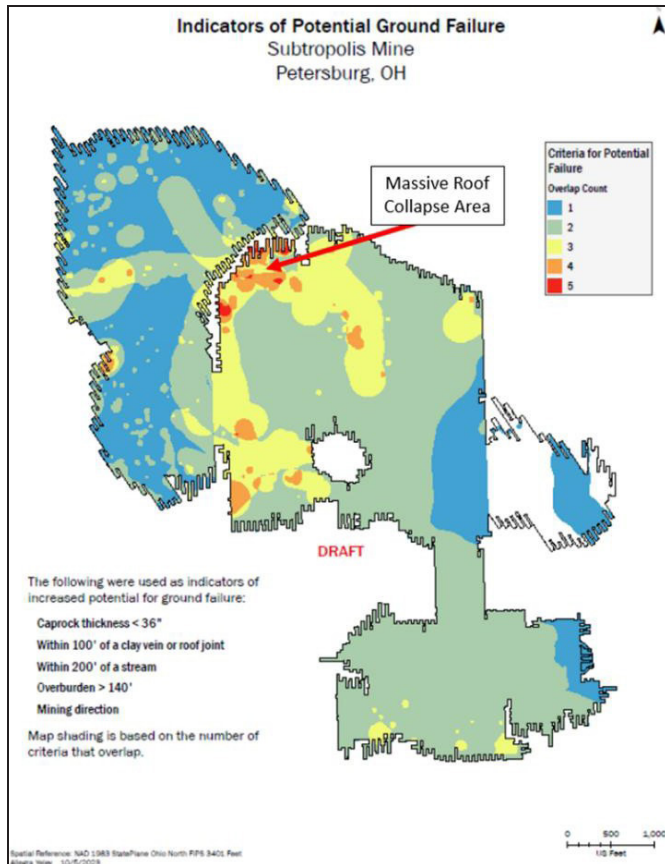
The AutoCAD version of the mine map that included the mine outline and the indicators listed above was imported into ArcGIS where a hazard map was produced (Figure 13). This map was produced without previous knowledge of the location of roof failure or the massive roof collapse. However, the map was able to indicate a potential for ground failure right over the massive roof collapse region. This may indicate that heading orientation,

Figure 13. Indicators of Potential Ground Failure Map of the Subtopolis Mine

overburden, stream beds, joints, clay veins, and caprock thickness might be leading factors in the cause of this massive roof collapse. The hazard map was also able to correctly map a hazardous area in the southwestern part of the mine, where a large roof fall occurred. This area had crisscrossing clay veins in the overlaying shale with several fractures in the roof and a constant flow of water prior to the fall. Cutter roof failures and rock flour were present during the failure as well indicating the shear failures as discussed in Figure 4. According to the operator, the Lower Kittanning Coal Seam may have also rolled down towards the top of the Vanport in this area.

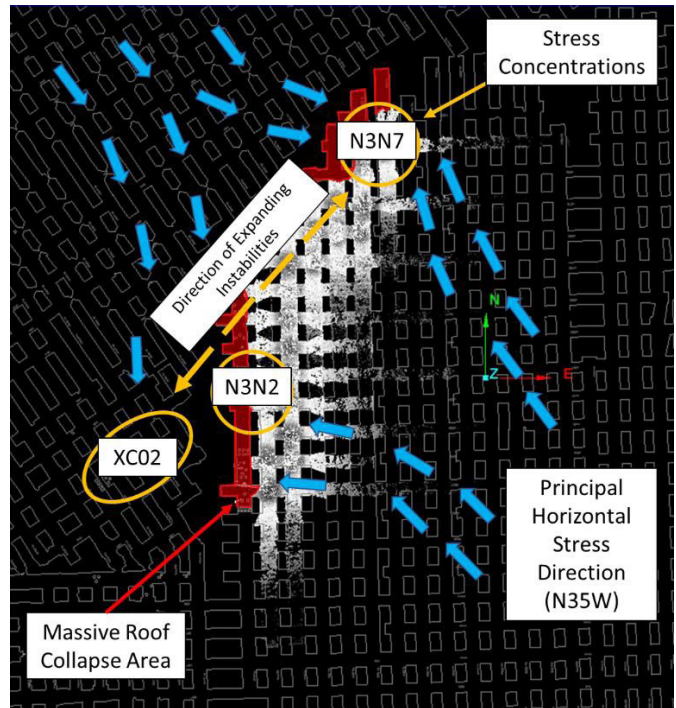
Figure 14. Ariel view of expected principal horizontal stress directional changes and concentrations around the massive roof collapse
