# EVALUATION OF POLYURETHANE INJECTION FOR BELTWAY ROOF STABILIZATION IN A WEST VIRGINIA COAL MINE

Gregory M. Molinda, Research Geologist
National Institute for Occupational Safety and Health
Pittsburgh Research Laboratory
Pittsburgh, Pennsylvania USA

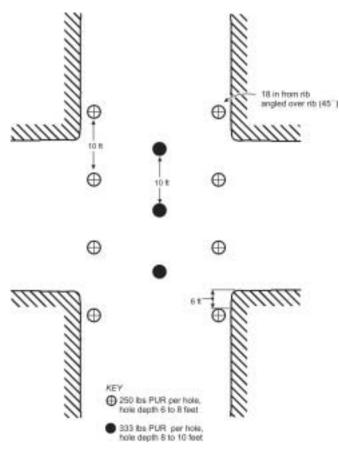
Figure 1. Idealized PUR injection array.

PUR injection arrays can have a number of configurations. A typical injection pattern for an intersection will have four injection holes angled over the rib on 10 ft centers spanning each crosscut in the intersection (Figure 1). PUR may be injected over the rib on each side of the intersection to erect a "grout curtain" which will act as a barrier and permit infilling of the intersection. These injection holes will be packed off to the destabilized zone, and then PUR is injected. The holes will be pumped to a predetermined volume or pressure or they may be injected to refusal. Then holes will be drilled and pumped in the center of the intersection to complete the beam. The exact specifications of the design are often determined by the experience of the contractor.

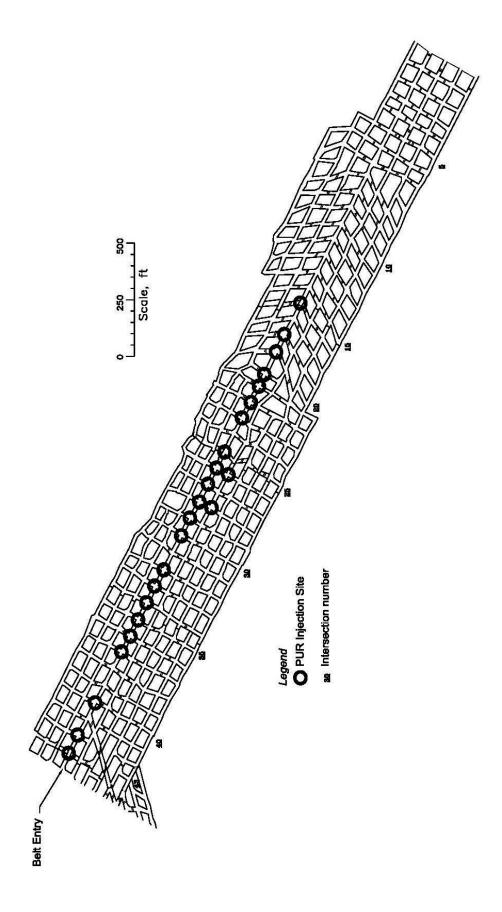
A coal mine in West Virginia was experiencing extremely difficult roof conditions in its main beltway throughout the life of the mine leading up to the autumn of 2002 (figure 2). The 18 ft wide belt entry was averaging 2-3 falls per year which threatened workers safety and resulted in costly delays due to cleanup and rehabilitation. The roof rock is an extremely weak clay shale which is highly moisture-sensitive. In August, roof falls occur almost 2.5 times more frequently than the annual monthly average. In addition, it is suspected that frequent clay veins also react to moisture, swell, and apply bulking pressures on the roof sequence. The roof begins to unravel between bolts in a relatively short time, leading to a progressive upward failure and finally a roof fall. Mine-wide, 63% of roof falls occurred in intersections. In the beltway from the portal to the first submains, 15 of 43 intersections had fallen (figure 2). The project goal was to stabilize all the unfallen intersections by polyurethane injection.

Figure 2. Intersections stabilized with polyurethane.

Because of its demonstrated value, it was decided to continue video monitoring through the project, and to use the information to refine the design of the PUR injection. Figure 2 shows the Mains and the beltway, and intersections selected for polyurethane stabilization. All intersections that had not fallen in the beltway were selected for PUR-injection stabilization. A total of 27 intersections had PUR injected for stabilization. The reinforced beam in the Mains was created by pumping PUR in a zone from 2-6 ft. Two pump zones were isolated. PUR was pumped first from 4-6 ft, allowed to set, and then was pumped from 2-4 ft. Each intersection averaged 12 injection holes and these holes averaged 6-7 ft long. The average amount of PUR injected per intersection was 425 gal. This volume was calculated to allow 2 - 55 gal drums of PUR mix to pump 3 holes. Injection pressures ranged from 0-2,000 psi and averaged about 400-500 psi.

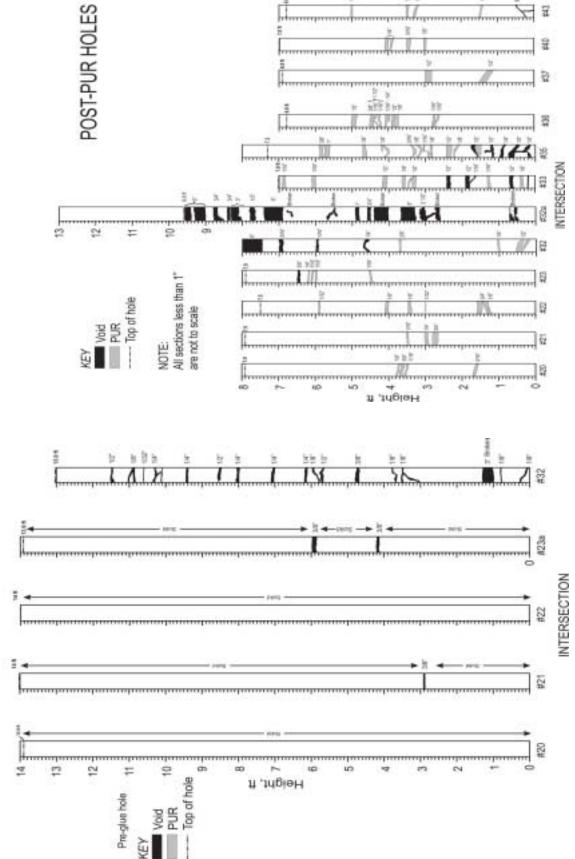
Video logs, some pre-and post injection, revealed the condition of the roof in selected intersections along the Mains project area (figures 3a and b). Pre-pumping video logs showed significant voids in the roof at two intersections (No. 23 and. 32) (figure 3a). At No. 32, highly fractured roof rock was loading standing support and falling between supports. Using the design plan of reinforcing a roof beam from 2-6 ft into the roof, PUR injection continued. Video logging was available at 16 post-injection test holes at 11 intersections. The test holes showed PUR successfully injected into numerous void spaces in the target zone in each of 11 intersections. Individual cracks ranging from paper thin up to ¾ in wide, and rubbleized zones up to 1.5 in were filled with PUR (figures 4a and 4b). This information allowed for an intersection-by-intersection evaluation of the PUR injection performance.

In 5 intersections (Nos. 20, 21, 22, 23, 32) both pre and post-injection test holes were video-logged in order to determine which pre-existing fractures were filled with PUR (figures 3a and 3b). Intersection No. 21 had a rubble zone 3/8 in thick at 2.9 ft into the roof prior to PUR injection (figure 3a). Twelve injection holes pumped 399 gal of PUR into the intersection in two isolated zones (4 ft and 2 ft) (table 1.). In a post-injection test hole (figure 3b), there are three prominent PUR "shows" from 2.7-3.5 ft. effectively filling the rubble zone (figure 5). 100% of the void space at this hole location in the intersection was filled with PUR (figure 3b, No. 21 post-injection hole).

Figure 3a. Borehole camera logs of monitoring holes prior to PUR injection. (These are the only pre-injection logs available.)

Figure 3b. Borehole camera logs of monitoring holes after PUR injection. (Some intersections listed here do not have pre-injection logs available.)

In intersection No. 23, two fractures existed at 4.2 ft (3/8 in wide) and 6.0 ft (3/8 in wide) prior to injection into the roof (figure 3a, test hole No. 23a). One-hundred ten gal of PUR was pumped into a zone packed at 4 ft and 289 gal of PUR was pumped into a zone packed at 2 ft (table 1). Both zones were filled with PUR, with another 3/8 in void left unfilled at 6.5 ft (figure 3b). This void was above the height of the injection holes.

In intersection No. 20 the pre-injection hole showed solid roof and no voids or even separations (figure 3a). Fourteen holes were drilled and approximately 432 gal of PUR was pumped (table 1). After injection, a video log revealed that PUR was injected into a zone at 1.7 ft and from 3.5-3.8 ft into the roof (figure 3b). It is assumed that PUR was injected into weak, unseparated bedding planes or that the bedding may have been hydrofractured with injection pressures up to 1,800 psi. Another possibility is that fractures were present that were not revealed by the pre-injection test hole. PUR could have been injected into these zones.

At intersection No. 22 pre-injection video monitoring again showed a solid roof with no voids or separations (figure 3a). Twelve injection holes were pumped. At 4 ft of each hole a packer was set and 110 gal total was pumped between all holes. The hole was repacked at 2 ft and 271 gal was pumped, between 2 and 4 ft. The post-injection video monitoring hole showed significant PUR injected into 6 zones from 1.2 ft to 6 ft (figure 3b). These zones may have been hydrofractured. It is also possible that PUR was injected into tight bedding plane separations not visible in the pre-injection videos. In this case, PUR may still have some reinforcing value, especially when roof movement begins. In tight roof, pre-monitoring can indicate that lesser volumes of PUR should be pumped.
