# **Effects of Hydraulic Stimulation on Coalbeds and Associated Strata**

**Report of Investigations 8260**

**By Curtis H. Elder**

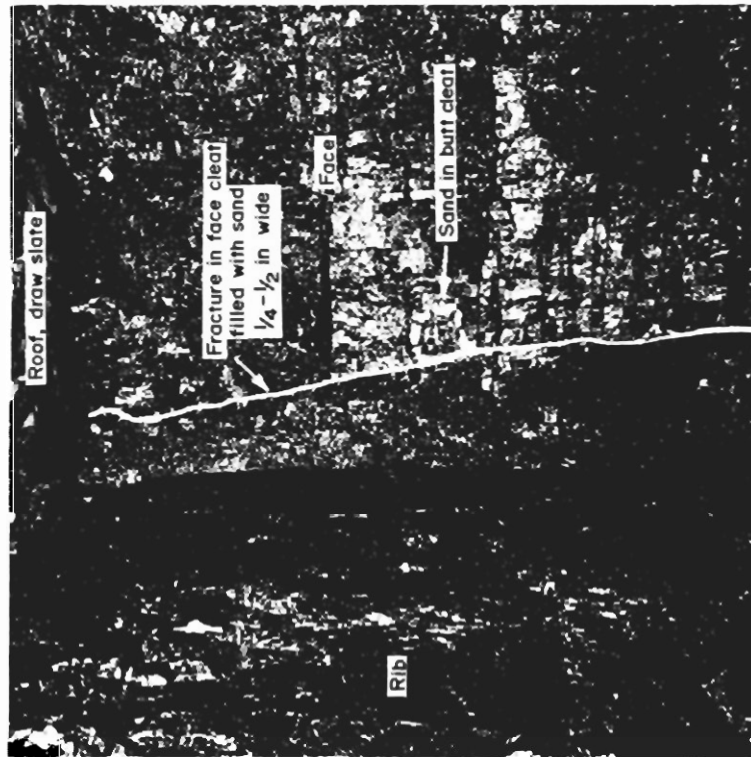
On June 12, 1974, the induced fractures were intercepted by mining. Twenty feet of vertical sand-propped fracture was mapped along the face cleat direction west of the borehole. The sand-filled fracture ranged from one-eighth to one-half inch in width, extending from the draw slate at the top of the coalbed to the mine floor. There was no evidence that the fracture extended into the roof or floor rock (figs. 4-6). Wide vertical fractures were propagated to the north of the borehole along the butt cleat direction. These fractures were 1/2 to 2-1/2 inches in width and were packed with the propping sand (figs. 7-8). They extended from the base of the draw slate to the floor. Again, no evidence was found to indicate that the induced fractures along the butt cleat direction penetrated the roof (fig. 9) or floor rock.

FIGURE 6. - Induced fracture in face cleat of Pittsburgh coalbed. Note termination of fracture at draw slate.

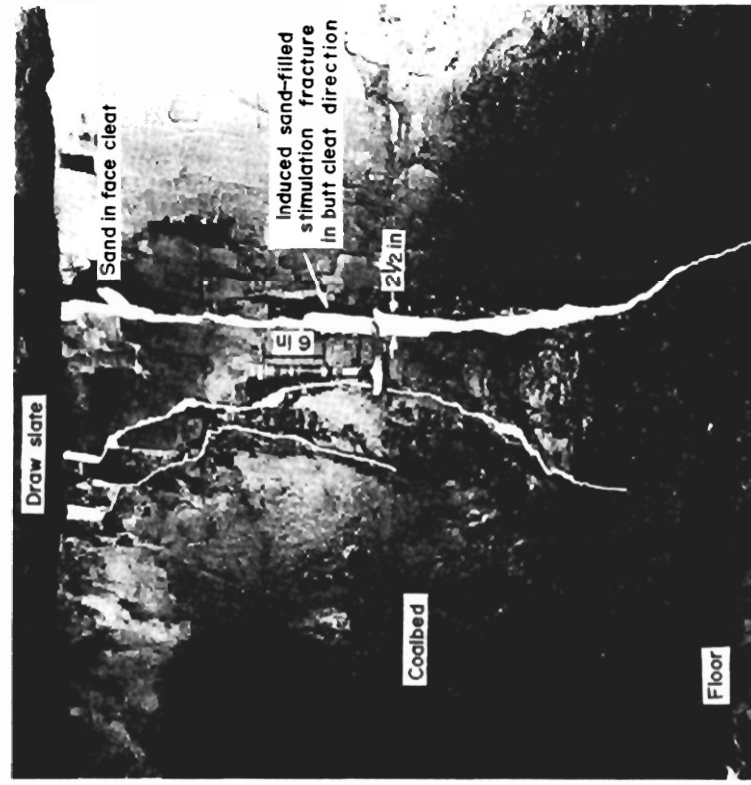
FIGURE 7. - Induced sand-filled fractures in butt cleat direction in Pittsburgh coalbed.

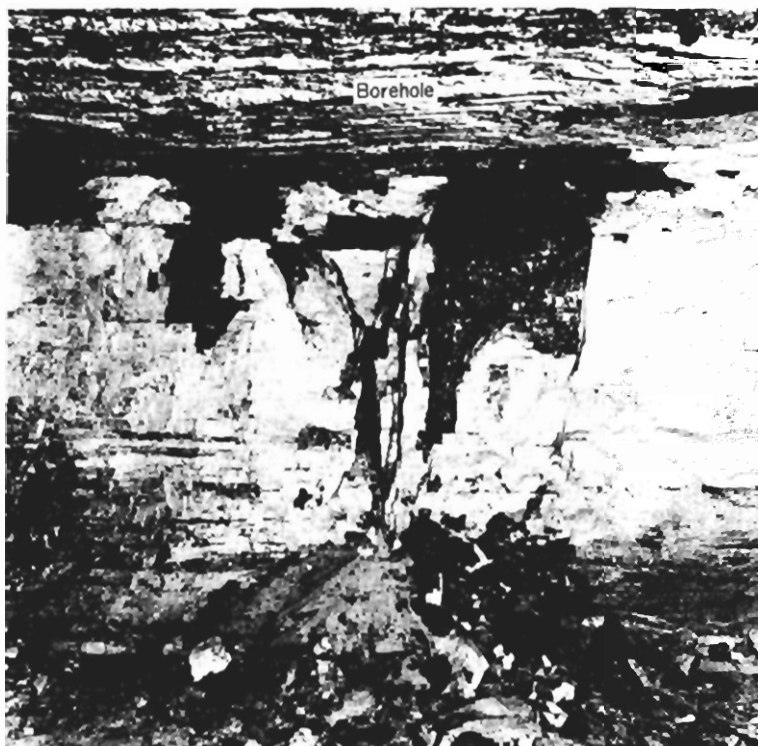
FIGURE 10. - Induced fracture after 2 years of exposure in mine.

The borehole and induced fracture site in the mine were inspected 2 years after treatment to observe long-term effects of stimulation on the roof strata and coal rib. No deterioration of roof or floor strata was evident. In addition, no spalling was observed along the roof or coal rib (fig. 10).

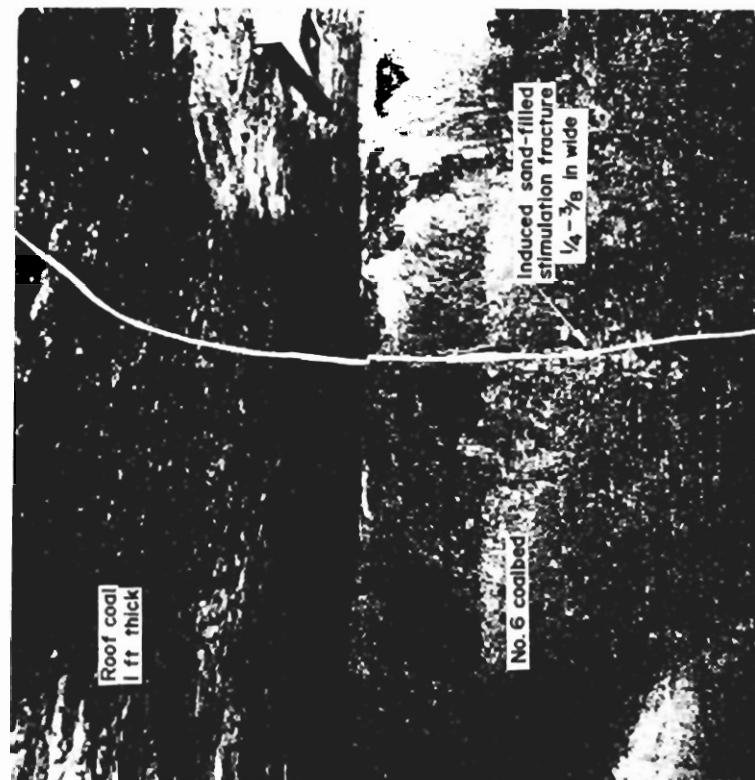
FIGURE 18. - Sand-filled induced fracture in rib and roof coal at point B on figure 13.

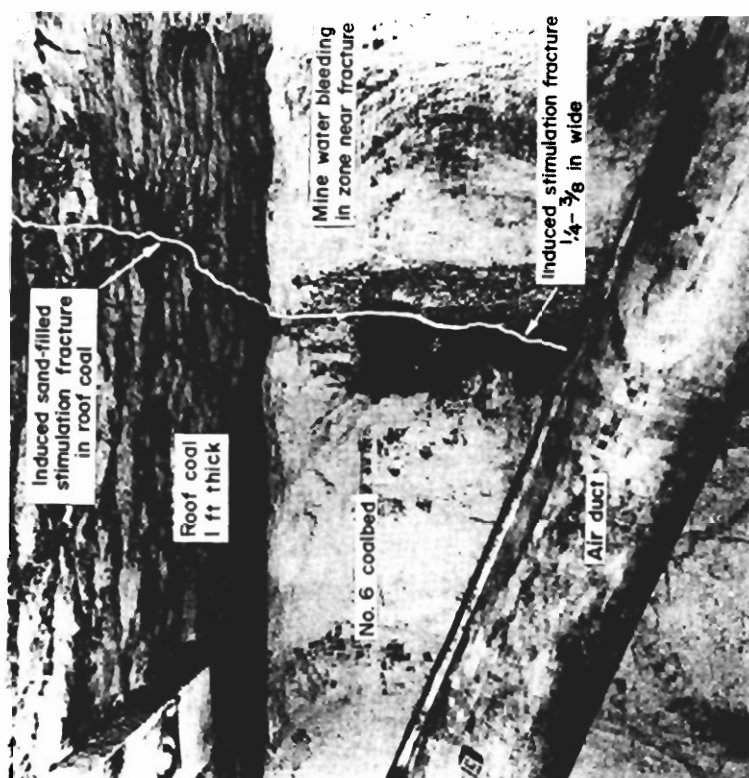
FIGURE 17. - Sand-filled induced fracture in rib and roof coal at point C on figure 13.

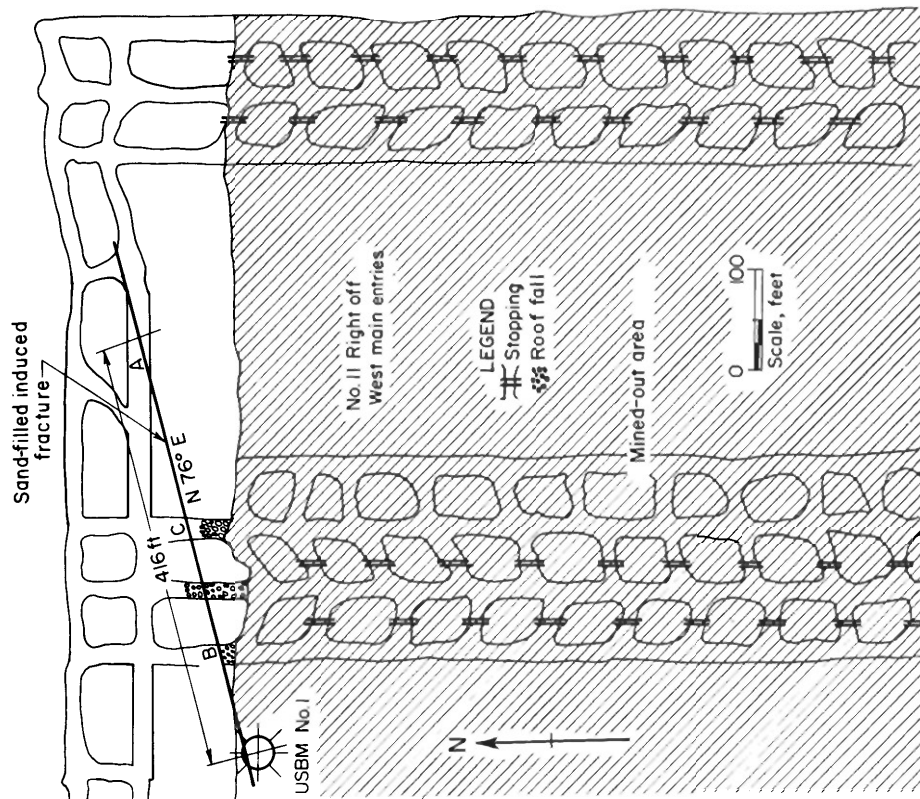
FIGURE 19. - Location of induced fracture in bleeder entry after the area was mined out.

strata that could be related to the induced fracture. There was some evidence of fluid and sand intruding a few inches into a rock joint that crossed the induced fracture at point B (fig. 19). There was no evidence that this intrusion of sand and fluid in the rock joint impaired the roof or affected its stability.
