**NIOSH**  
Fire Fighter Fatality Investigation  
and Prevention Program

***A summary of a NIOSH fire fighter fatality investigation***

***July 8, 2015***

## ***4 Career Fire Fighters Killed and 16 Fire Fighters Injured at Commercial Structure Fire – Texas***

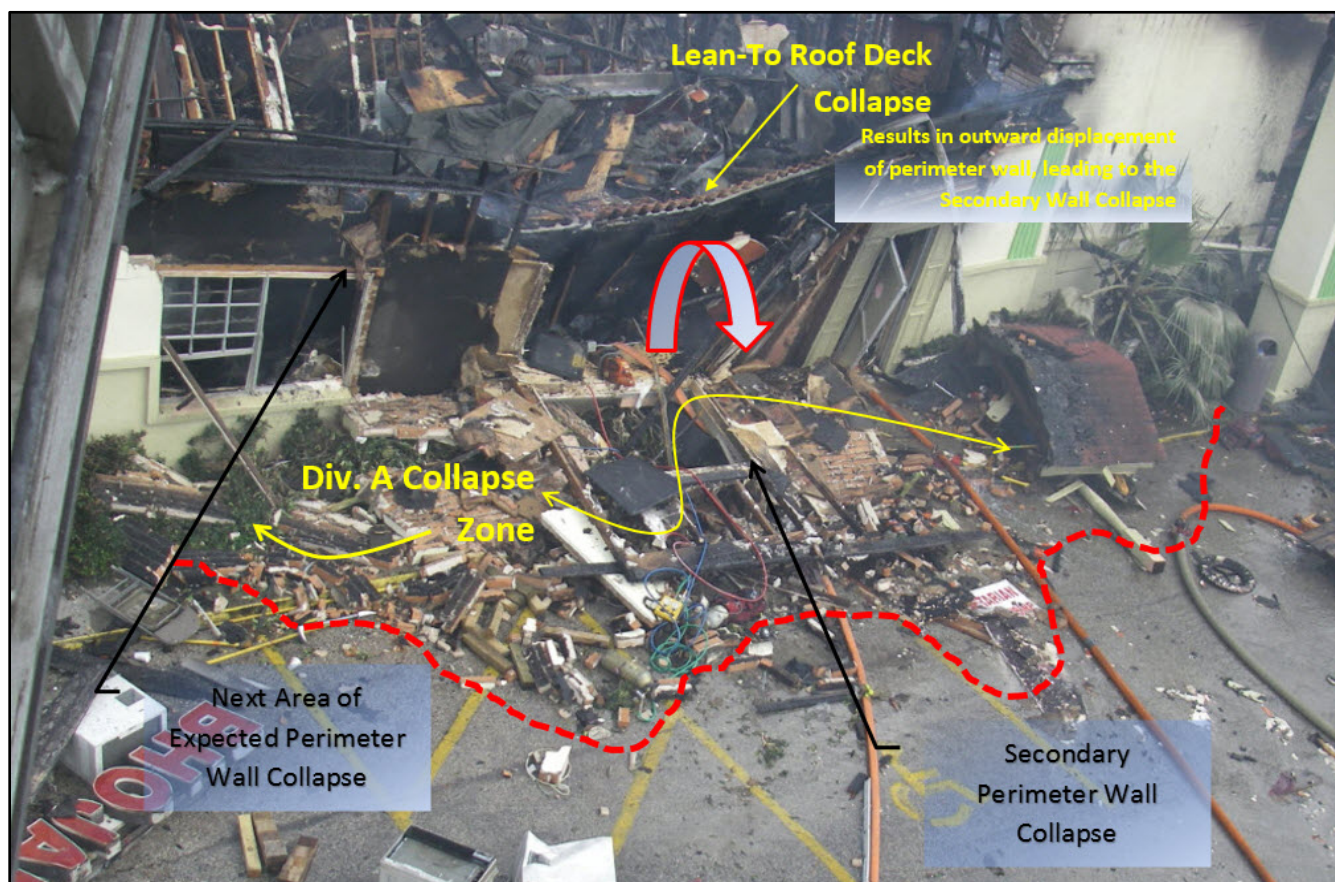
The roof deck came to rest in a slight lean-to configuration creating lateral forces acting upon the outer (north) perimeter wall. This degraded the integrity of the gypsum wall board and wood stud frame wall and caused cracking along the outer wall. Since the primary entry point to the interior of the restaurant was located on the Side Alpha, this was the entry point for the initial handline taken in the building.

**Photo 3. Details of the secondary collapse on Side Alpha.**  
(Photo courtesy of the fire department/Analysis Diagram Courtesy of Buildingsonfire.com)

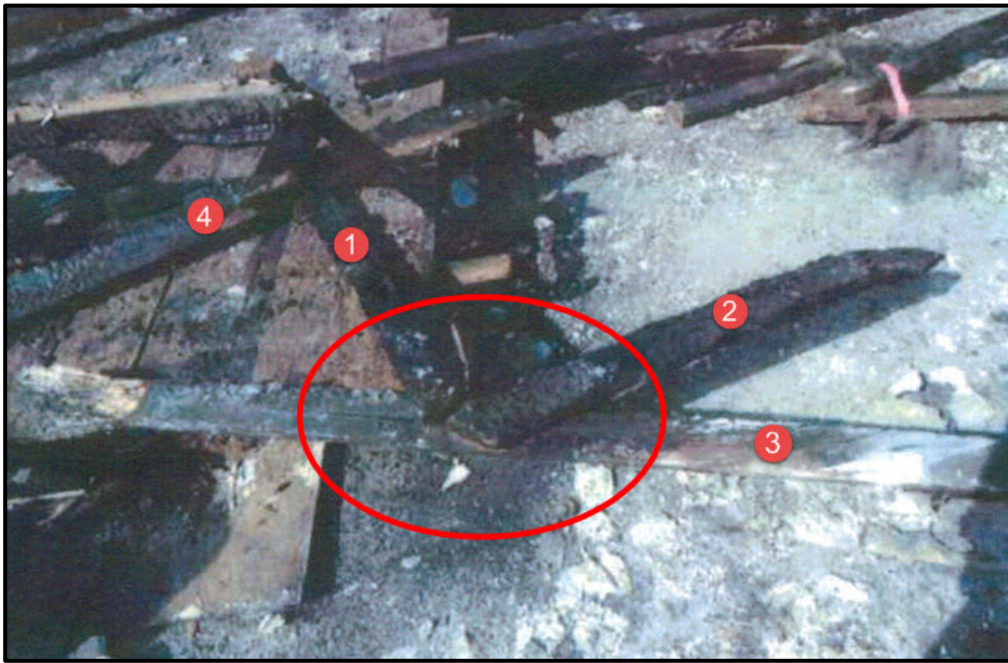
**Photo 10. Bottom Truss Cord and Two-Web**  
*(Photo courtesy of the fire department/ Diagram Courtesy of Buildingsonfire.com)*

- [1] 2 in. x 4 in. Wood Web;
- [2] 2 in. x 4 in. Wood Web; **Note:** See loss of remaining web material
- [3] 2 in. x 4 in. Wood Bottom Chord;
- [4] 2 in. x 6 in. Wood Top Chord;
- [5] **Circle** depicts the typical surface connection point of the truss webs as they are mechanically fastened with nails to the cord, (absent is any MCP, which is typical of most fabricated truss assemblies of that period, and today).
