Structure Collapse at 140-Year Old Mill Building Kills 2 Career Fire Fighters and Injures 2 Others – Pennsylvania

Executive Summary

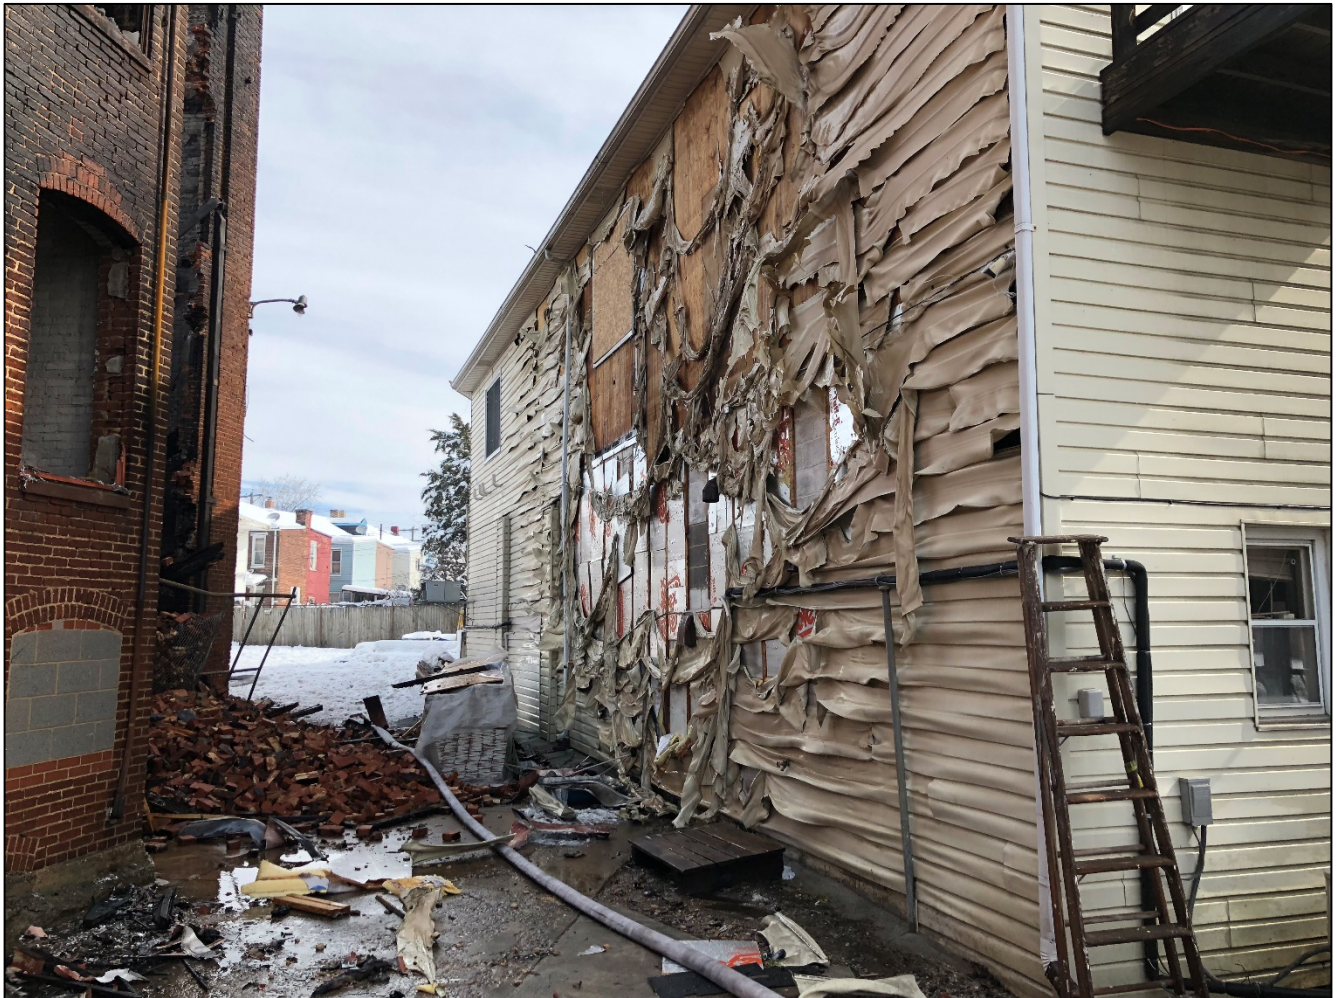
**Photo 5. Photo shows heat damage to the rear of the building containing the beer distributor near the Side Delta / Charlie corner.
(Photo courtesy of the Fire Department.)**

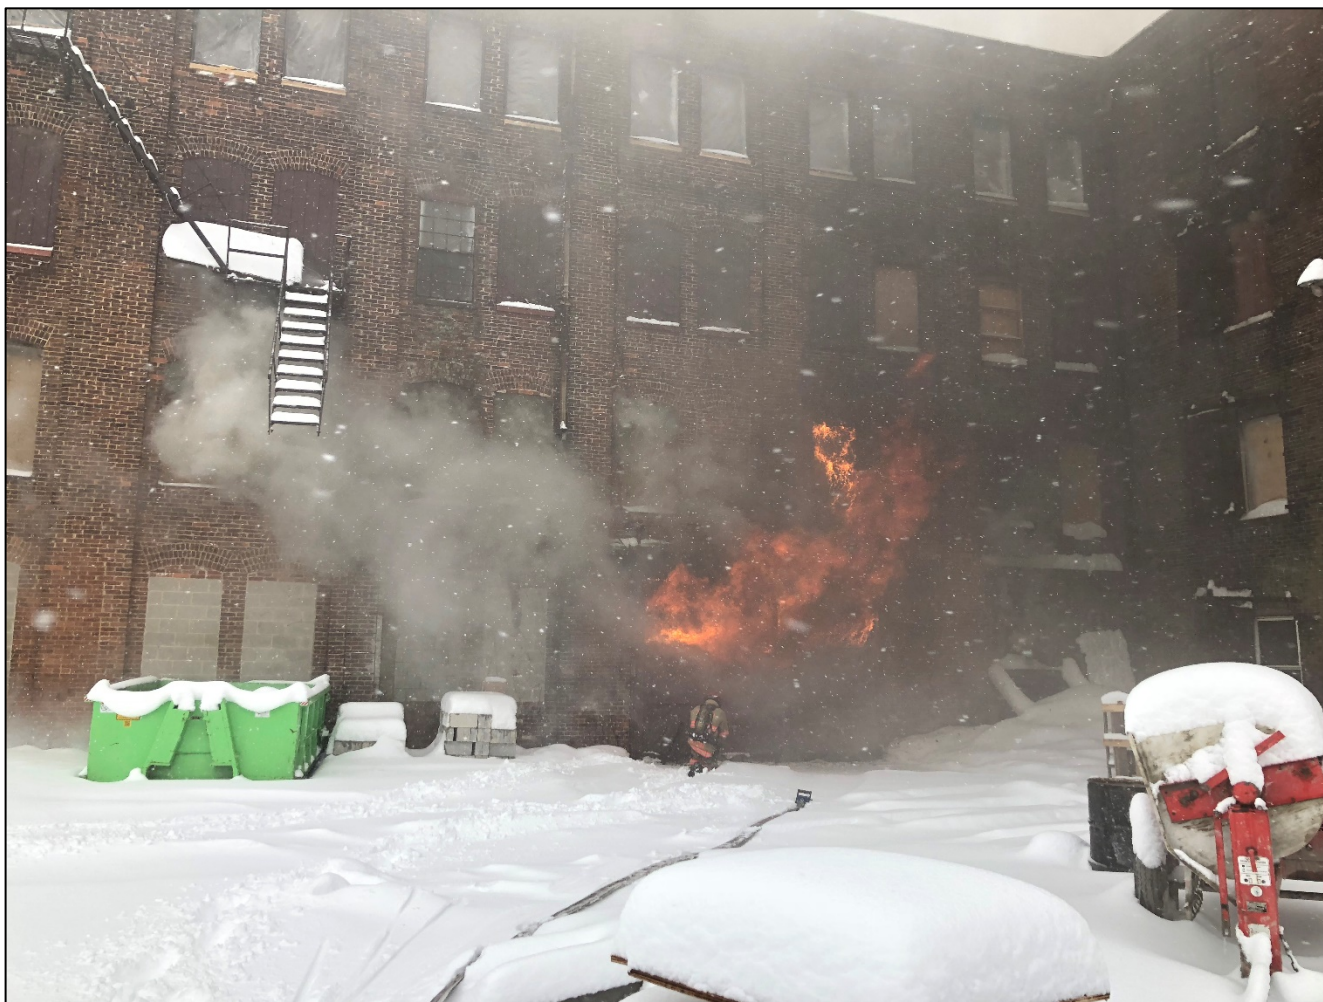
**Photo 8. Photo shows fire at door on Side Bravo soon after initial crews arrived on scene. Time approximately 1626 hours on March 21, 2018.
(Photo courtesy of the Fire Department.)**

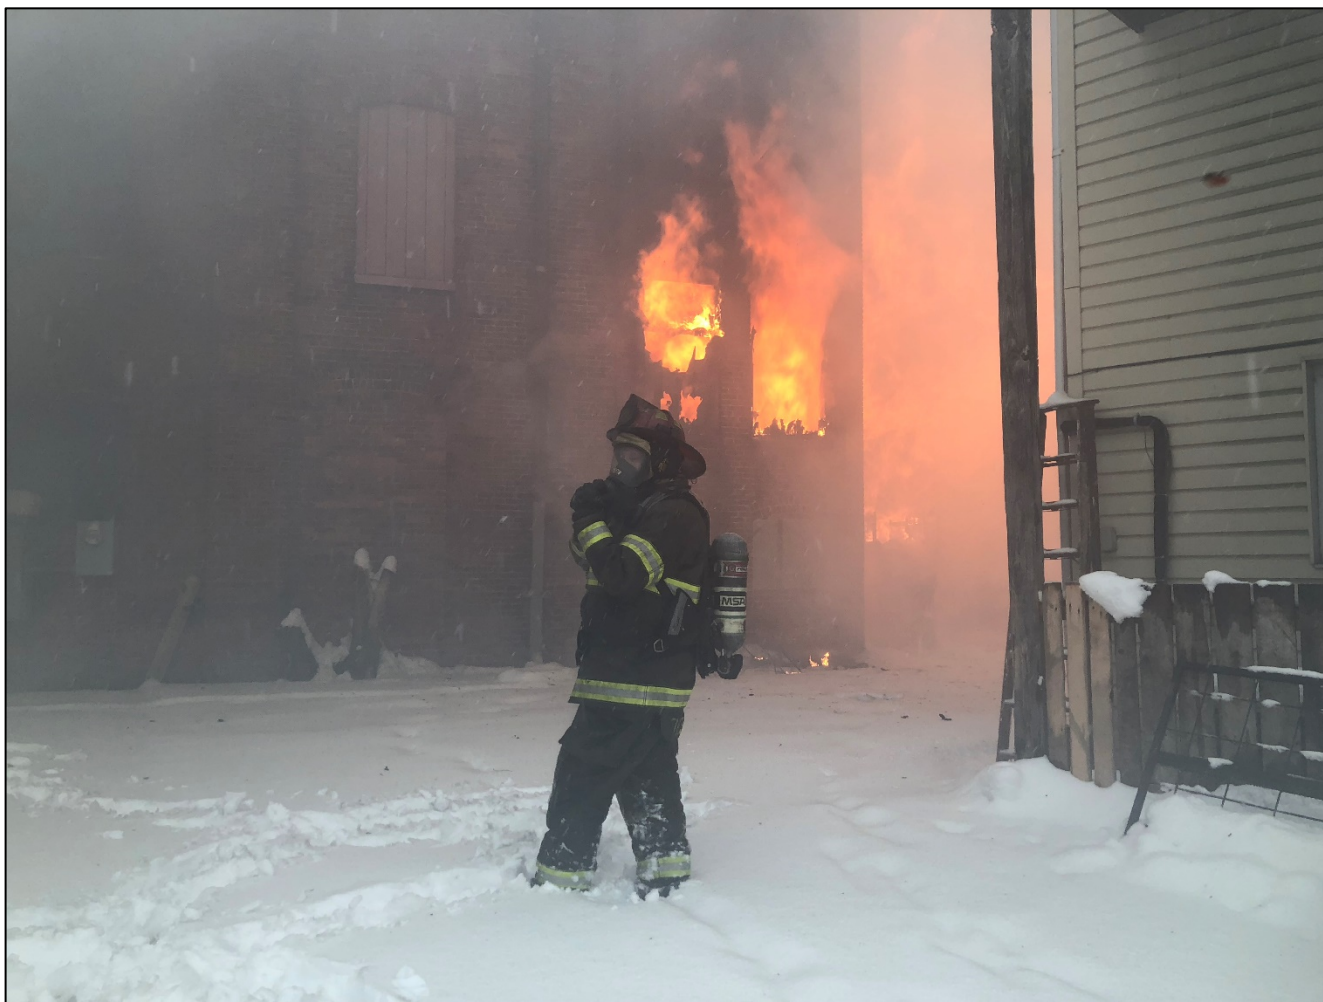
Photo 9. Photo shows fire at the Side Delta / Charlie corner soon after fire department arrived on scene on March 21, 2018.

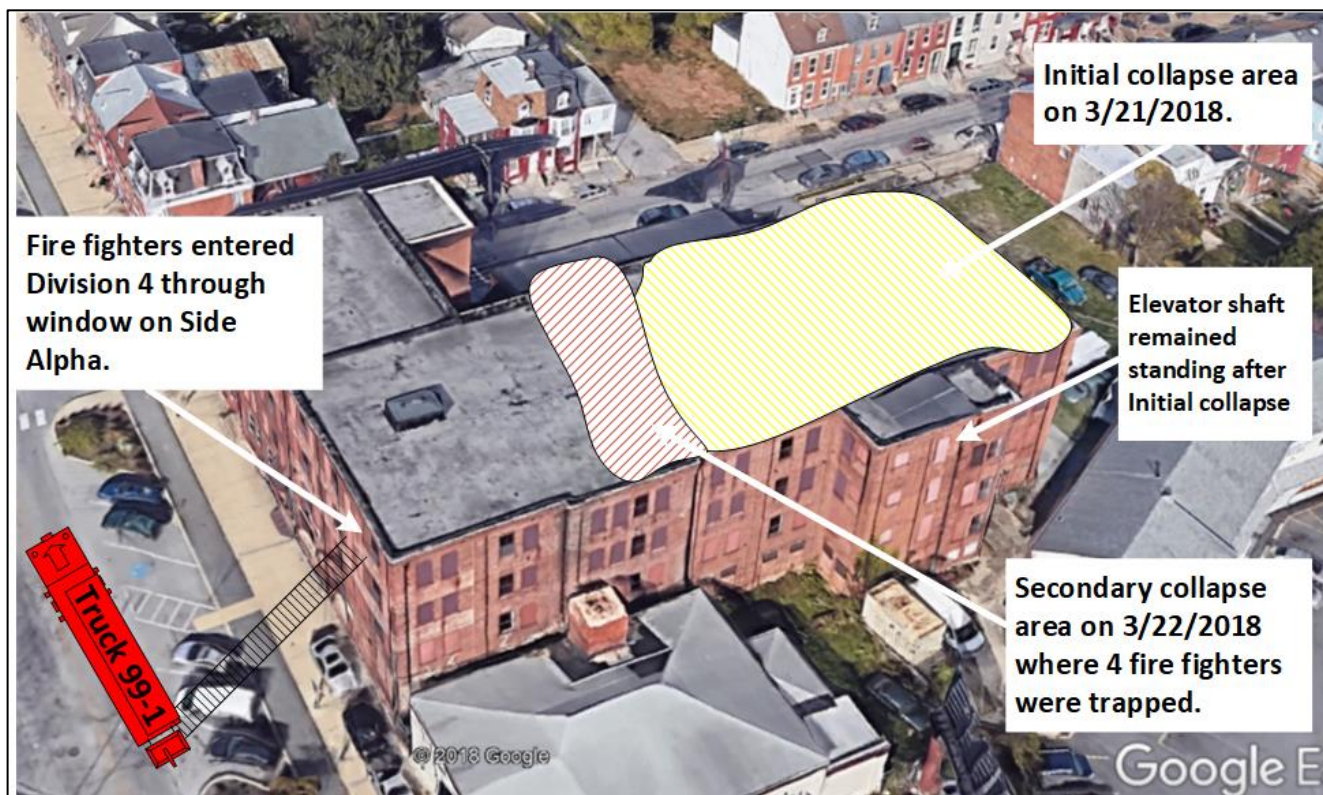
Diagram 2. Initial collapse occurred on March 21, 2018 at approximately 1805 hours. Secondary collapse occurred on March 22, 2018 at approximately 1515 hours after fire fighters used elevated aerial platform to access Division 4 to extinguish hot spots which could not be extinguished using master streams in defensive mode outside the collapse area. All locations are approximate.

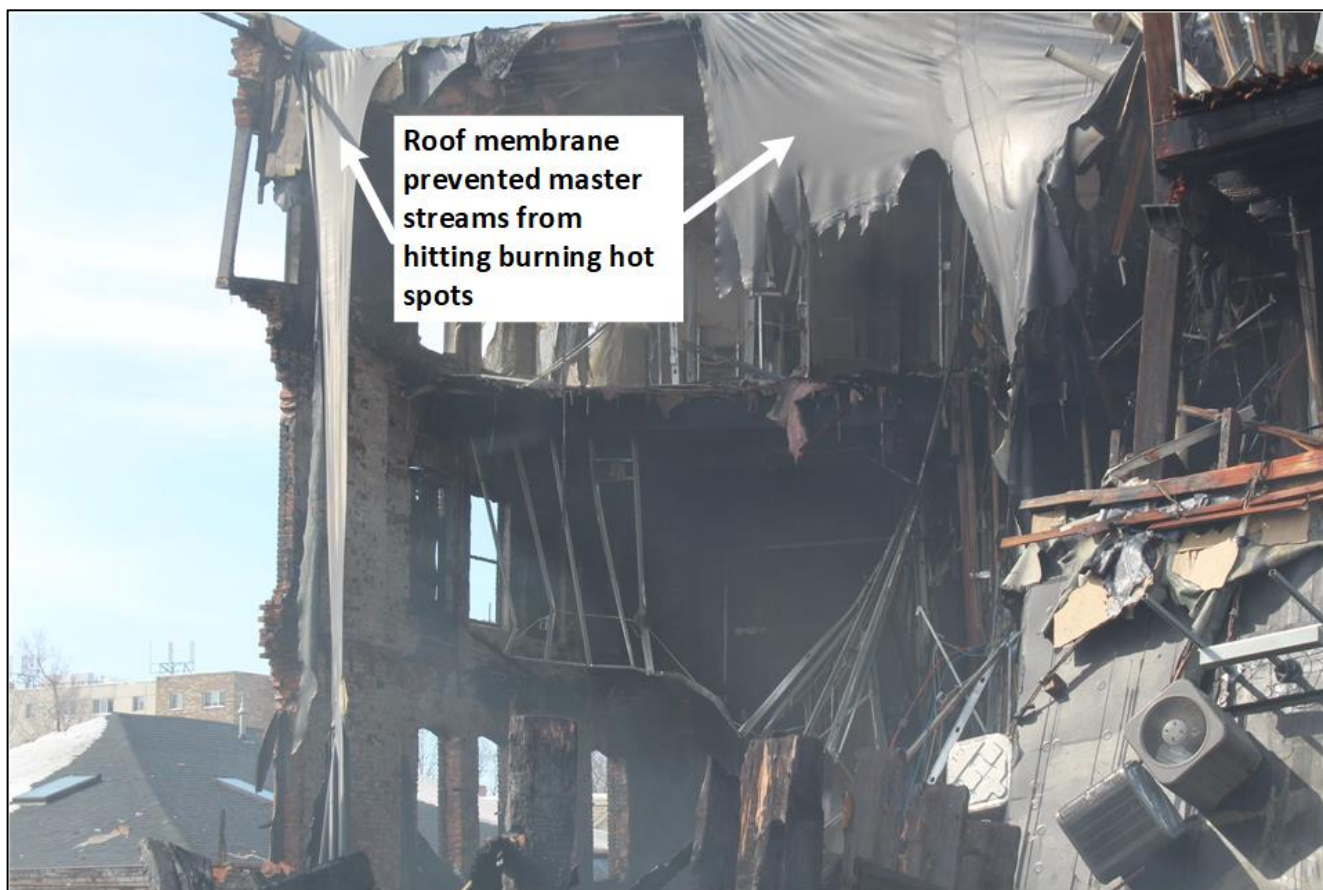
Photo 11. View from Side Charlie facing rear of remaining structure. Photo shows the partially melted roof membrane which deflected master streams and prevented water from reaching burning hot spots in roof and ceiling areas on the Division Three and Division Four. The inability to extinguish the burning hot spots ultimately led to the decision to enter the third and fourth floors to attempt to extinguish the remaining hot spots.
