A summary of a NIOSH fire fighter fatality investigation

April 14, 2015

## ***Two Career Fire Fighters Die in a Rapid Fire Progression While Searching for Tenants—Ohio***

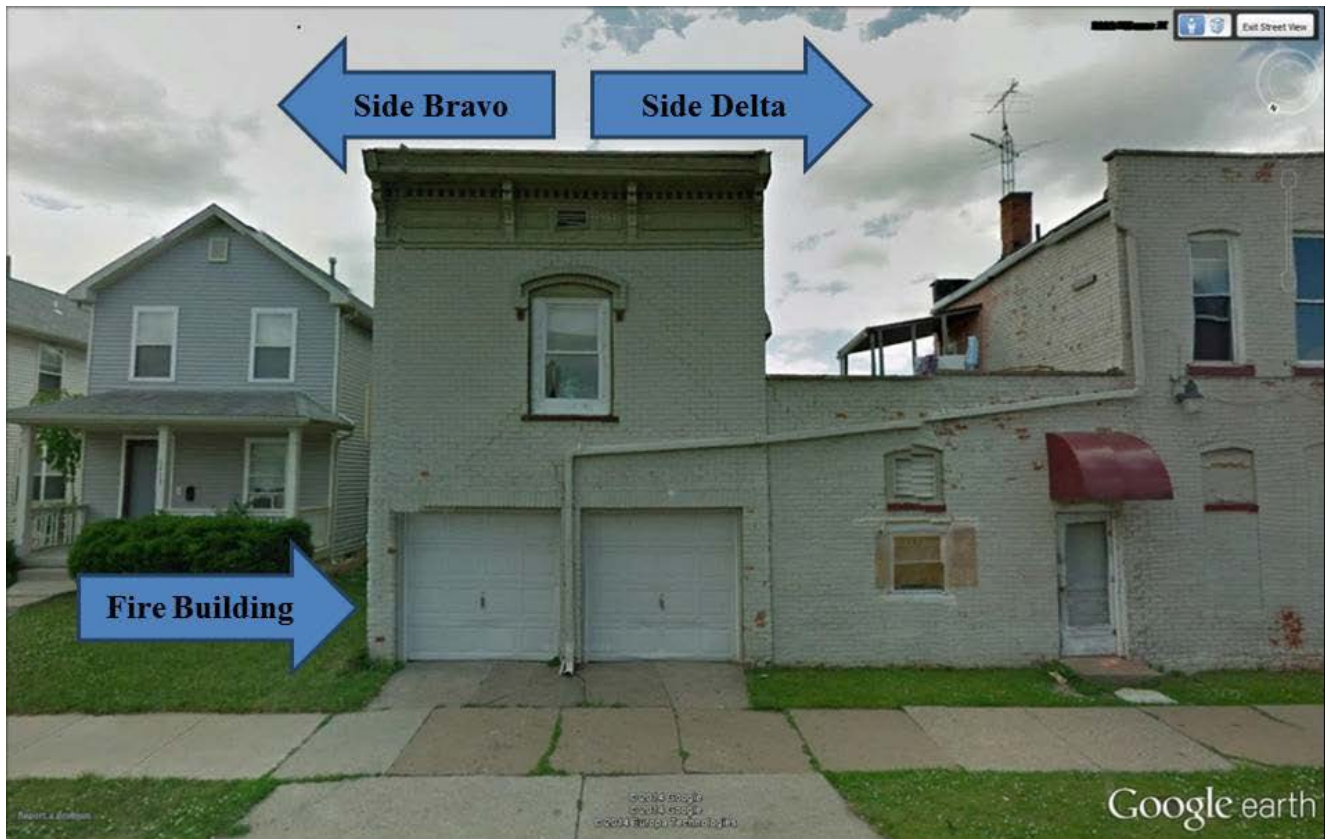
**Photo 1. View of structure from Side Alpha. The first floor at the Alpha/Delta corner (to the right) was a small local market. The remainder of the structure is apartments, both first floor and second floor.  
(Photo from Google Earth.)**

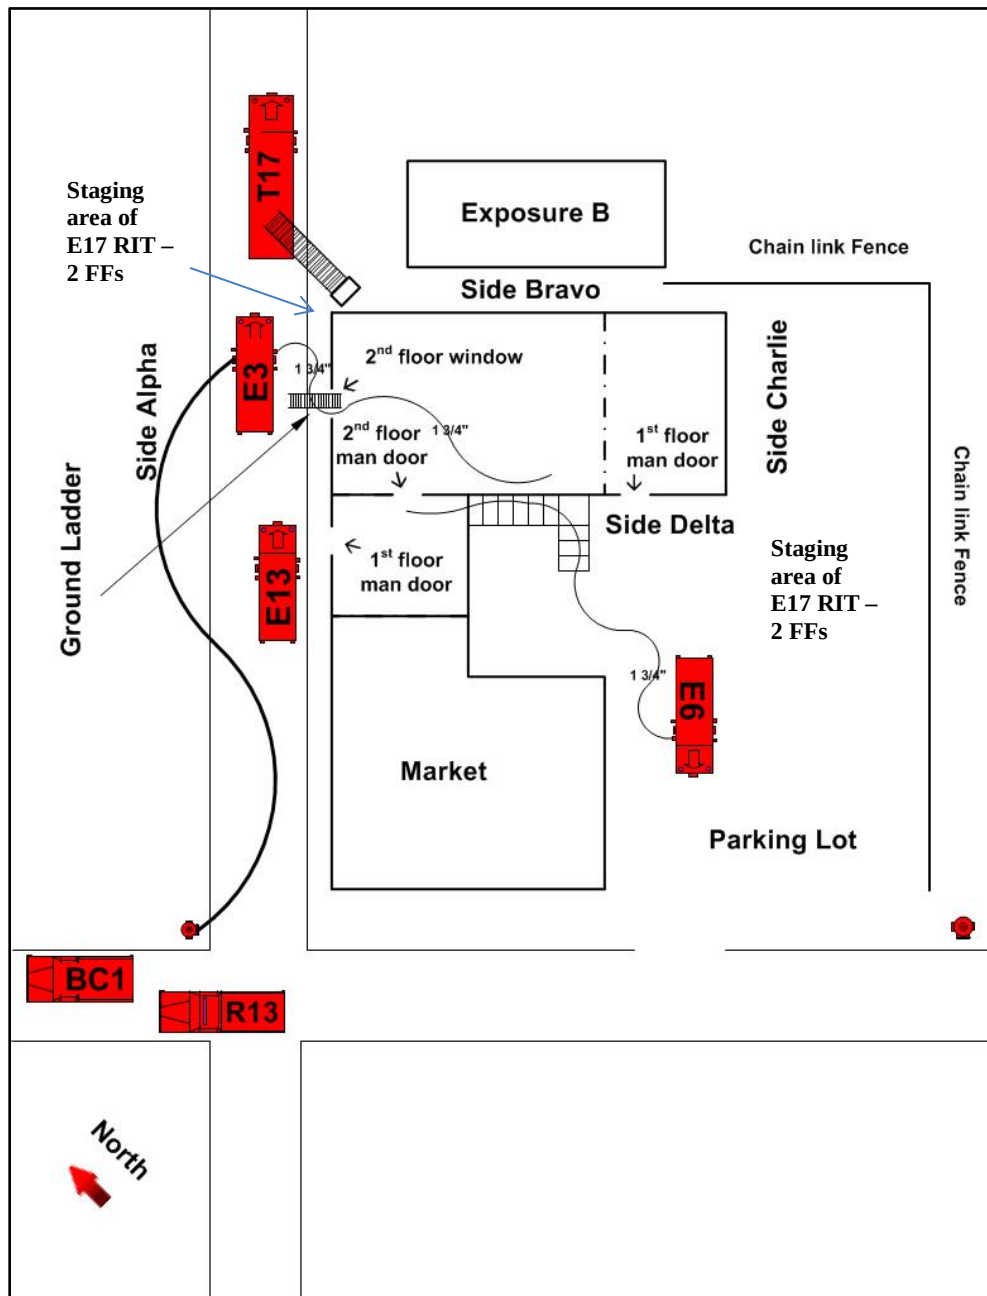
assigned search with Rescue 13 (see Diagram 4). *Note: Command was informed by an occupant at the scene that all occupants were out of their apartment but there was a dog on the second floor.* Engine 13 opened a first-floor Side Alpha apartment man-door on the Delta exposure of the garage.

**Diagram 4. Initial apparatus placement and hoseline deployment of the first alarm companies.**

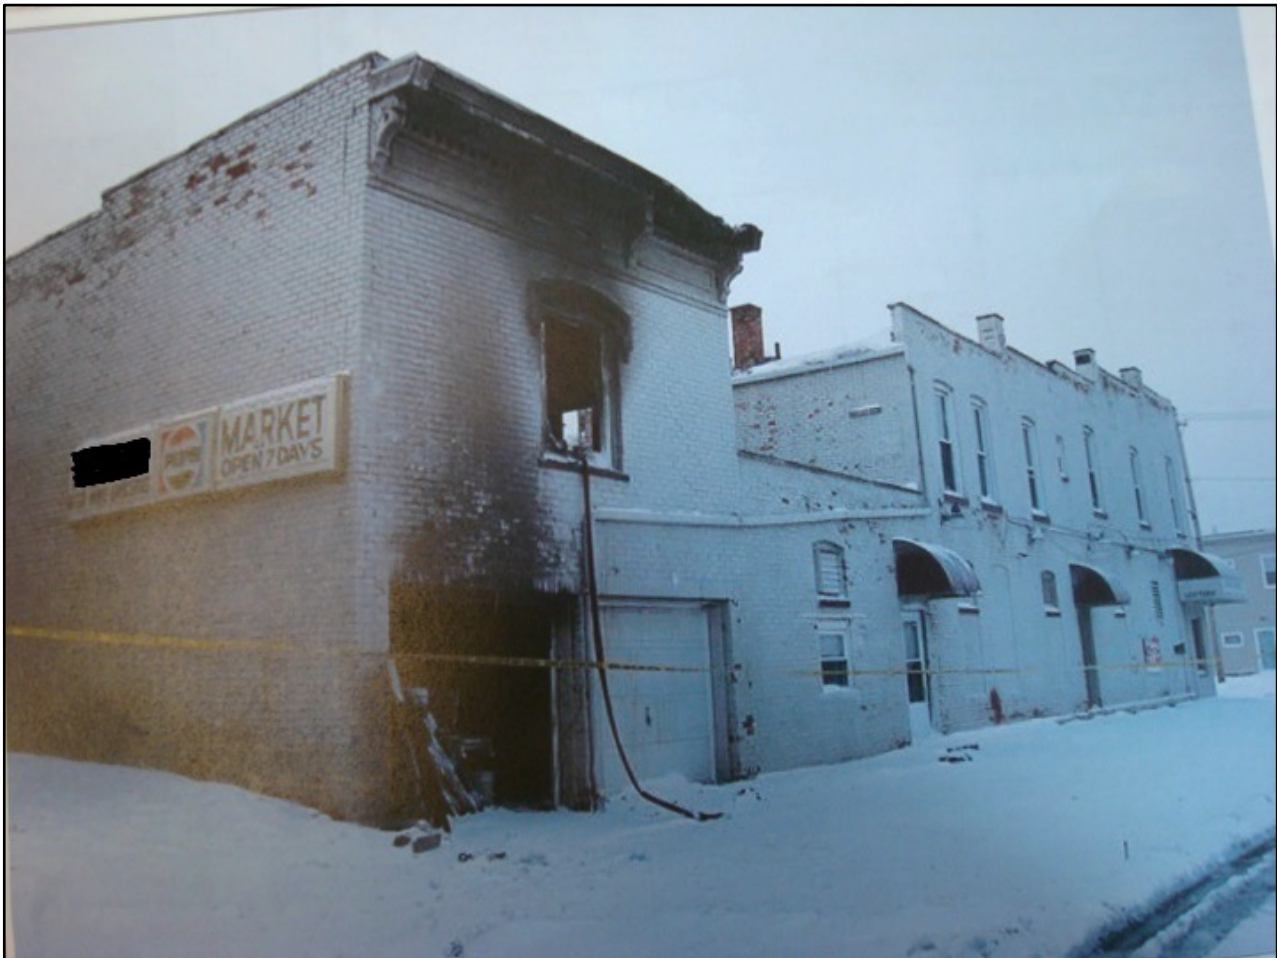
**Photo 2. Side Alpha of the structure. Engine 3 entered the second-floor window upon arrival. Engine 13 opened the left garage door to initiate the initial search.**  
*(NIOSH photo)*

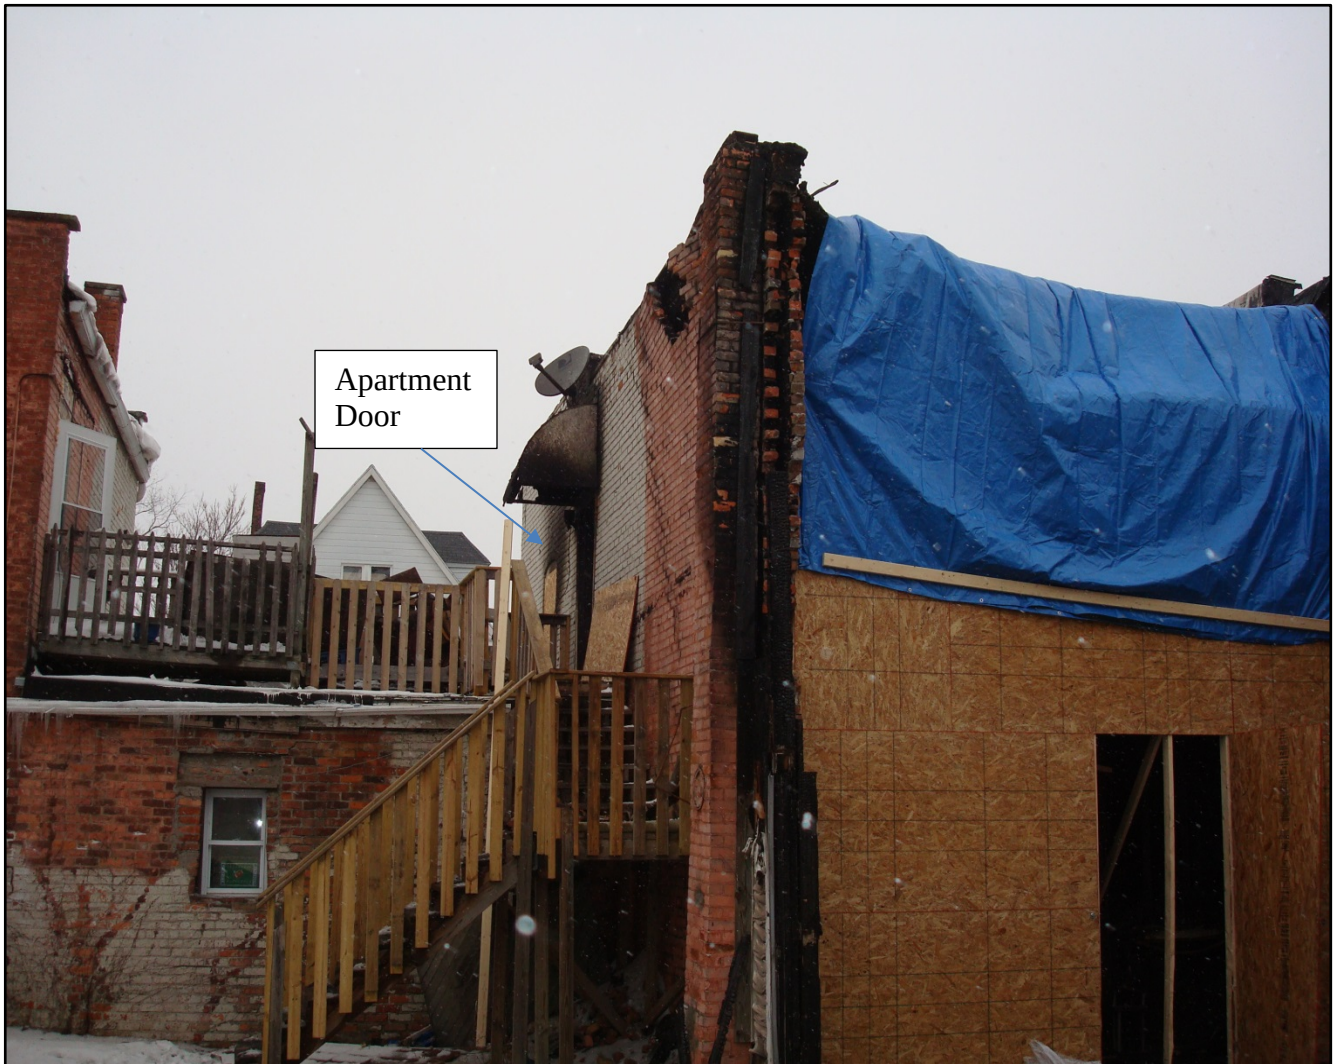
**Photo 3. Exterior stairs to Side Delta man-door to second-floor apartment that Engine 6 entered.**  
***(NIOSH Photo)***

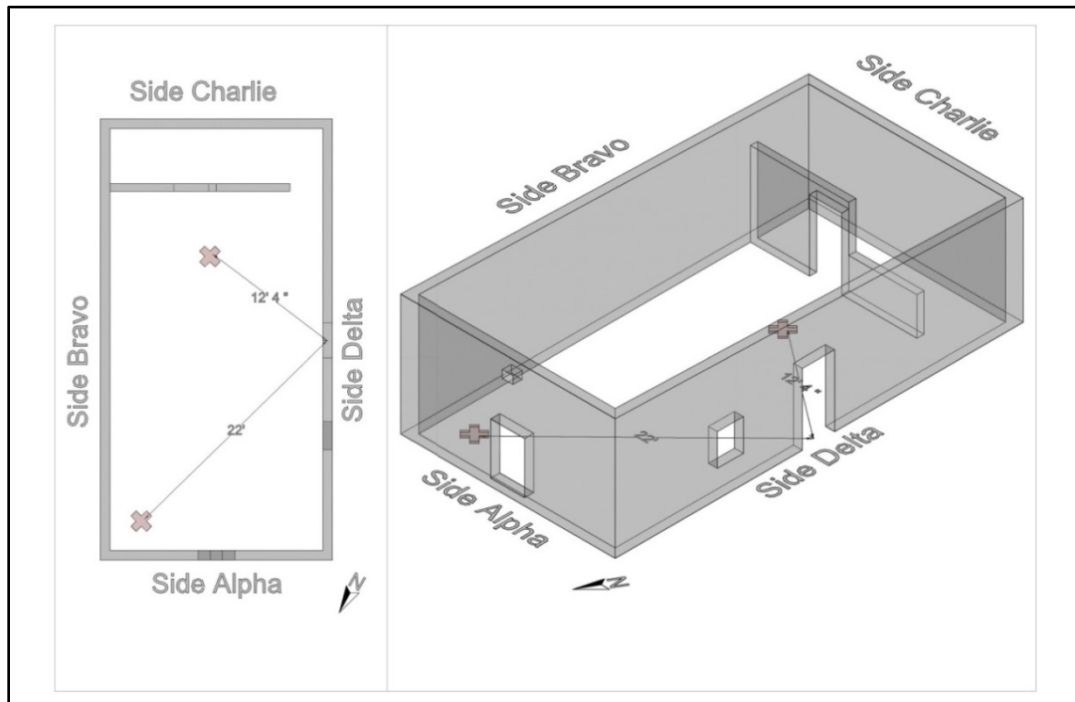
**Diagram 5. Approximate locations of the two fallen fire fighters on the second floor of the fire structure. Fire fighter #1, which was located first, was found near the Alpha/Bravo corner. Fire fighter #2 was found closest to the Side Delta man door.**  
(Diagram courtesy of the city's Engineering Services.)
