## Career Captain Sustains Injuries at a 2-1/2 Story Apartment Fire then Dies at Hospital – Illinois

***A summary of a NIOSH fire fighter fatality investigation***

***September 24, 2013***

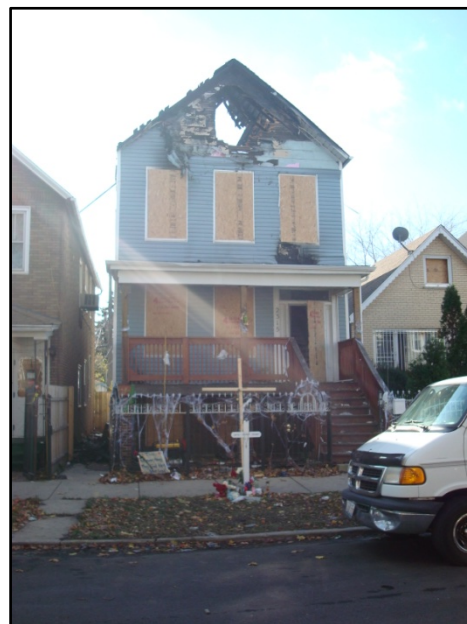
**Front view of the fire structure  
(NIOSH Photo)**

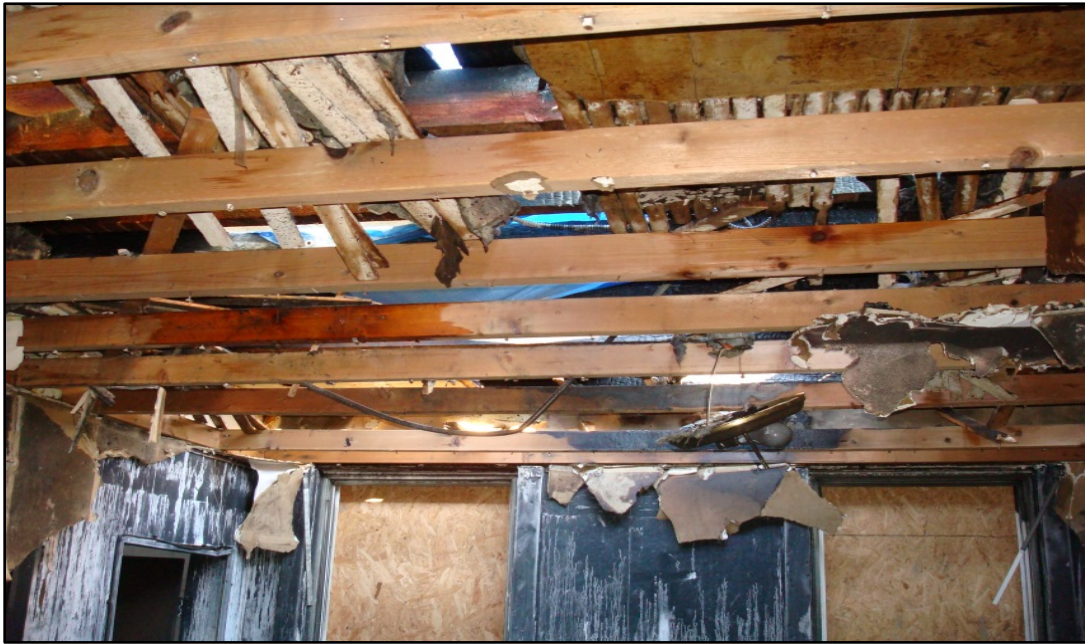
**Photo 1. Second floor ceiling has multiple layers – drywall, 2 x 4 joists, lathe (subflooring), and 2 x 6 joists covered by OSB.**  
*(NIOSH Photo)*

***Recommendation #9: Municipalities, building code officials, and authorities having jurisdiction should consider requiring apartment complexes and associated multiple-family dwellings that have been "retrofitted" into current structural building code requirements also be brought up to current codes for such things as sprinkler systems and adequate structural roof members when requests for permits are made.***

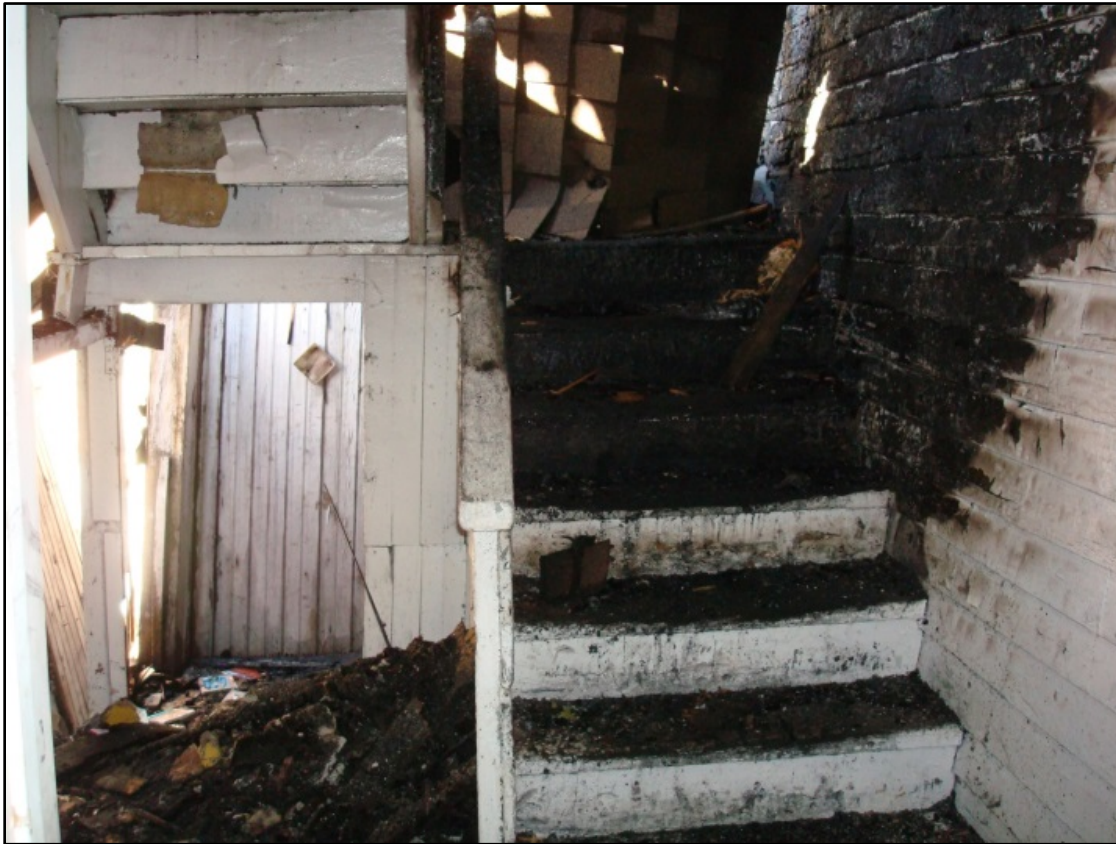
**Photo 2. Covered porch and stairwell of Sector 3 from 1<sup>st</sup> floor apartment.**  
*(NIOSH Photo)*

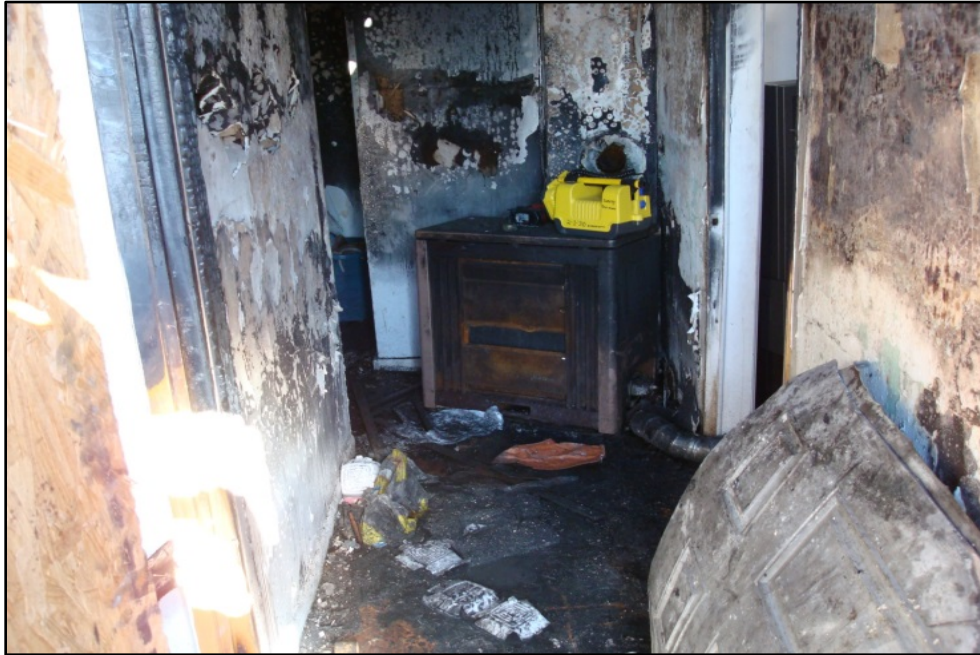
**Photo 3. Hallway in which victim was operating prior to incident. Note the space heater that the victim was near when he yelled for help and the metal door that had been attached to the doorway in Photo 4 to the covered porch and was warped by the heat.**  
*(NIOSH Photo)*

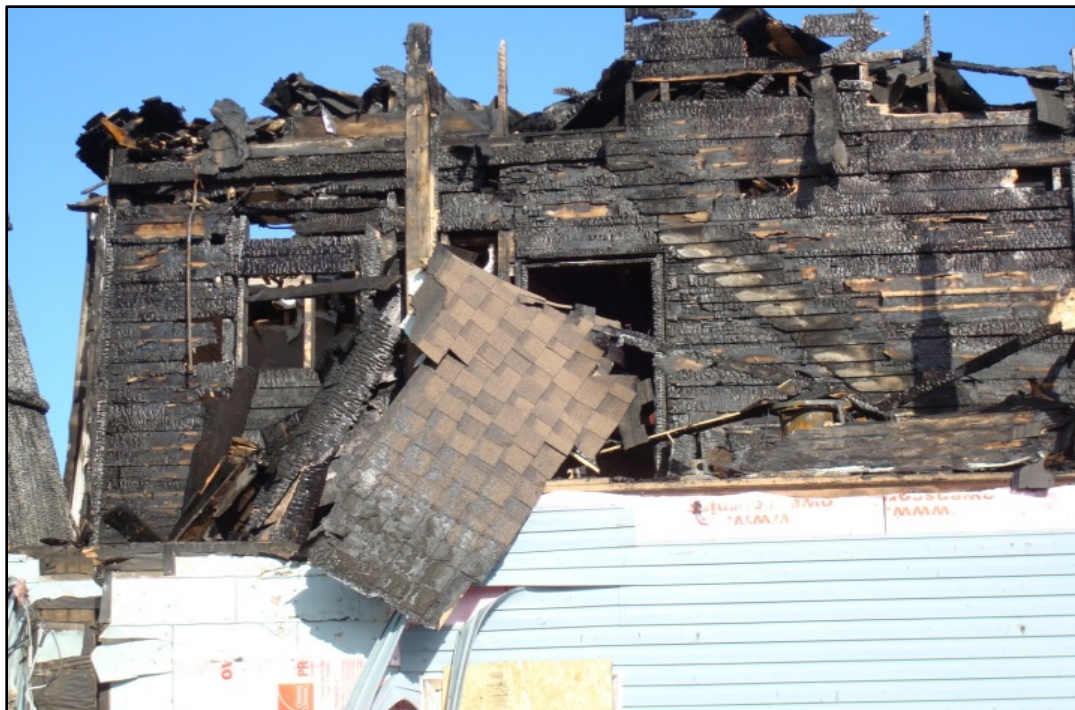
**Photo 4. Second floor doorway to covered porch, in which, the victim was operating behind  
(NIOSH Photo)**

The developing fire burning in the attic void space was ventilation limited and produced a large volume of unburned products of incomplete combustion and high pressure. The first arriving companies observed optically dark smoke from the 2-1/2 story apartment building coming from the front and rear attic windows. As the engine crew advanced a hoseline to the 2<sup>nd</sup> floor, BC19 searched the 1<sup>st</sup> floor and went to the rear of the structure and noticed fire in the enclosed rear porch area. Another engine crew advanced a hoseline down the back alley to the exterior rear of the structure. Once the 2<sup>nd</sup> floor rear porch door failed, the fire gases from the porch flowed into the hallway.
