Volunteer Lieutenant Killed and Two Fire Fighters Injured Following Bowstring Roof Collapse at Theatre Fire – Wisconsin

Executive Summary

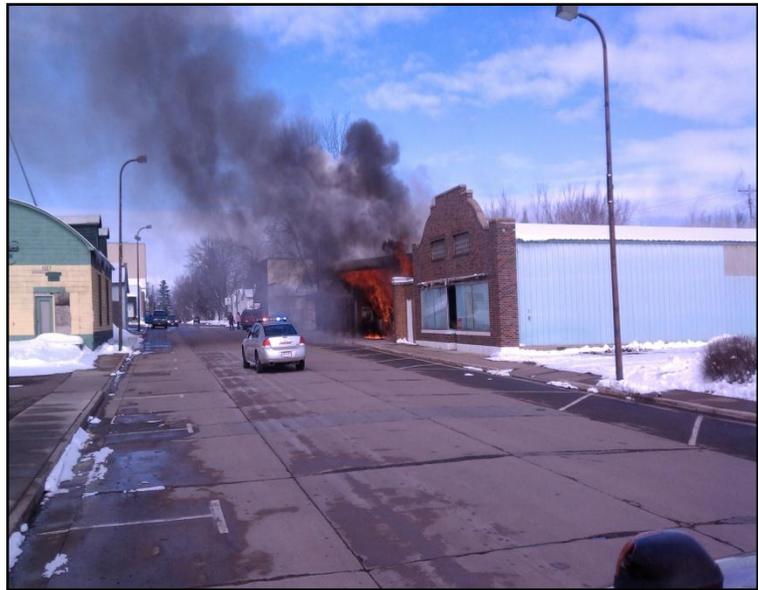
Incident scene when fire was first discovered.
(Photo courtesy of Julie Miklaszewicz.)

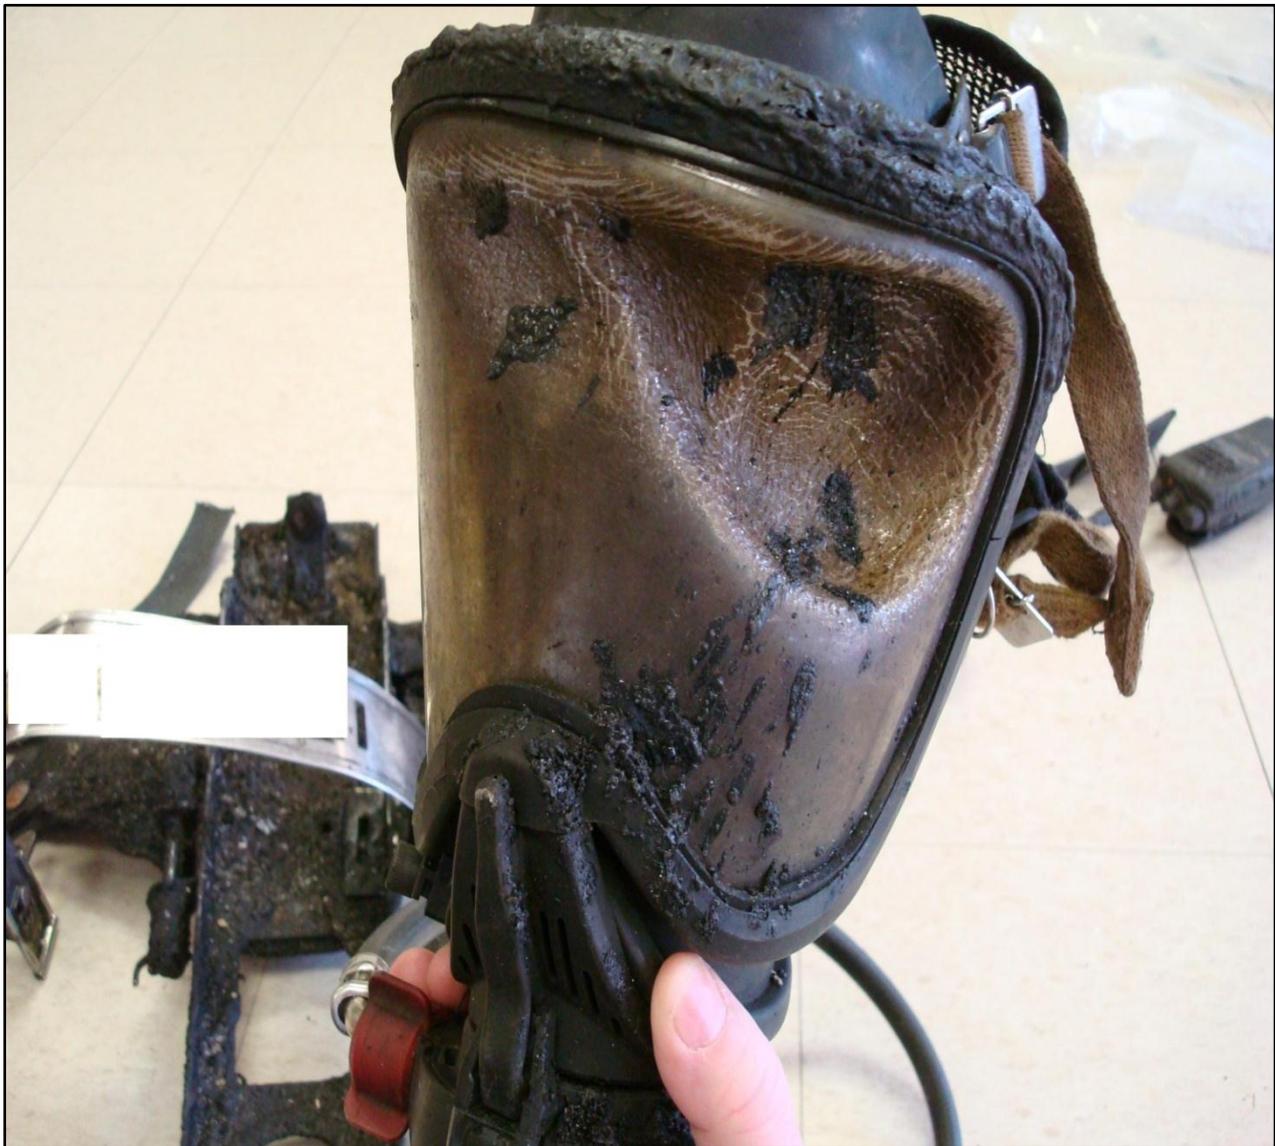
It was reported to NIOSH investigators that the victim, FF1, and FF2 entered the structure wearing a full array of personal protective clothing and equipment, consisting of turnout gear (coat and pants), gloves, boots, a hand-held radio (no extended mics), SCBA with an integrated PASS device, Nomex® hoods and helmet. *Note: The hand-held portable radios did not have a programmed emergency button.* The victim’s facepiece was properly connected to his mask-mounted-regulator and was reported to be appropriately positioned about his face prior to the collapse and when located in the debris. The victim’s facepiece showed signs of thermal degradation (see Photo 1) and the immediate

pressure hose had been burned through. The victim's SCBA cylinder was empty. The last flow test on the SCBA was conducted in 2010 due to budgetary constraints.

Photo 1. Victim's facepiece showing thermal degradation.
(NIOSH Photo.)

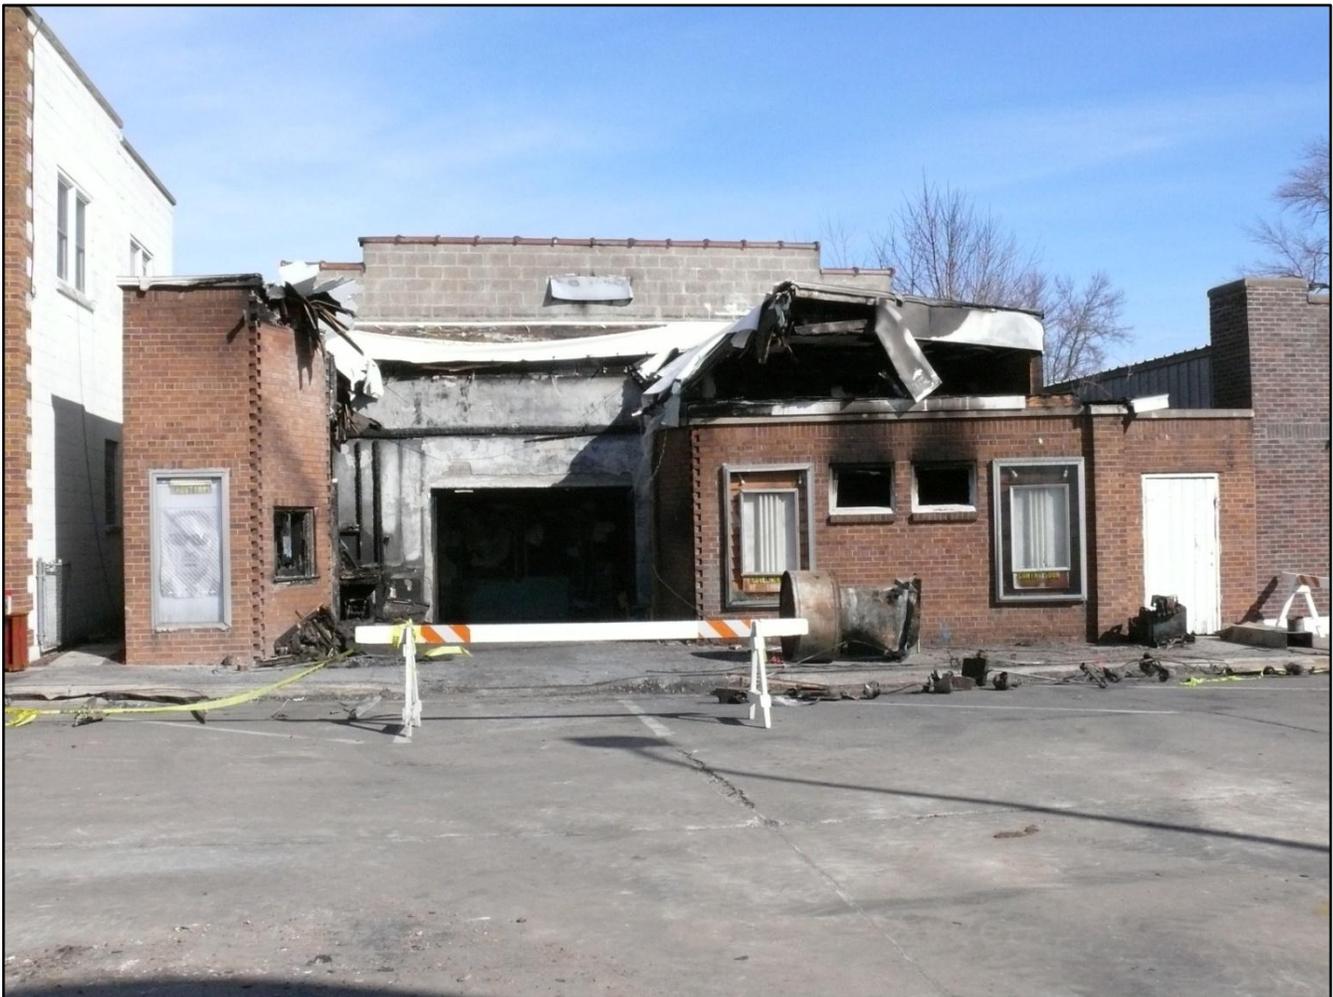
Photo 2. A-side of the structure showing the front of the theatre.
(Photo courtesy of Mark D. Krueger.)

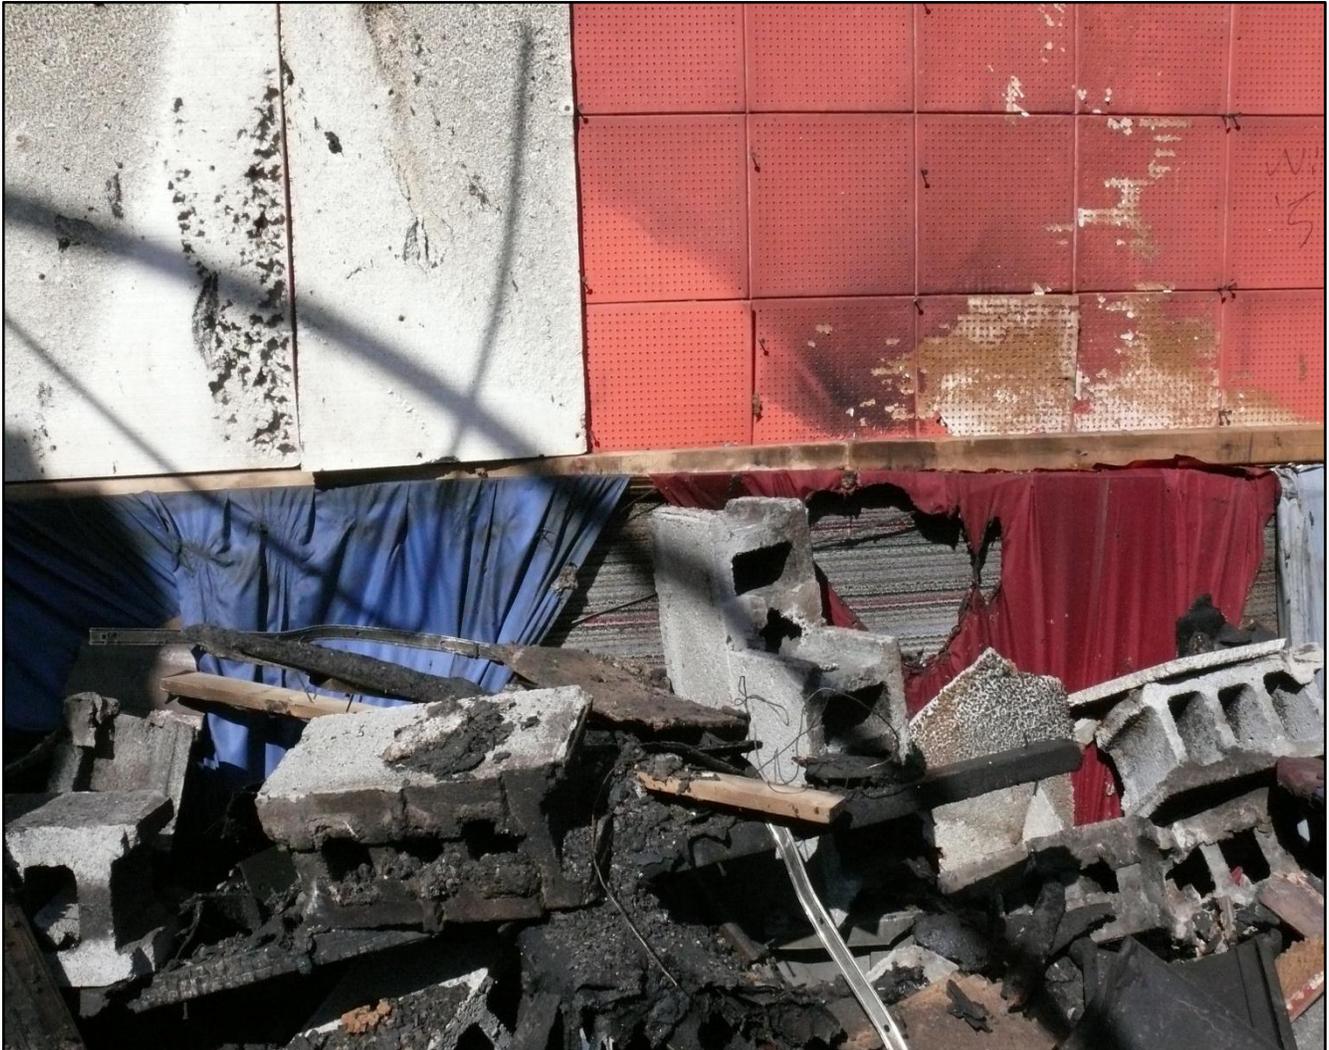
Photo 4. Interior auditorium walls, showing peg board, sound insulation, and wall curtains within the auditorium.

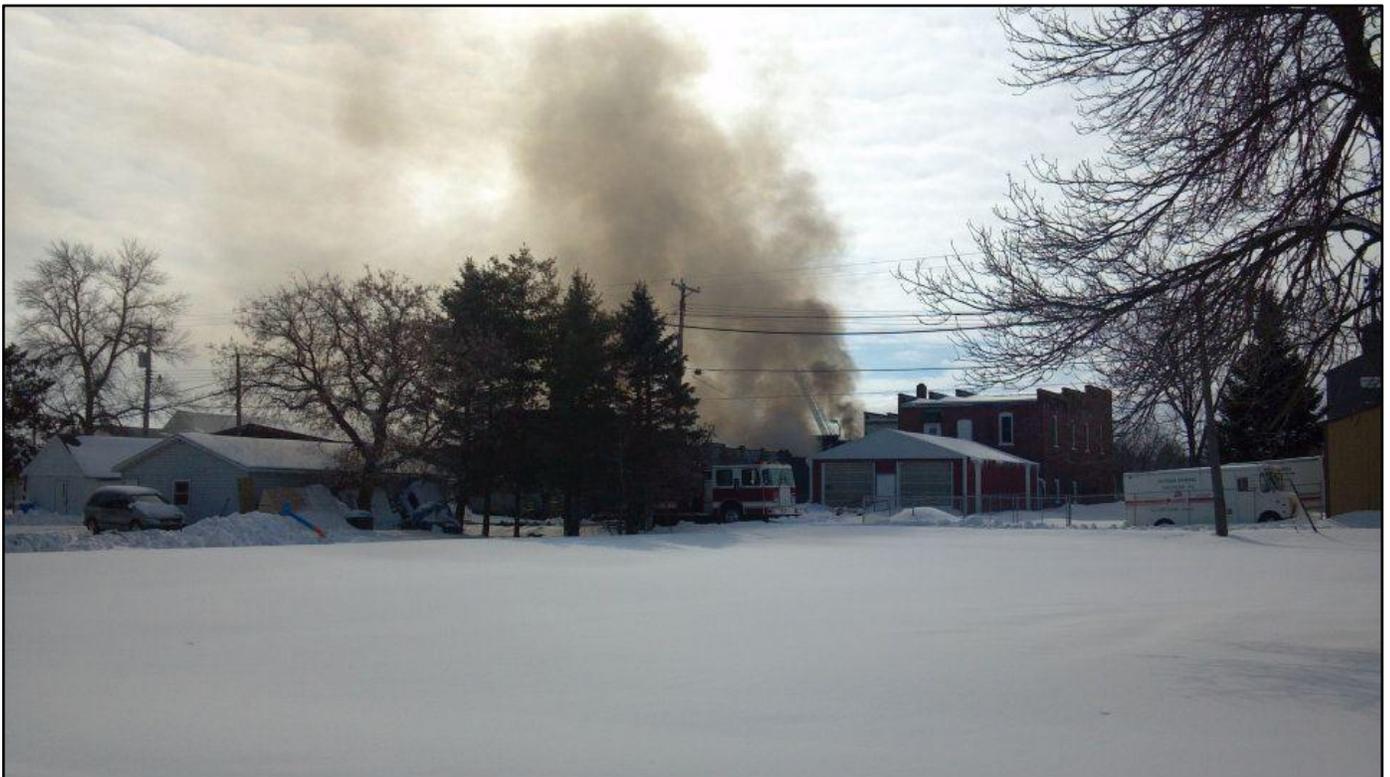
The incident occurred during a sunny, partly cloudy day with temperatures outside ranging in the 20s. This area of the state had seen varying amounts of snow the previous few months. NIOSH investigators could not determine the amount of snow and ice on the roof at the time of the incident, but photos taken by bystanders during the incident indicated there could have been several inches to potentially a foot or more of snow and ice remaining in the area (see Photo 5).

Photo 5. Photo taken from a field directly behind the C-side of the structure showing snow accumulations.

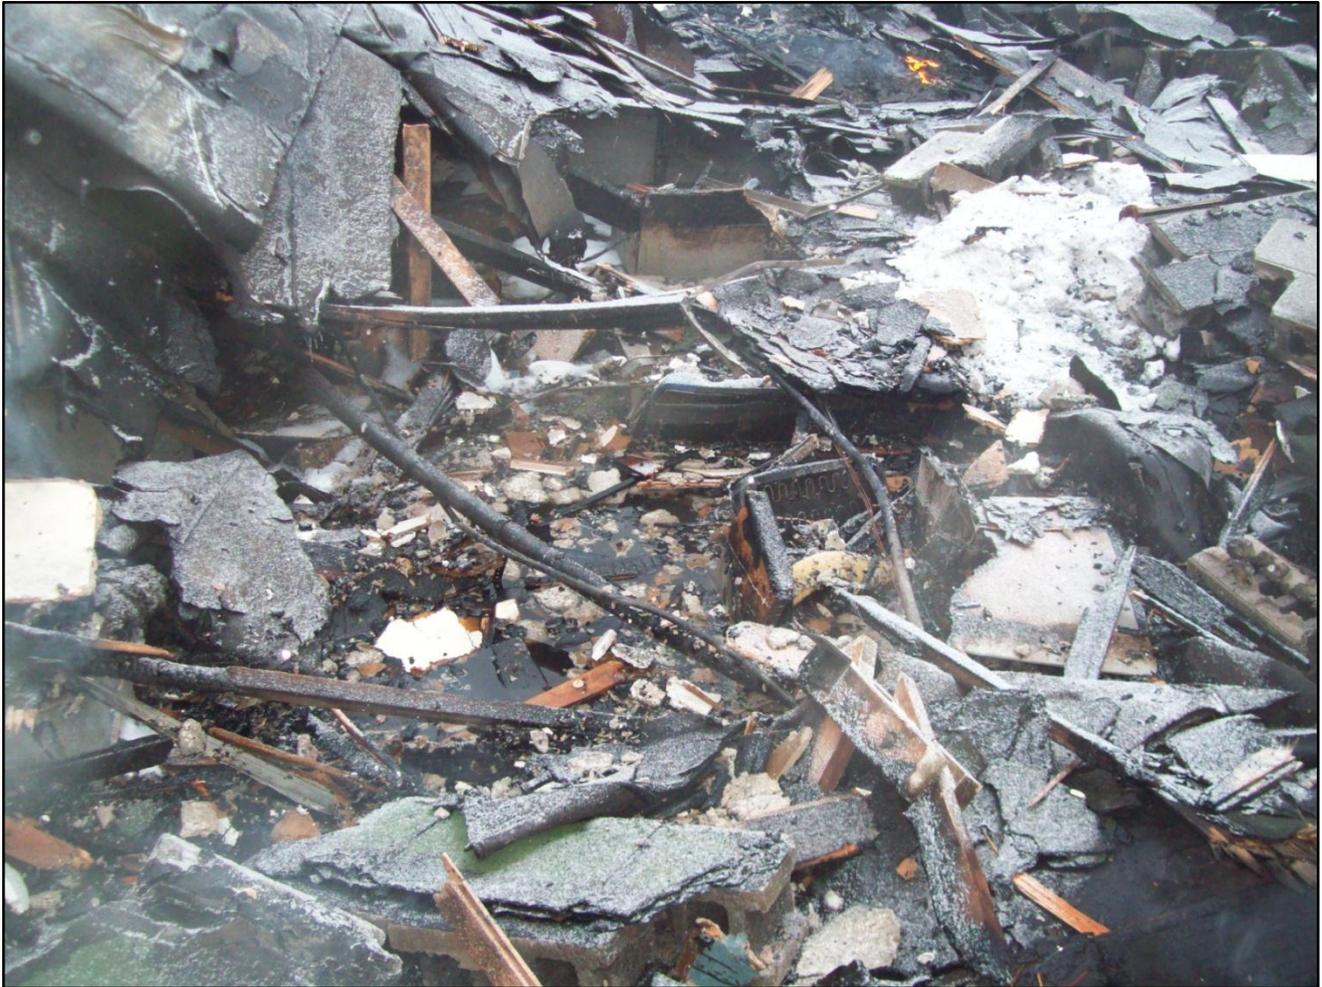
Photo 6. Victim discovered in this general area.
(Photo courtesy of 1st due department.)
