Death in the line of duty...

NIOSH
Fire Fighter Fatality Investigation
and Prevention Program

June 25, 2012

Career Fire Fighter Dies and Another is Injured Following Structure Collapse at a Triple Decker Residential Fire – Massachusetts

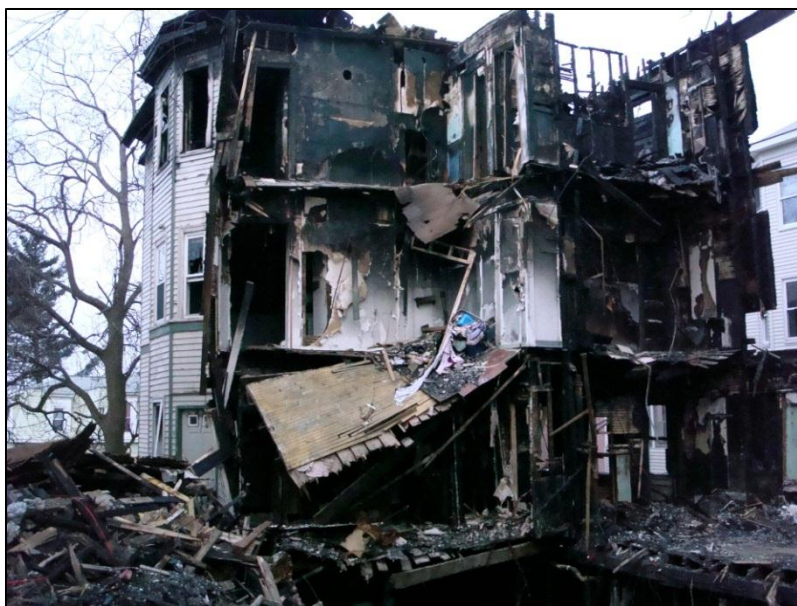
Rear view of the “triple decker” residential structure following partial cleanup of collapse debris. Search crews were on the second floor at the time of collapse. (NIOSH Photo)

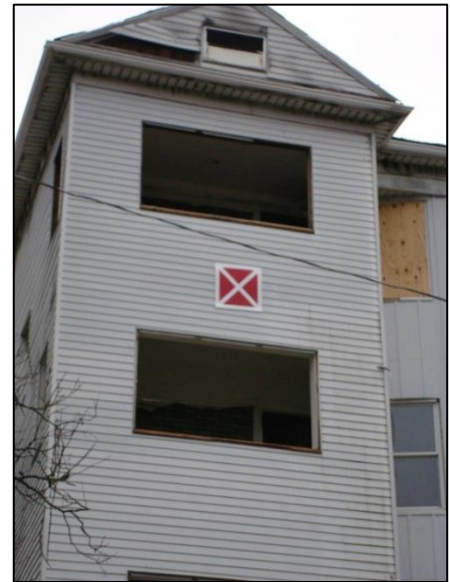
**Hazardous building placard attached to exposure structure located just south of the fire building.
(NIOSH Photo)**

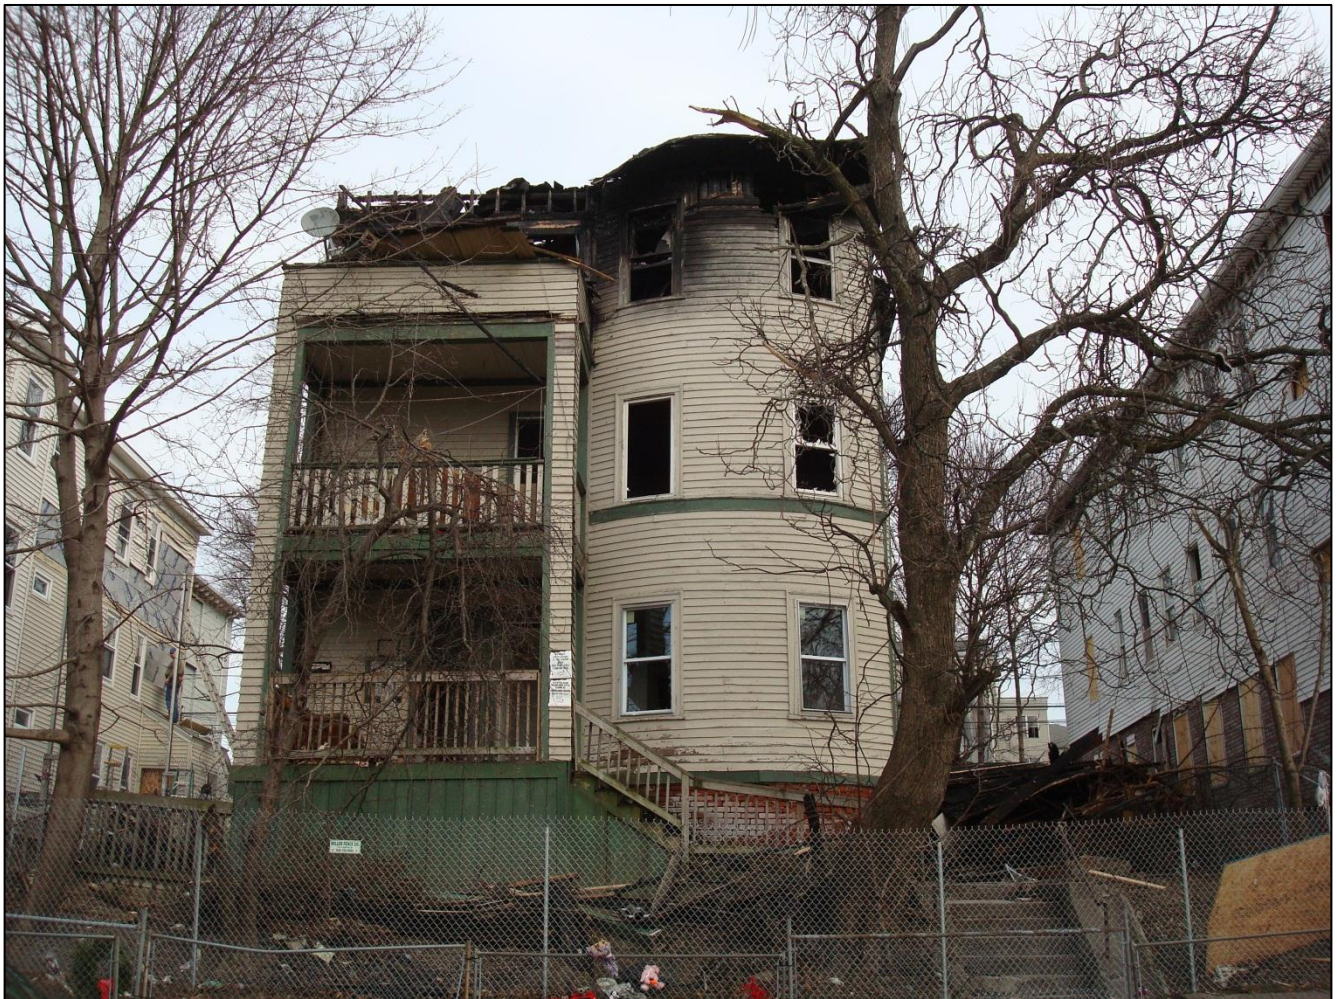
Photo 1. Front of the triple-decker residential structure viewed from the street. All structures on the east side of street on this block were elevated above street level. The first and third floors were vacant at the time of the fire.

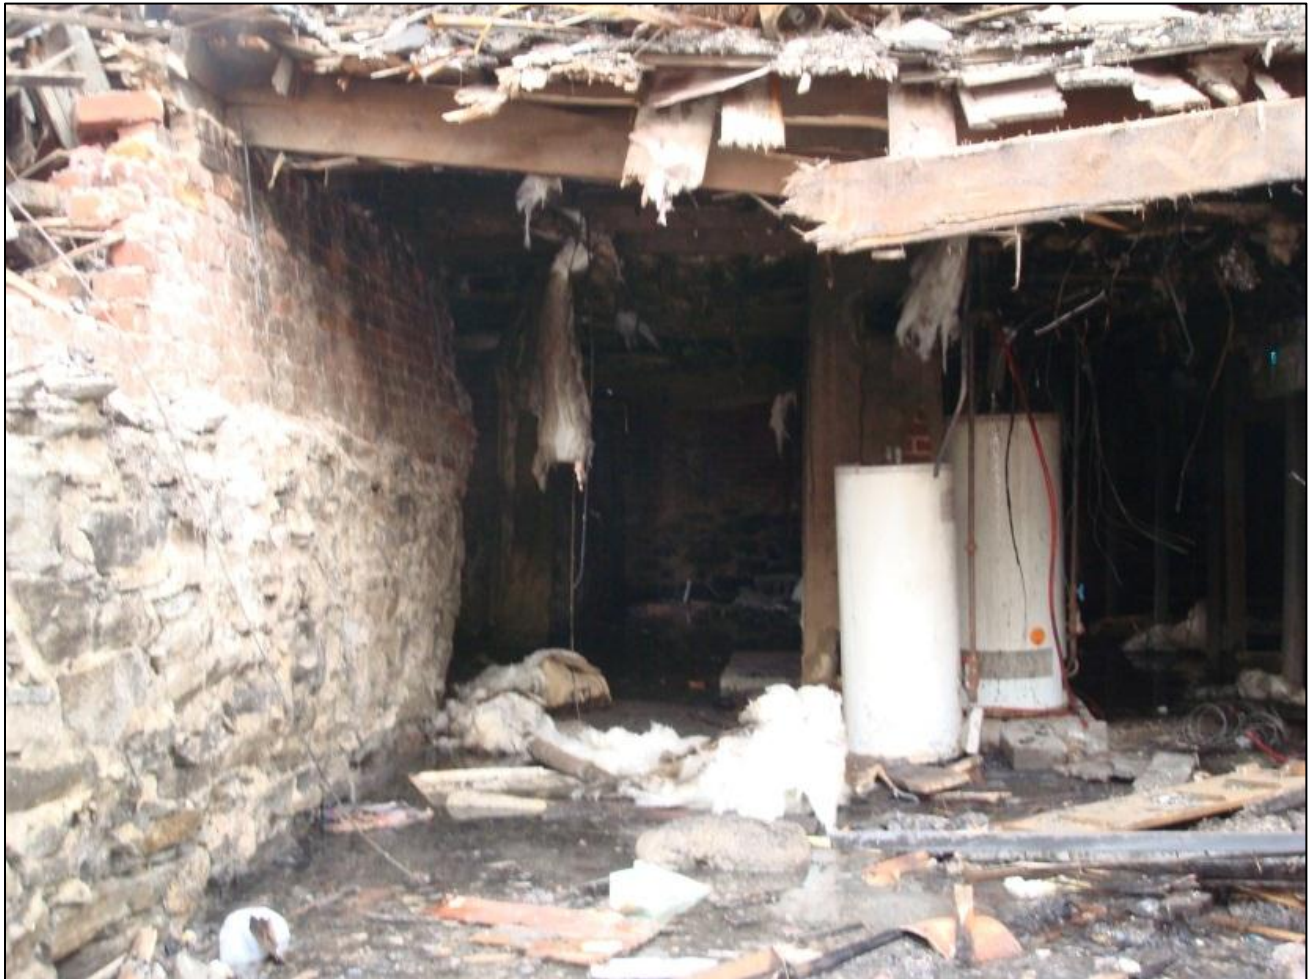
The structure featured typical balloon frame construction and measured roughly 28 feet wide by 50 feet long. It was built over an unfinished basement. The basement walls were of mixed construction. The lower portion of the basement walls were stacked field stone. The top portions of the walls, (extending above ground level) were constructed of brick and mortar (see Photo 2 and Photo 3). Some of the building code violations cited by the city included cracks and deterioration in the exterior brick walls.

Photo 2. View of the D-side basement wall. Note the brick and mortar wall laid over top of the field stone. View is close to the area where the injured fire fighter was extricated.
(NIOSH Photo)

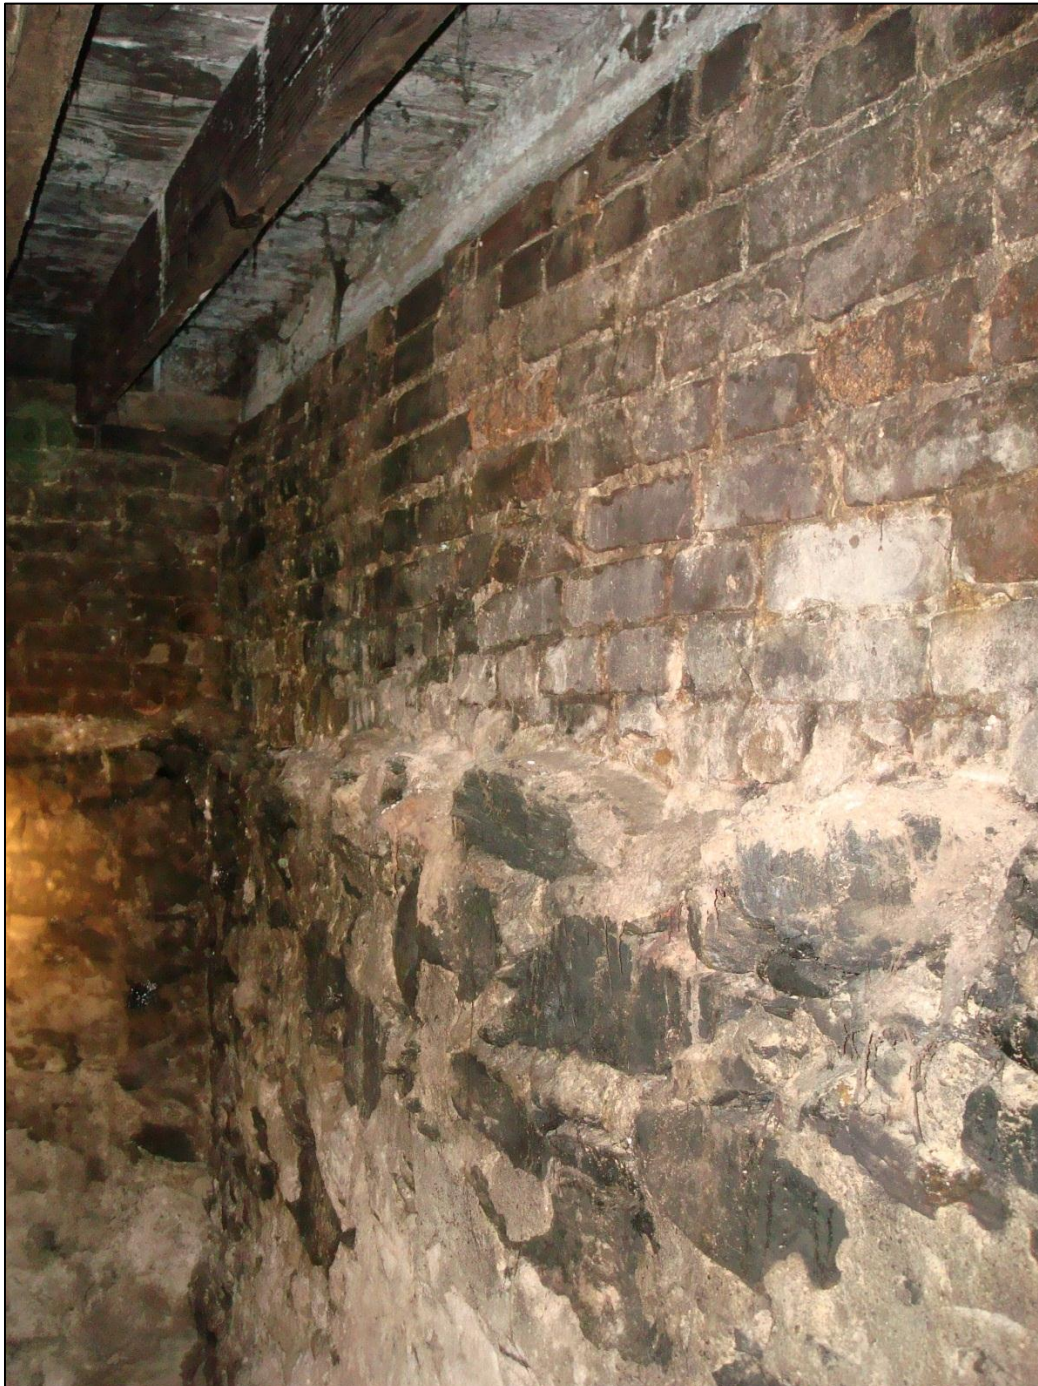
Photo 3. Photo shows the basement wall in the vacant structure located adjacent to the fire structure. This structure was built during the same time period as the fire structure. Photo was taken at the Side A/D corner.

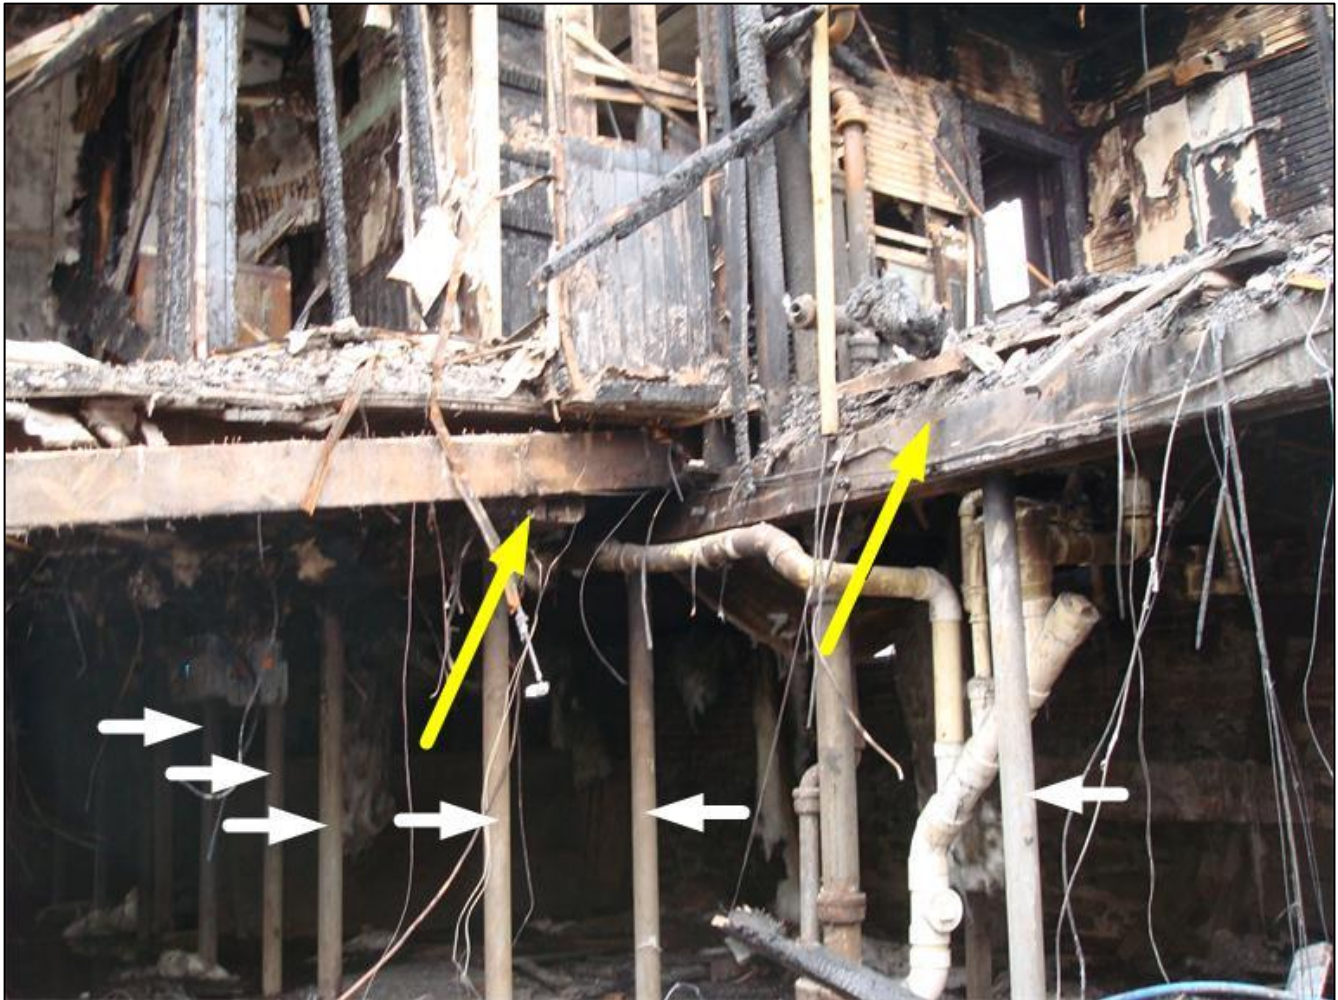
The structure was supported by the exterior walls resting on top of the basement walls and by two heavy timber beams running from front to back near the center. Each beam spanned approximately one-half of the length of the structure and were likely offset to provide support for the interior load bearing walls (See Diagram 2 and Photo 4).

Photo 4. Yellow arrows indicate the two heavy timber support beams running front to rear and located near the center of the structure. White arrows indicate tubular metal support posts commonly referred to as lally columns or lally posts. Note the off-set between the two support posts as indicated by the two supports at the lower center of the photograph.

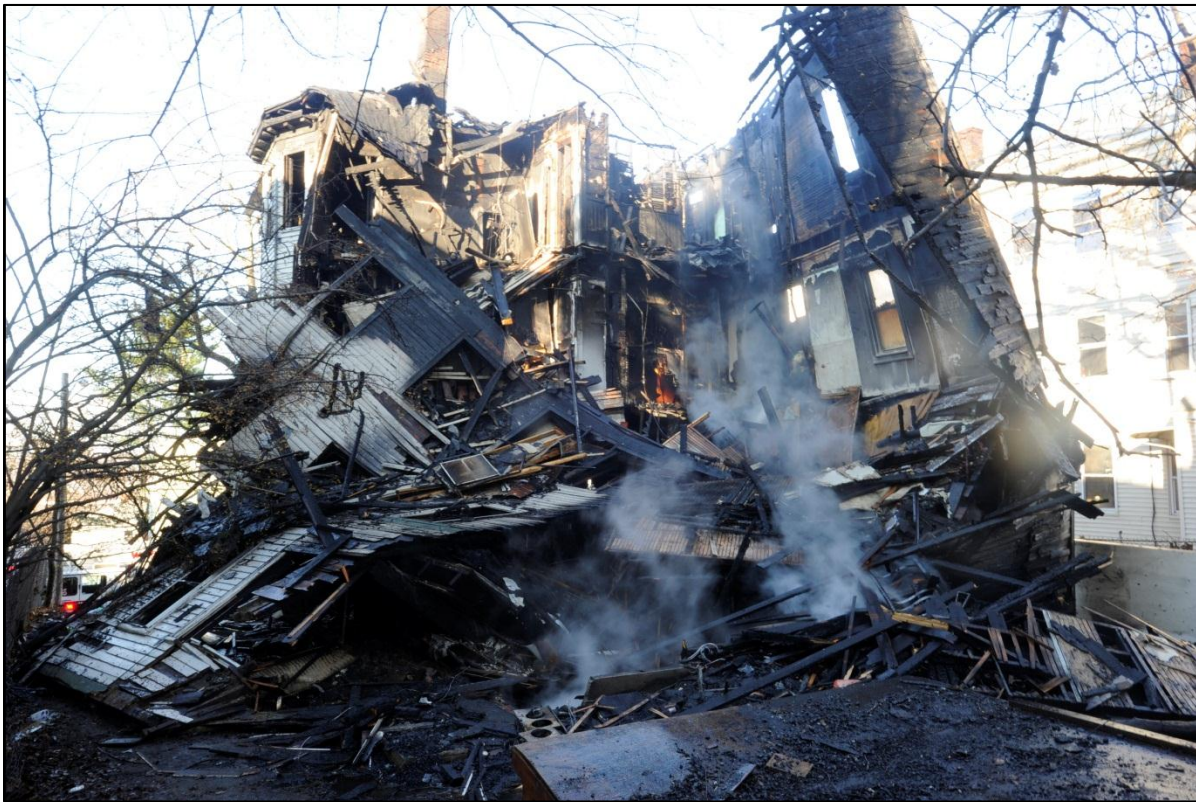
Following the fire, local and state fire investigators determined that the collapse was unusual for the type of building and size of the fire. Due to the unexpected collapse, both the city and state commissioned engineering analysis of the structure in an attempt to identify the cause(s) of the collapse. The main support beams (see Diagram 2) were examined and found that they were not unduly damaged by the fire. The support beams were determined to not have been the cause of the collapse. Further analysis revealed that Side D foundation wall near the C/D corner had blown outward at some point during the incident, possibly due to the deteriorated condition of the mortar joints and the general decay of the wall. The resulting loss of support when the foundation wall gave way caused the rear of the building to collapse. This is consistent with eye-witness reports from fire fighters on scene who stated that the C/D corner collapsed. Photographs taken by state fire investigators following the fire showed the Side D wall collapsed outward with debris located near the fence at the property line to the south (see Photo 5).

Photo 5. Photo taken from the rear of the structure just hours after the collapse. The left side of photo shows the remains of the collapsed portion of the Side D wall.
(Photo courtesy of the State Fire Marshal's Office)

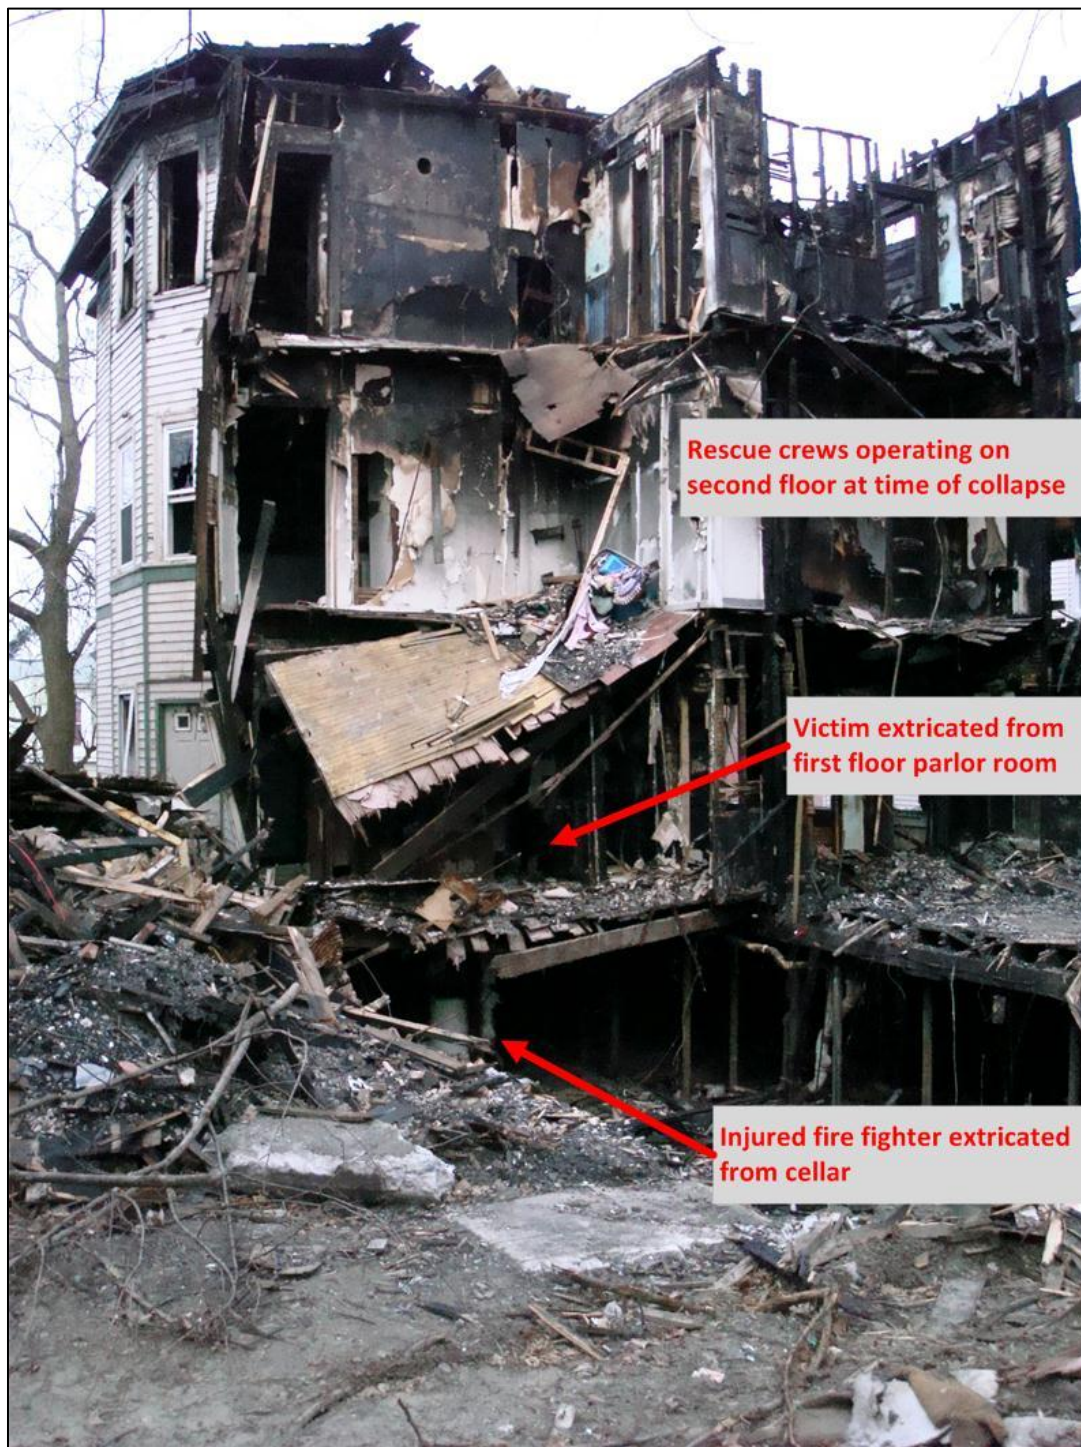
Photo 6. Locations of Victim and injured fire fighter post collapse Photo taken after partial cleanup of the debris.
(NIOSH Photo)

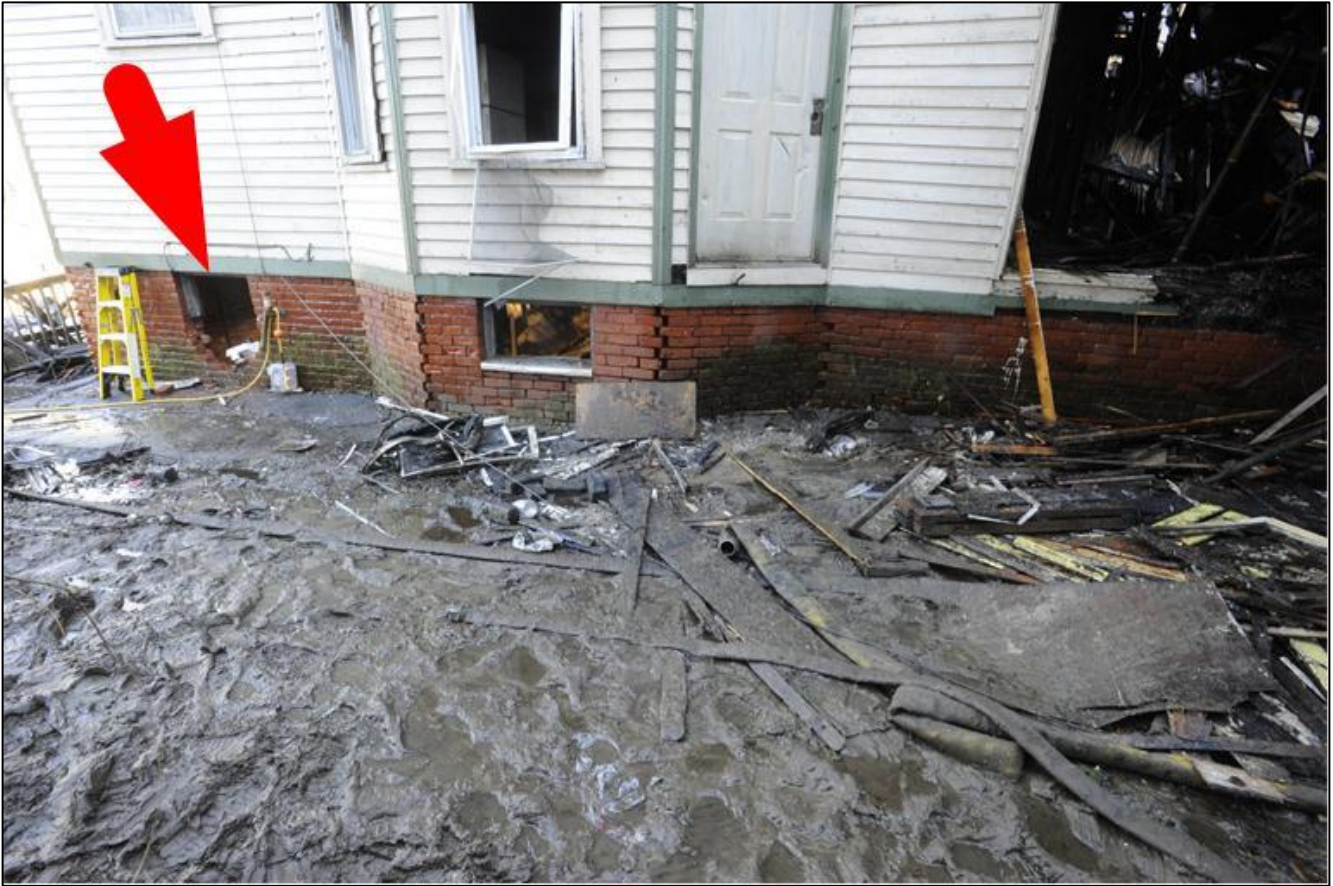
The Special Operations Task Force team (Engine 5 and Ladder 4 crews) arrived on-scene and were instructed to breach the cellar wall near the A/D corner to gain access to the cellar to work on extricating the injured fire fighter (see Photo 6). Fire fighters took out a window in the foundation wall near the A/C corner and enlarged the opening for access into the basement (see Photo 7). The Special Operations team leader (the Engine 5 Lieutenant) went inside the basement to size up the rescue operation. Limited access was established at the opening in the foundation wall to control who was going in and out of the basement.

Photo 7. Arrow marks location where foundation wall was breeched to access the cellar to extricate the injured fire fighter.

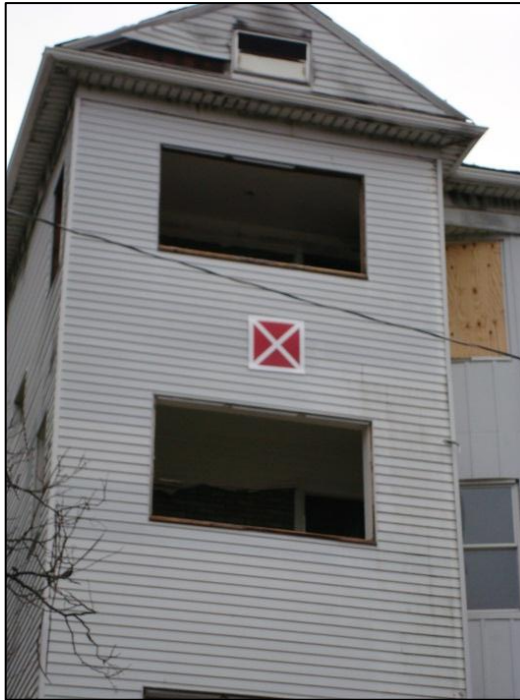
In this incident, the fire department responded to a structure that had been cited by the city building department for a number of code violations including structural deterioration. This information was not available in the city dispatch system so it was not readily available to the fire department. The fire department did have a process to mark hazardous buildings identified by the fire department. The fire department had responded to a fire at an adjacent triple decker apartment building just a few months prior to this incident. The fire department had marked that structure as a hazardous structure (see Photo 8). The structure where the fatality occurred had been cited by the city building department for structural deficiencies but there was no formal process for the building department to notify the fire department of the deficiencies or to make this information readily available through the dispatch system. Information about structural deficiencies should be considered by fire officers when making operational decisions.

**Photo 8. Hazardous building placard attached to exposure structure located just south of the fire building.
(NIOSH Photo)**

Recommendation # 2: Authorities having jurisdiction should ensure that hazardous building information is part of the information contained in computerized automatic dispatch systems.
