## ***Two Career Fire Fighters Die and 19 Injured in Roof Collapse during Rubbish Fire at an Abandoned Commercial Structure – Illinois***

On December 22, 2010, a 47-year-old male (Victim # 1) and a 34-year old male (Victim # 2), both career fire fighters, died when the roof collapsed during suppression operations at a rubbish fire in an abandoned and unsecured commercial structure. The bowstring truss roof collapsed at the rear of the 84-year old structure approximately 16 minutes after the initial companies arrived on-scene and within minutes after the Incident Commander reported that the fire was under control. The structure, the former site of a commercial laundry, had been abandoned for over 5 years and city officials had previously cited the building owners for the deteriorated condition of the structure and ordered the owner to either repair or demolish the structure. The victims were members of the first alarm assignment and were working inside the structure. A total of 19 other fire fighters were hurt during the collapse.

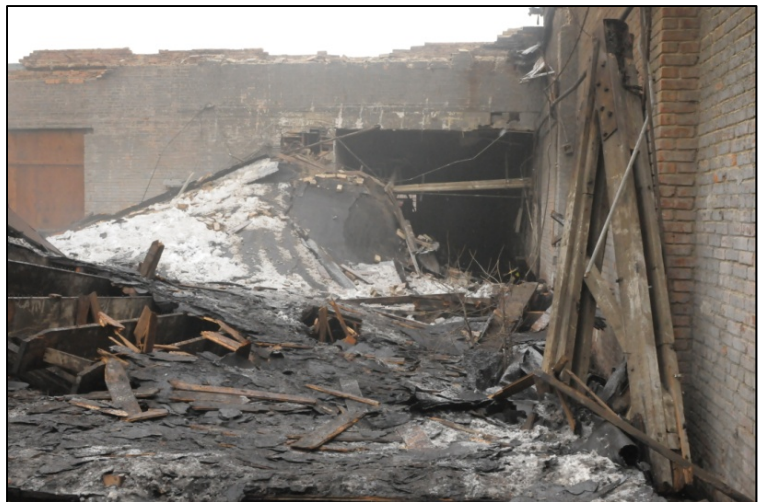
**Collapse scene as viewed from building rear facing building front. Note portion of bowstring truss leaning against wall at right side of photo.**  
*(Photo courtesy of fire department)*

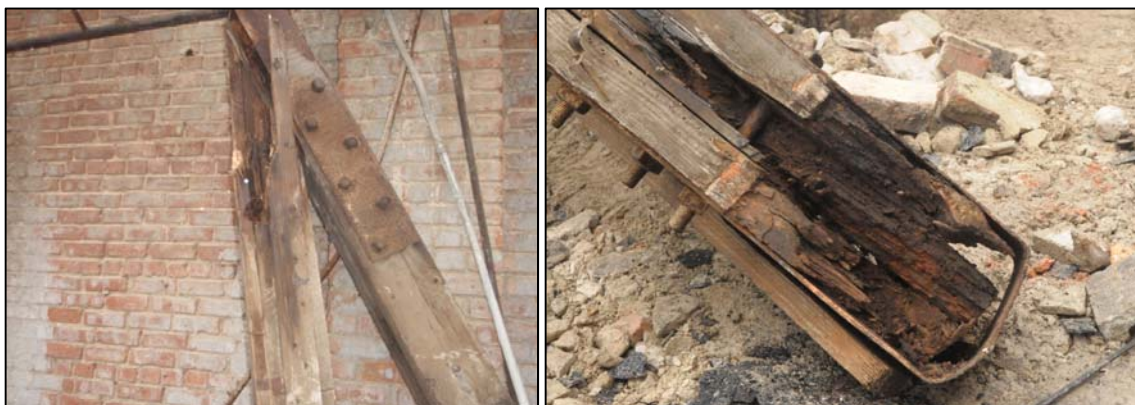
**Photos show the deteriorated condition of bowstring roof trusses. Note the truss end in the left photo and the deteriorated condition caused by water damage in right photo.**  
***(Photos Courtesy of Fire Department Office of Fire Investigations)***

Bowstring truss roof systems may suffer from a little-known phenomenon related to inaccuracies in early industry-accepted truss design assumptions. One significant design deficiency involves the tensile strength of the bottom chord. Early truss designs assumed wood tensile strength could be defined by bending tests of small straight-grained wood samples free of common wood defects. Prior to the 1960s, large scale test facilities were uncommon so full-size lumber tests were rarely conducted. During the 1960s, full-size lumber tests revealed that construction grade lumber with natural imperfections such as knots, checks and irregular grain, provides in-service tensile strength

significantly less than that predicted by the earlier small scale, clear wood tests. By 1968, lumber industry standards established a reduction factor of 0.55 to relate tensile strength to bending strength. Current building codes have increased this factor to 0.60, meaning the allowable tensile strength design values are only about 40 percent of those listed in the early codes. Thus, all trusses constructed prior to the late 1960s have a common code deficiency; the bottom chord members may have inadequate tensile strength to support code-prescribed roof loads.<sup>6</sup> Diagram 2 and Photo 8 represent the bowstring roof trusses found in the building involved in this incident. Photo 9 provides additional roof details.

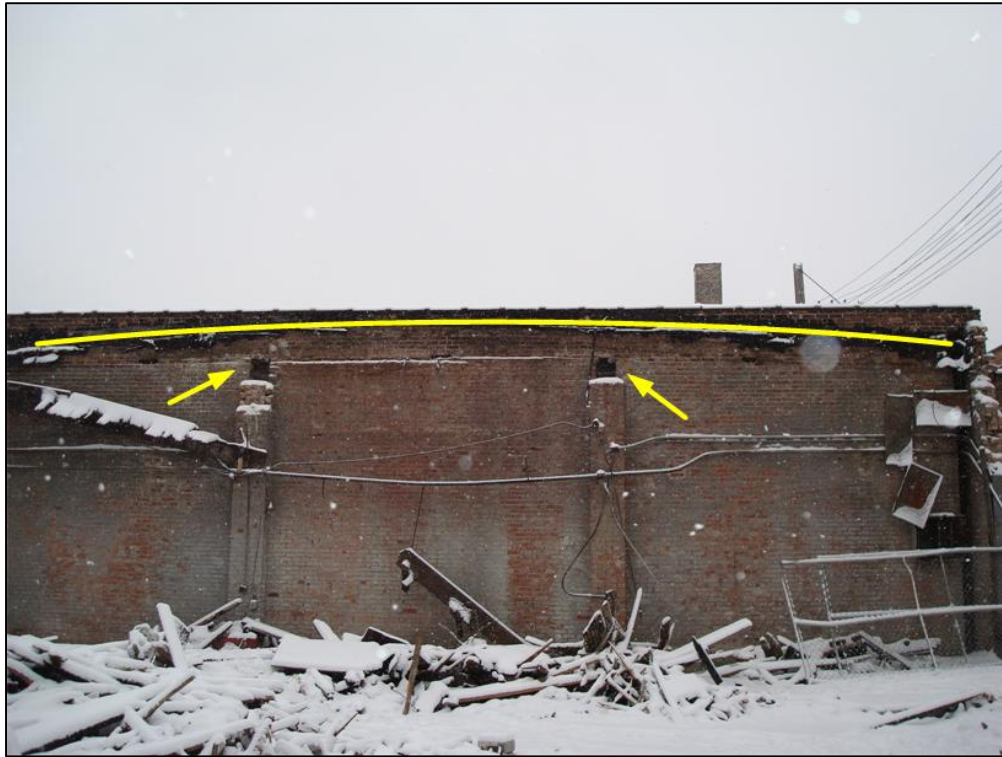
**Photo 2. Photo shows the Sector 2 wall that supported western end of the bowstring truss roof. The two arrows indicate the truss-end pockets in the brick masonry wall at the top of the brick pilasters where the ends of the two bowstring trusses rested. The roof was supported in the middle by the two bowstring trusses while the north and south ends were supported by the front and rear non-load bearing walls. The line indicates the approximate curvature of the roof.**  
*(NIOSH photo)*

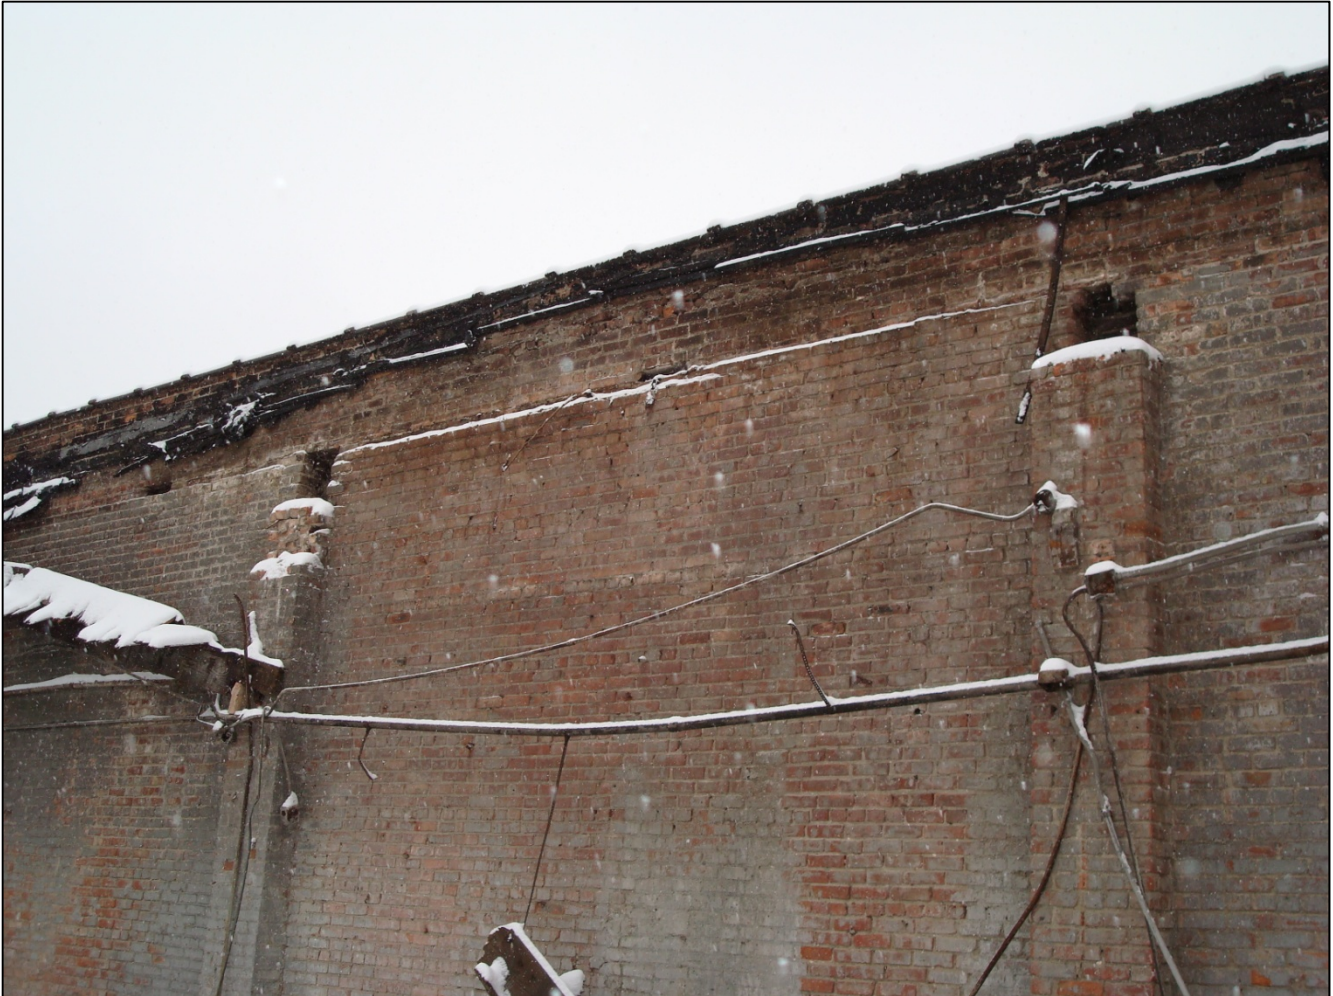
**Photo 3. Photo shows the truss support pilasters built into the Sector 2 (west) wall. The Sector 4 (east) load bearing wall also contained support pilasters. The Sector 4 wall partially collapsed during the incident and was demolished after the recovery operations.**

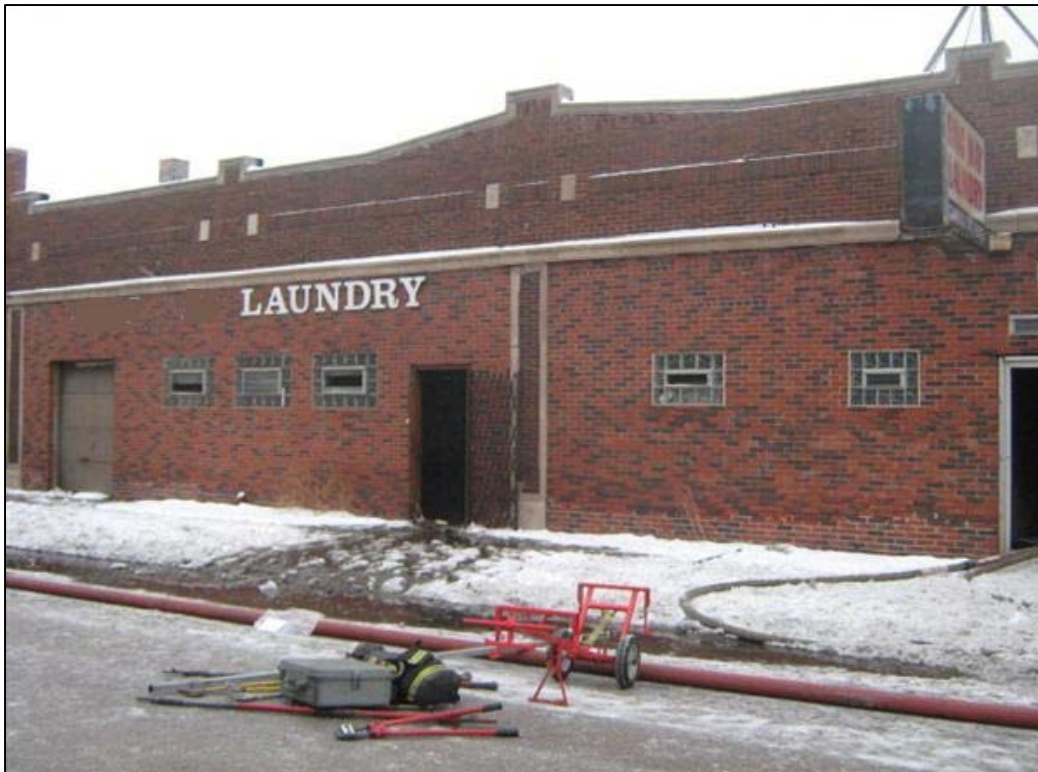
In 2007, the city Department of Buildings (DOB) cited the building owner for the deteriorated condition of the structure and ordered the owner to either repair or demolish the structure. When viewed from the street, the structure appeared to be in good repair (see Photo 5), but the structure was open and unsecured at the alley (Sector 3) and courtyard (Sector 4). An overhead roll-up door that fronted the alley (Sector 3) was missing and access doors to the courtyard had also been removed. The courtyard was overgrown with brush and small trees and had been used as a dumping area for rubbish and construction materials.

**Photo 5. Front view of structure as viewed from the street (Sector 1). Buildings along the street appeared to be in good condition from this view. The deteriorated condition of the roof was not visible from street level. Photo taken the day of the incident.**  
*(Photo courtesy of city Department of Buildings)*

Some of the code violations cited in the 2007 written complaint included: failure to maintain parapet wall in good repair; failure to maintain lintel in good condition; failure to securely fasten loose plate glass in windows; failure to cut or remove weeds, grass and other growth; failure to remove accumulation of refuse and debris; failure to maintain roof in sound condition; failure to remove sewage and stagnant water from basement; failure to maintain exterior walls free from holes, breaks...or other conditions that might admit rain or dampness; and, failure to maintain building in a structurally safe and stable condition.

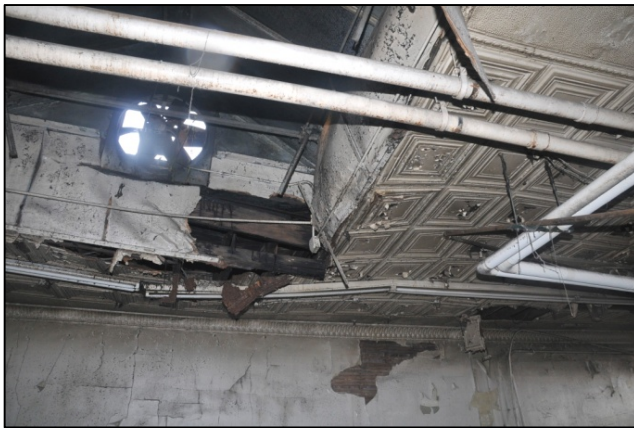
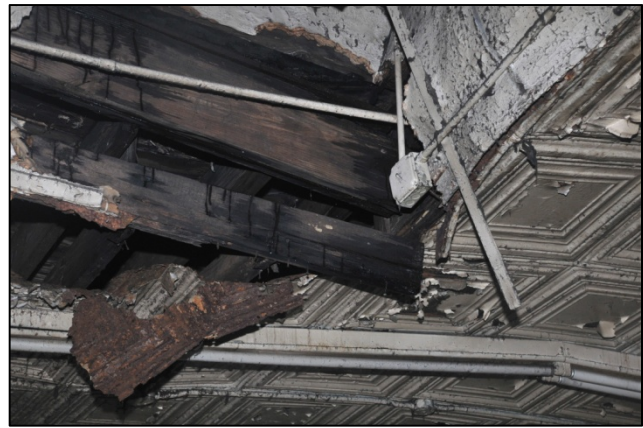
Photo 6 and Photo 7 show some of the deteriorated ceiling conditions observed by fire fighters when they entered the front portion of the structure during the incident. This deterioration appears to have been caused by water penetrating the roof.

**Photo 6 and Photo 7. Photo 6 (left) and Photo 7 (right) show the deteriorated ceiling conditions inside the front part of the structure.**  
*(Photos courtesy of fire department)*

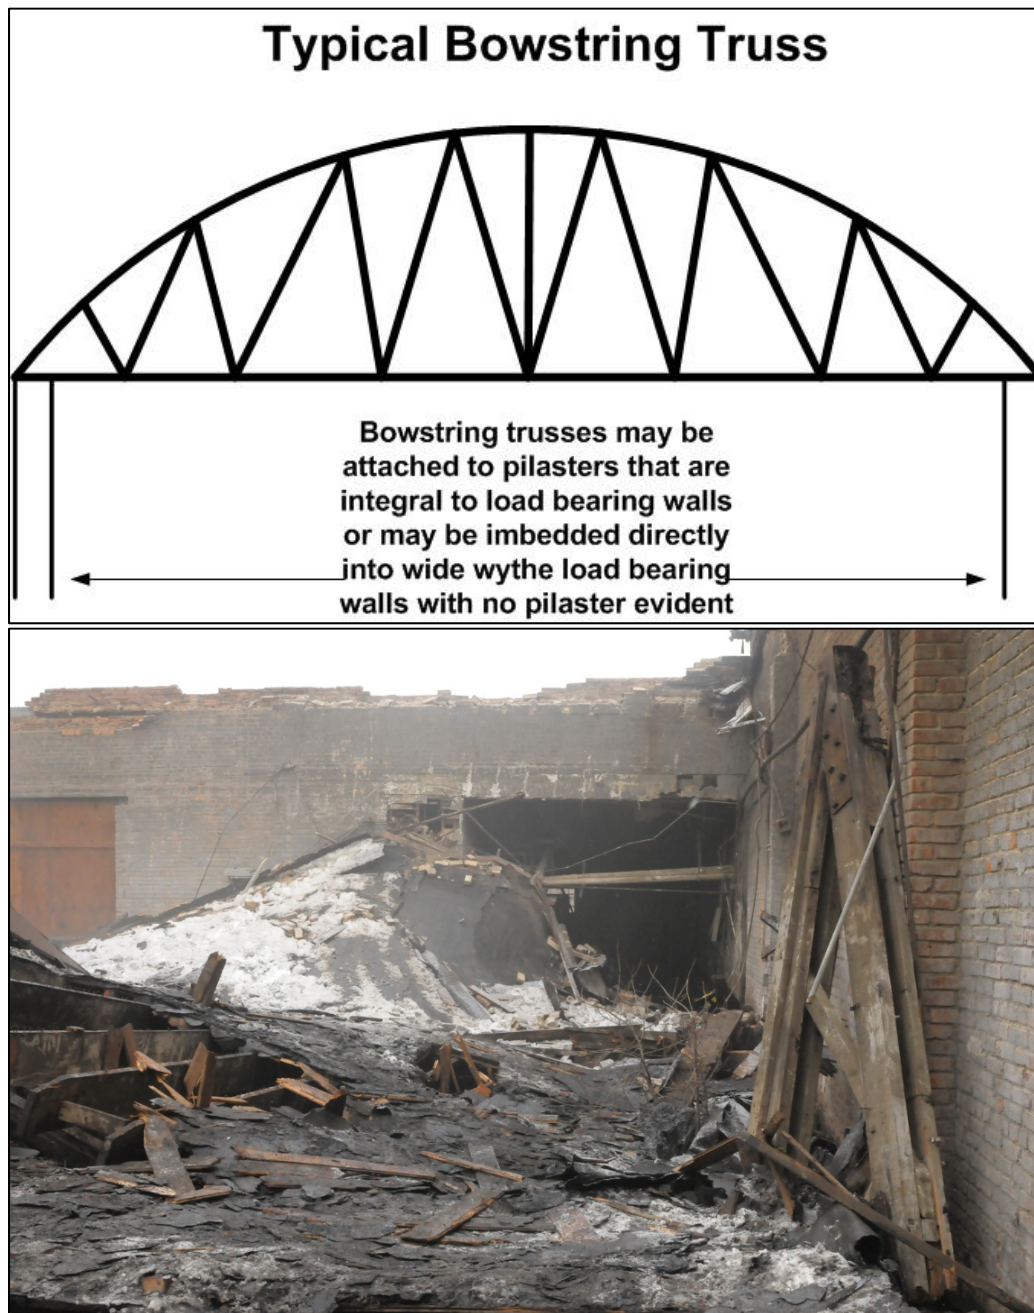
**Diagram 2 (top) and Photo 8 (bottom). Diagram 2 shows typical bowstring truss design. Photo 8 shows portion of bowstring truss leaning against support pilaster built into Sector 2 wall at right. The foreground in Photo 8 is the area where Victim # 2 was recovered.**  
*(Photo courtesy of fire department)*

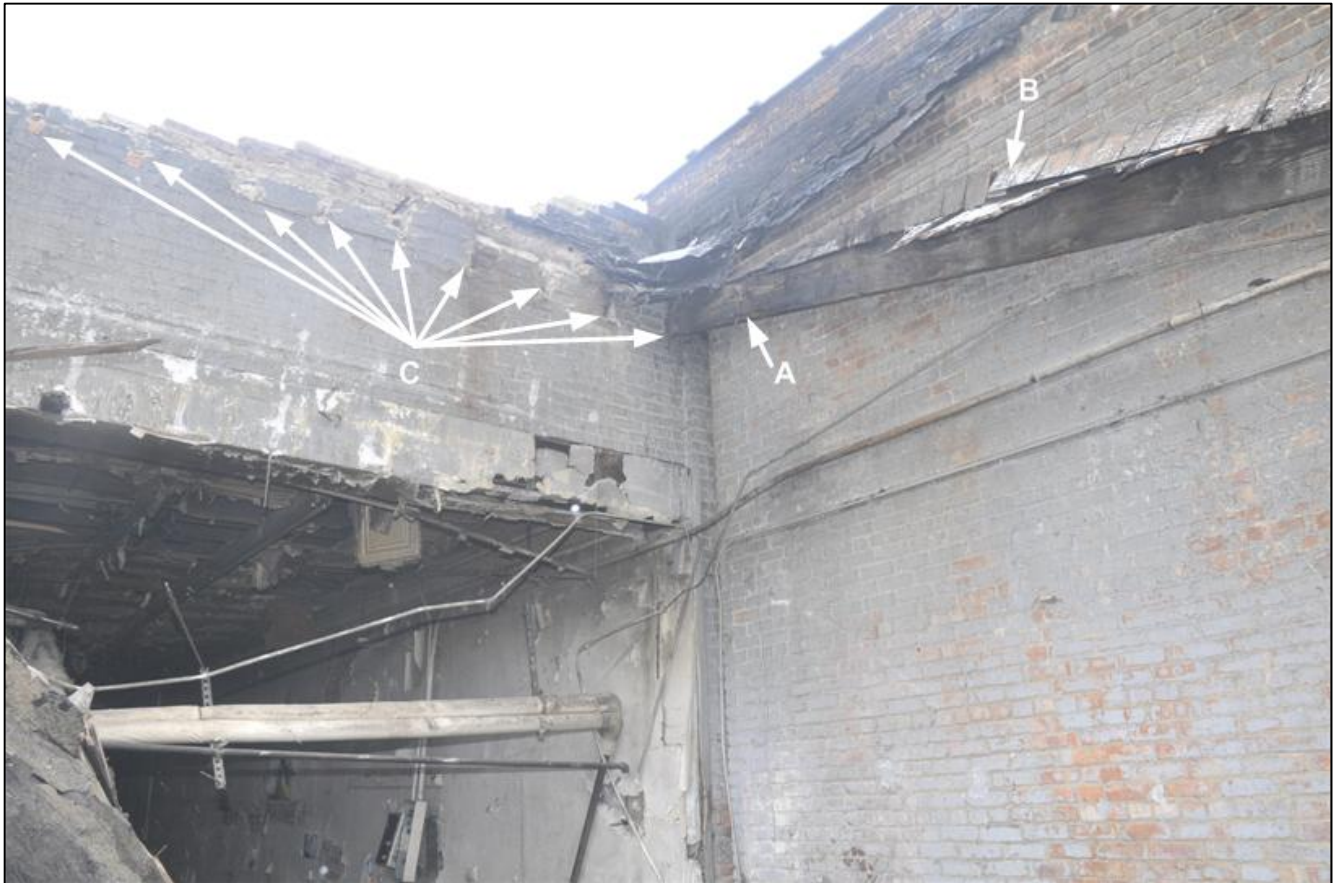
**Photo 9. Photo shows connection of the front and rear portions of the structure as viewed from Sector 3 facing Sector 1 (same view as Photo 8). Note the roof purlin still attached to the Sector 1 wall (A) and the remains of tongue and groove roof deck boards attached to the top of the purlin(B). Also note how the end of the remaining purlin sets into a recessed pocket in the brick masonry wall and the locations where other roof purlins pulled away from wall (C). Vertical marks on the wall above the opening indicate where the roof purlins contacted the wall as the roof collapsed.**

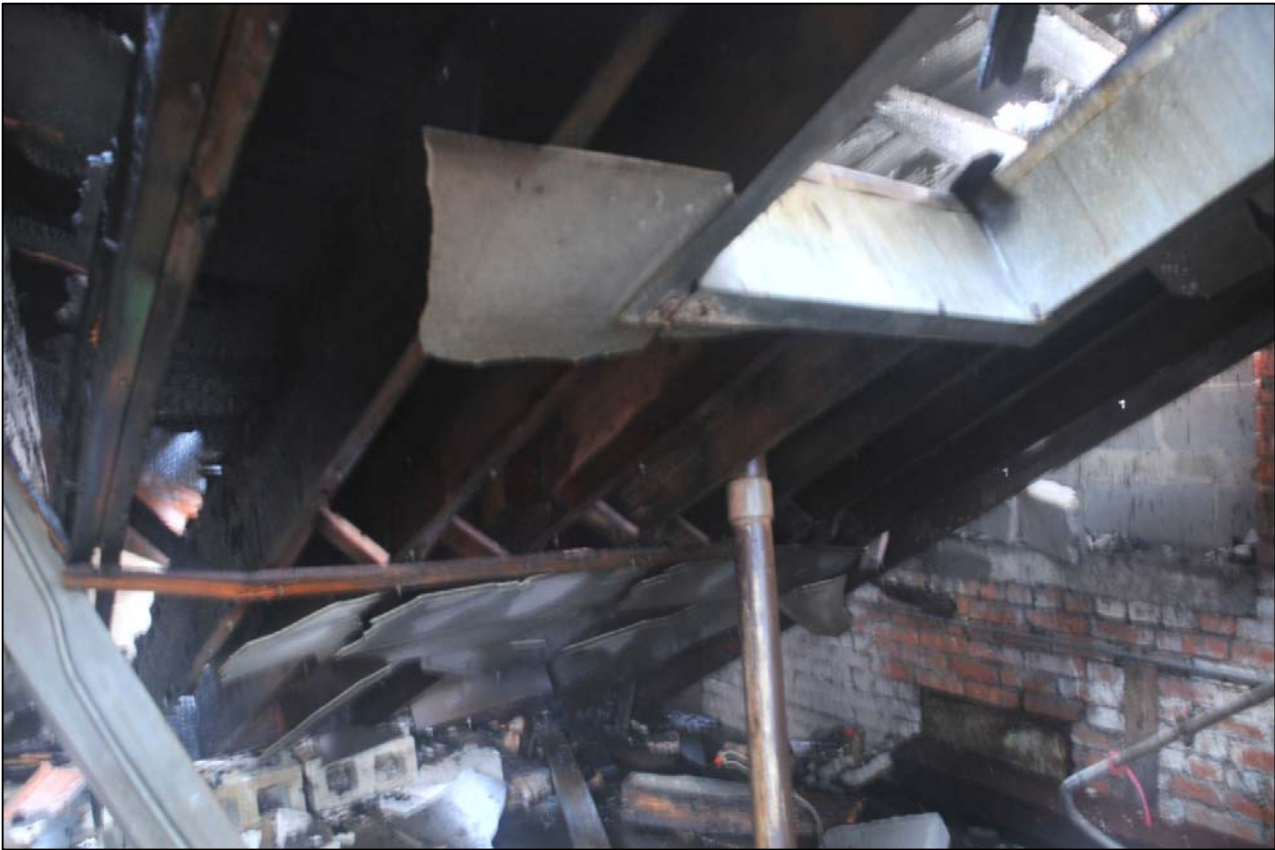
**Photo 10. Photo shows the scuttle hole in the roof where the E-126 lieutenant looked into truss void for fire extension. Note condition of roof rafters indicates little fire damage in this area.**  
*(Photo courtesy of fire department)*

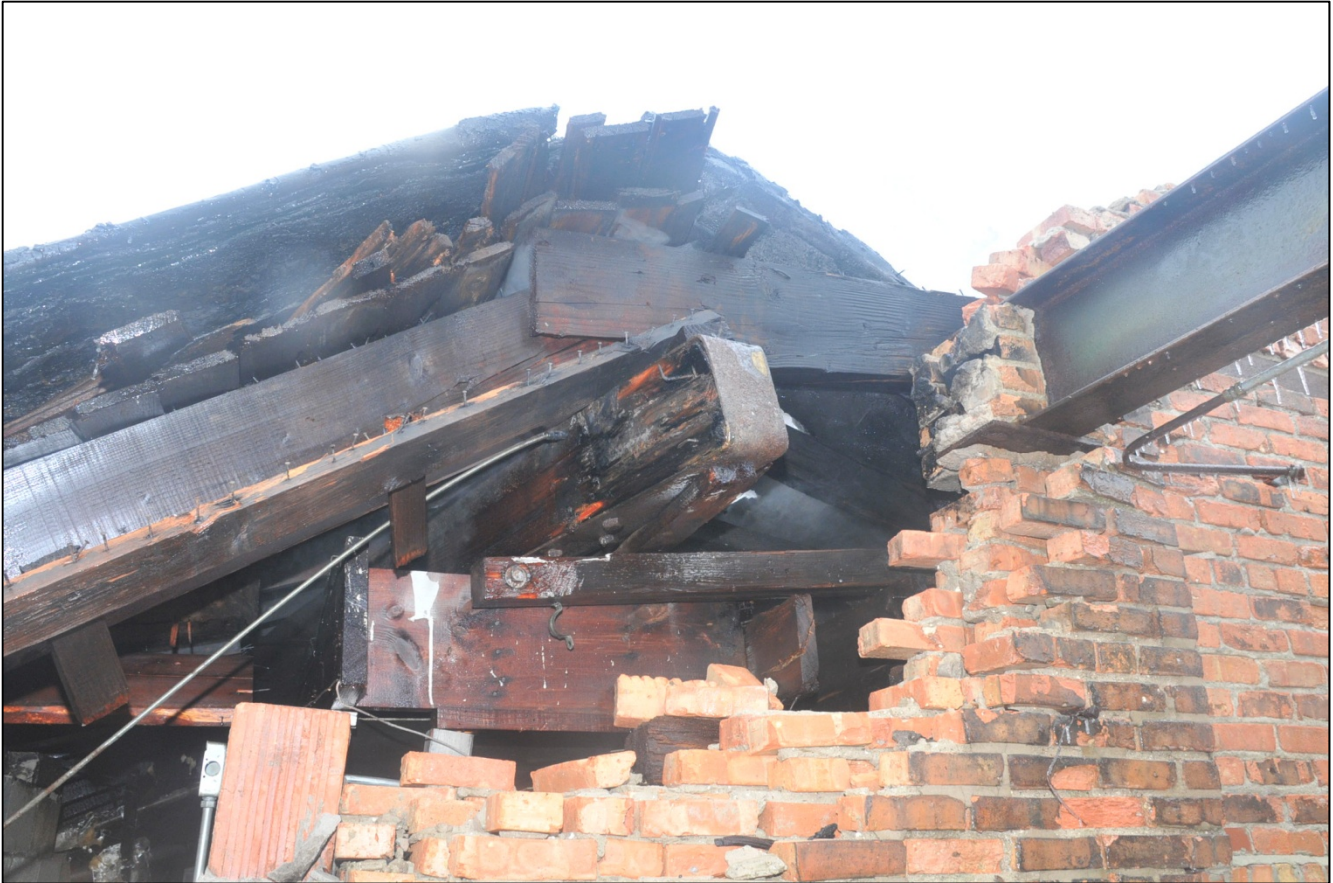
**Photo 12. One end of heavy timber roof truss can be seen in center of photo. The truss has rolled over onto its side with the end penetrating through the Sector 4 wall. Photo was taken from the court yard on the Sector 4 side (facing west).  
(Photo courtesy of Fire Department)**
