## **A Career Lieutenant and a Career Fire Fighter Found Unresponsive at a Residential Structure Fire – Connecticut**

### **Executive Summary**

On July 24, 2010, a 40-year-old male career lieutenant (Victim #1) and a 49-year-old male career fire fighter (Victim #2) were found unresponsive at a residential structure fire. The victims and two additional crew members were tasked with conducting a primary search for civilians and fire extension on the 3<sup>rd</sup> floor of a multifamily residential structure. The fire had been extinguished on the 2<sup>nd</sup> floor upon their entry into the structure. While pulling walls and the ceiling on the 3<sup>rd</sup> floor, smoke and heat conditions changed rapidly. Victim #1 transmitted a Mayday (audibly under duress) that was not acknowledged or acted upon. Minutes later the incident commander ordered an evacuation of the 3<sup>rd</sup> floor. As a fire fighter exited the 3<sup>rd</sup> floor, Victim #1 was discovered unconscious and not breathing, sitting on the stairs to the 3<sup>rd</sup> floor. Approximately 7 minutes later, Victim #2 was discovered on the 3<sup>rd</sup> floor in thick, black smoke conditions. Both victims were remo

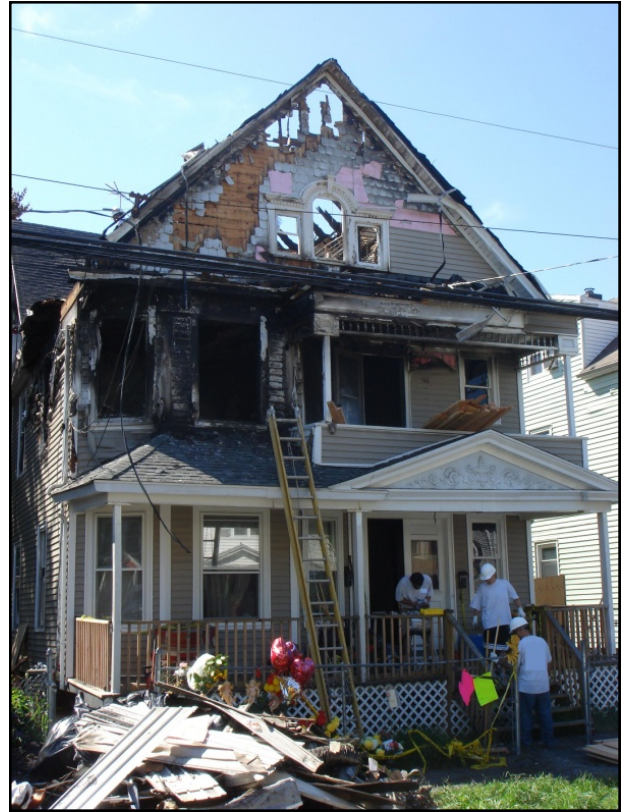
Built in the early 1900s, the two-and-half-story house (see Photo 1) was purchased approximately 4 years prior to the incident as a multifamily rental occupancy. One family lived in the 1<sup>st</sup> floor apartment (approx. 1,300 sq. ft.); a second family lived in the 2<sup>nd</sup> floor apartment (approx. 1,300 sq. ft.) (See Diagram 2), and the owner occupied the finished half-story or attic space (approx. 700 sq. ft.) (See Diagram 3). The house also contained an unfinished basement (approx. 1,300 sq. ft.). The common front entrance contained access to the 1<sup>st</sup> floor apartment and a private stairwell, located at the A/D corner of the house, which provided access to the 2<sup>nd</sup> floor apartment. The house also had a single rear-entry door that provided access to a stairwell that led up to the owner's apartment and had landings to access all the apartments from the rear. According to the owner of the house, smoke detectors were installed within the house about a year prior to the incident. These smoke detectors were installed in every bedroom, in each hallway, and in the stairwells. The house did not have an installed sprinkler system and had been inspected in accordance with Department of Housing and Urban Development Section 8<sup>a</sup> guidelines, according to the homeowner. The house was Type V wood frame construction, but, during the initial stages of the fire, was presumed by arriving fire fighters to be balloon-framed due to the era when it was constructed. State fire investigators were able to confirm Type V construction after closer inspection.

**Photo 1. A-side of house during cleanup operations.  
(NIOSH photo.)**

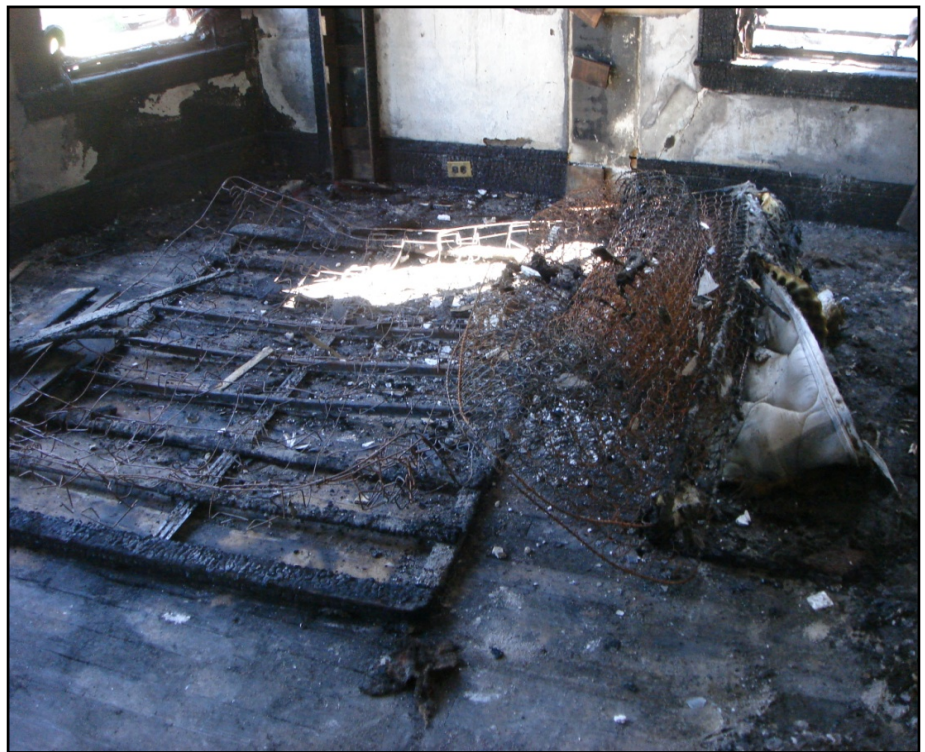
The room and contents fire was determined to have originated in a bedroom on the 2<sup>nd</sup> floor, A/B corner; it was quickly knocked down by E3 (see Photo 2). It is believed that the fire got into the eaves when it was lapping out the A/B corner windows, and then spread within the large void spaces in the ceiling and walls of the 3<sup>rd</sup> floor. The fire was situated toward the A/B corner of the 3<sup>rd</sup> floor, but the open void areas allowed smoke to accumulate within the ceilings and walls before they were opened.

**Photo 2. Remnants of a mattress and box springs within the room of origin on the 2<sup>nd</sup> floor.  
(NIOSH photo.)**

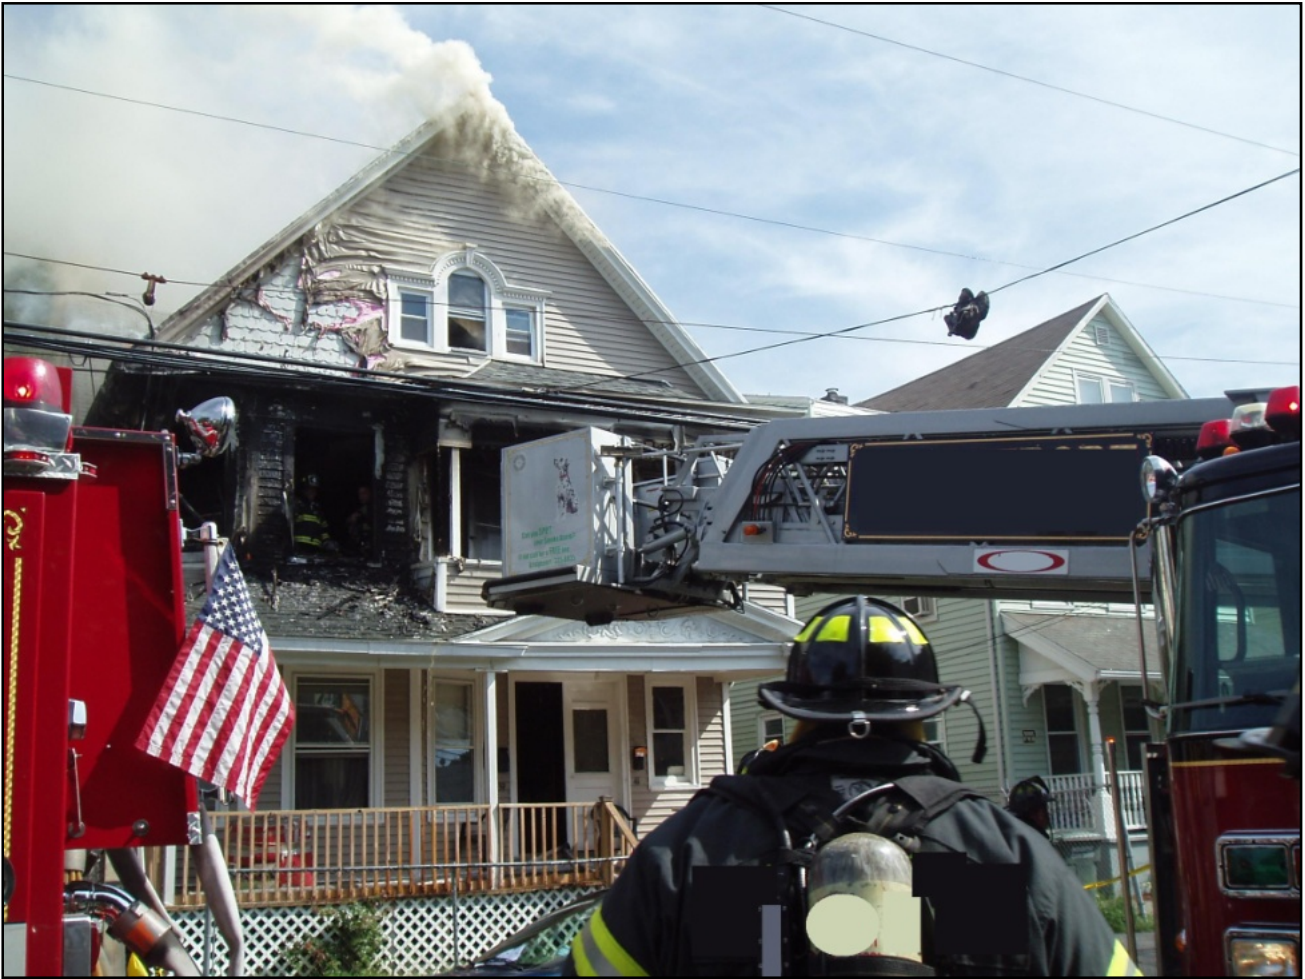
**Photo 3. Initial conditions observed when the BC arrived on scene at approximately 1551 hours.**  
*Note: Fire was under control on the 2<sup>nd</sup> floor and fire fighters were checking for extension. White-to-gray smoke can be seen flowing in the direction of right to left from the gables. The A-side window on the 3<sup>rd</sup> floor had been opened for ventilation (unsure at what stage of the fire or by whom).*  
*(Photo courtesy of fire department.)*

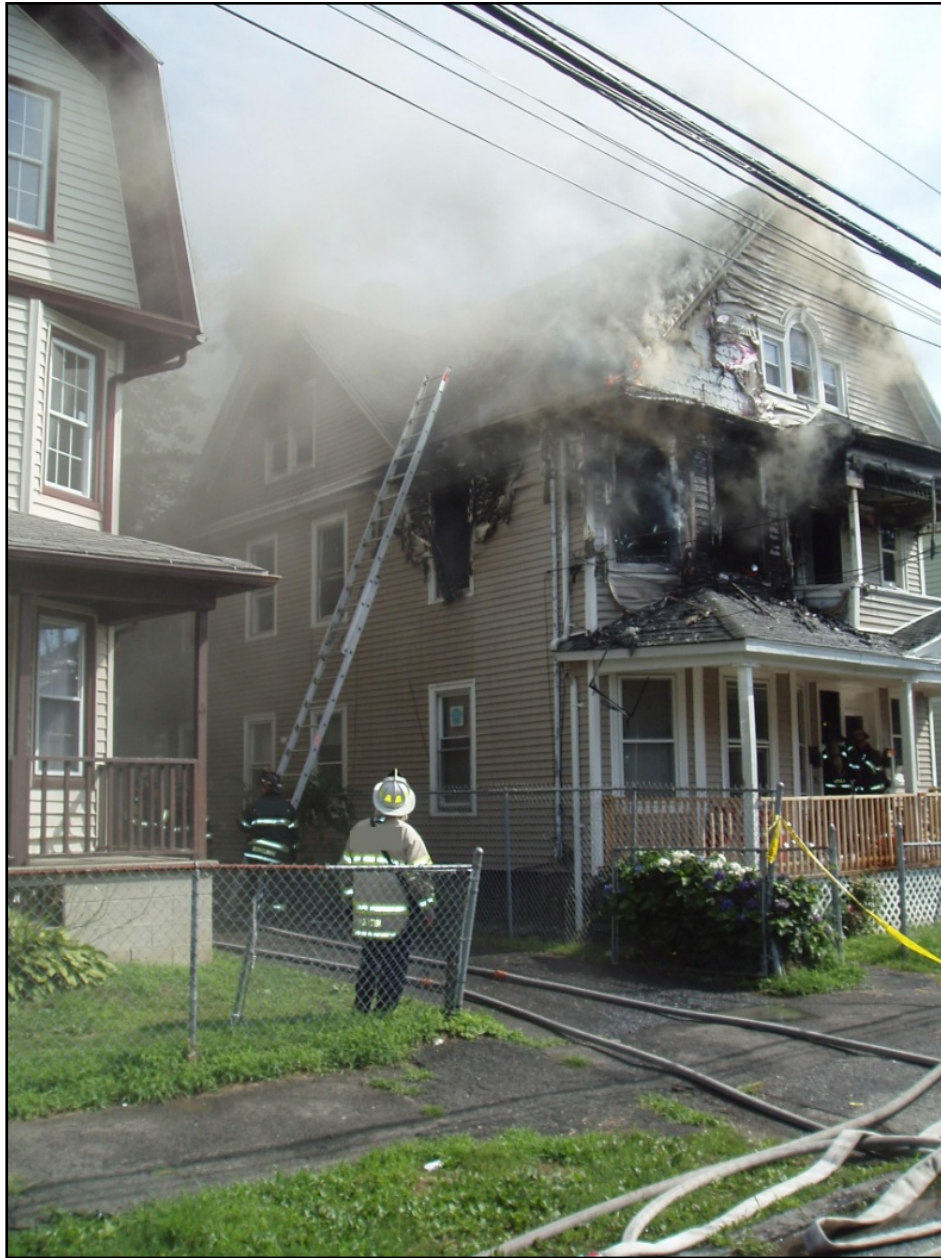
**Photo 5. Conditions at approximately 1609 hours.** *Note: L5 personnel were preparing to ascend the ladder placed on the B-side of the house. The IC (white helmet) is observing the scene. Smoke seen coming from the 3<sup>rd</sup> floor B-side double window and pushing from the eaves. At this time, ceiling and walls were likely being opened on the 3<sup>rd</sup> floor, and water would have been available.*  
*(Photo courtesy of fire department.)*

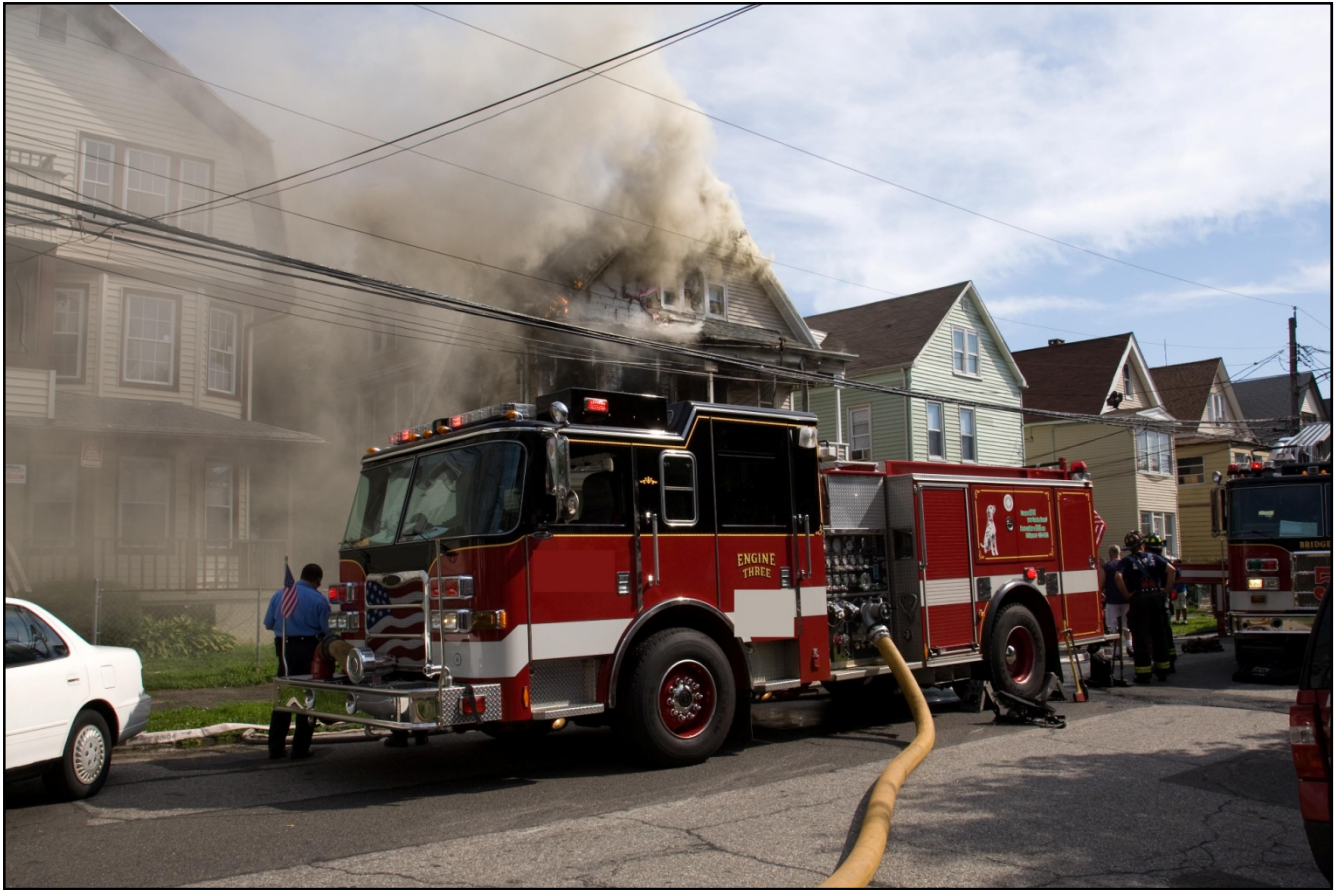
**Photo 7. Conditions at approximately 1613 hours.** *Note: L5 personnel were on the peak of the roof and having difficulty starting the roof saw. Smoke was denser than before and pushing from the roof and eaves. The fire fighters were unable to vent the roof. NIOSH investigators believe that Victim #1 transmitted his Mayday about this time.*  
*(Photo courtesy of Keith Muratori.)*

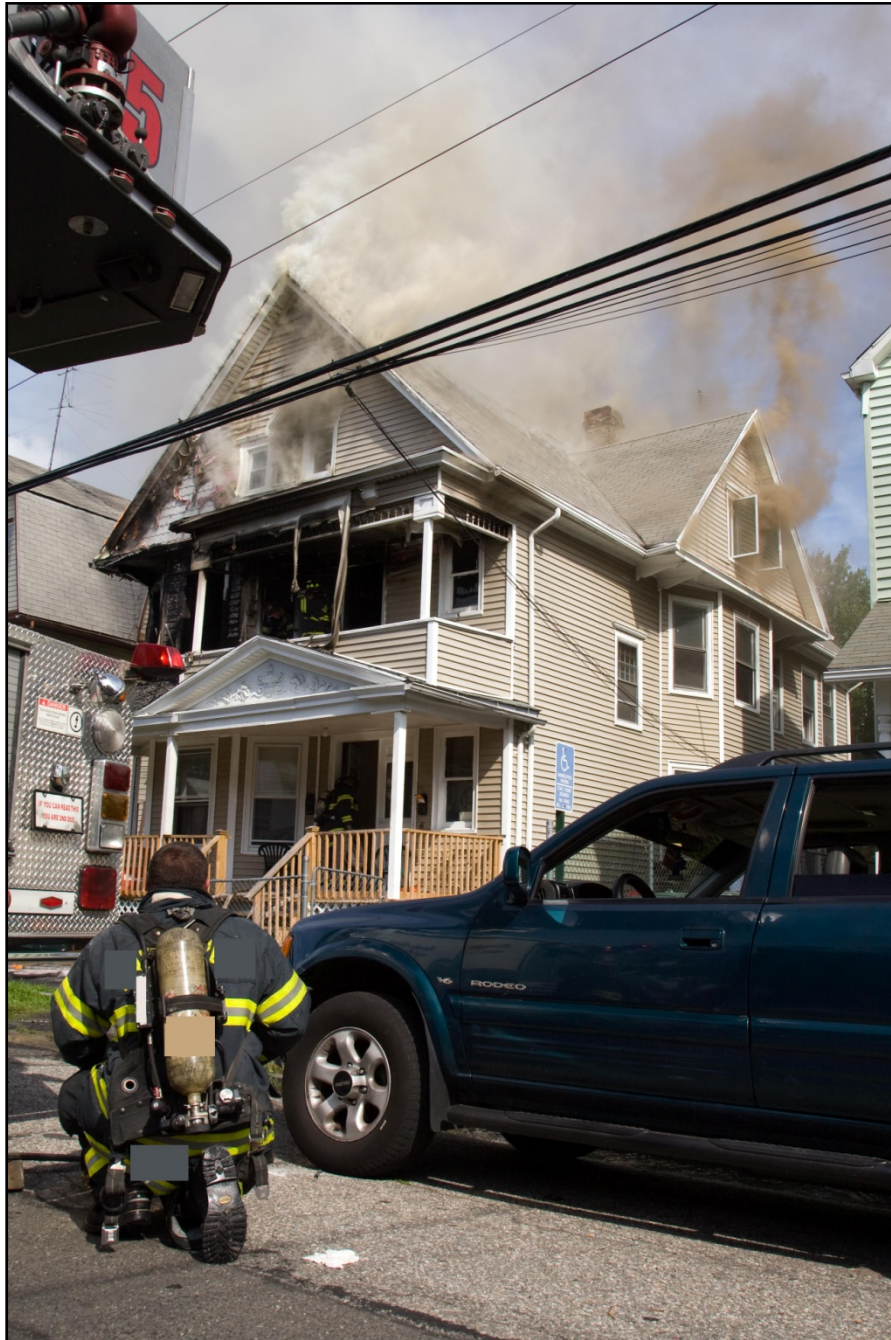
**Photo 8. Conditions at approximately 1616 hours.** *Note: View from the A/D corner, scene conditions very close to when FF2 discovered FF1 pulling Victim #1 off the 3<sup>rd</sup> floor stairs. White and gray smoke can be seen flowing from the A-side window and eaves while brown smoke flowed from the D-side window.*

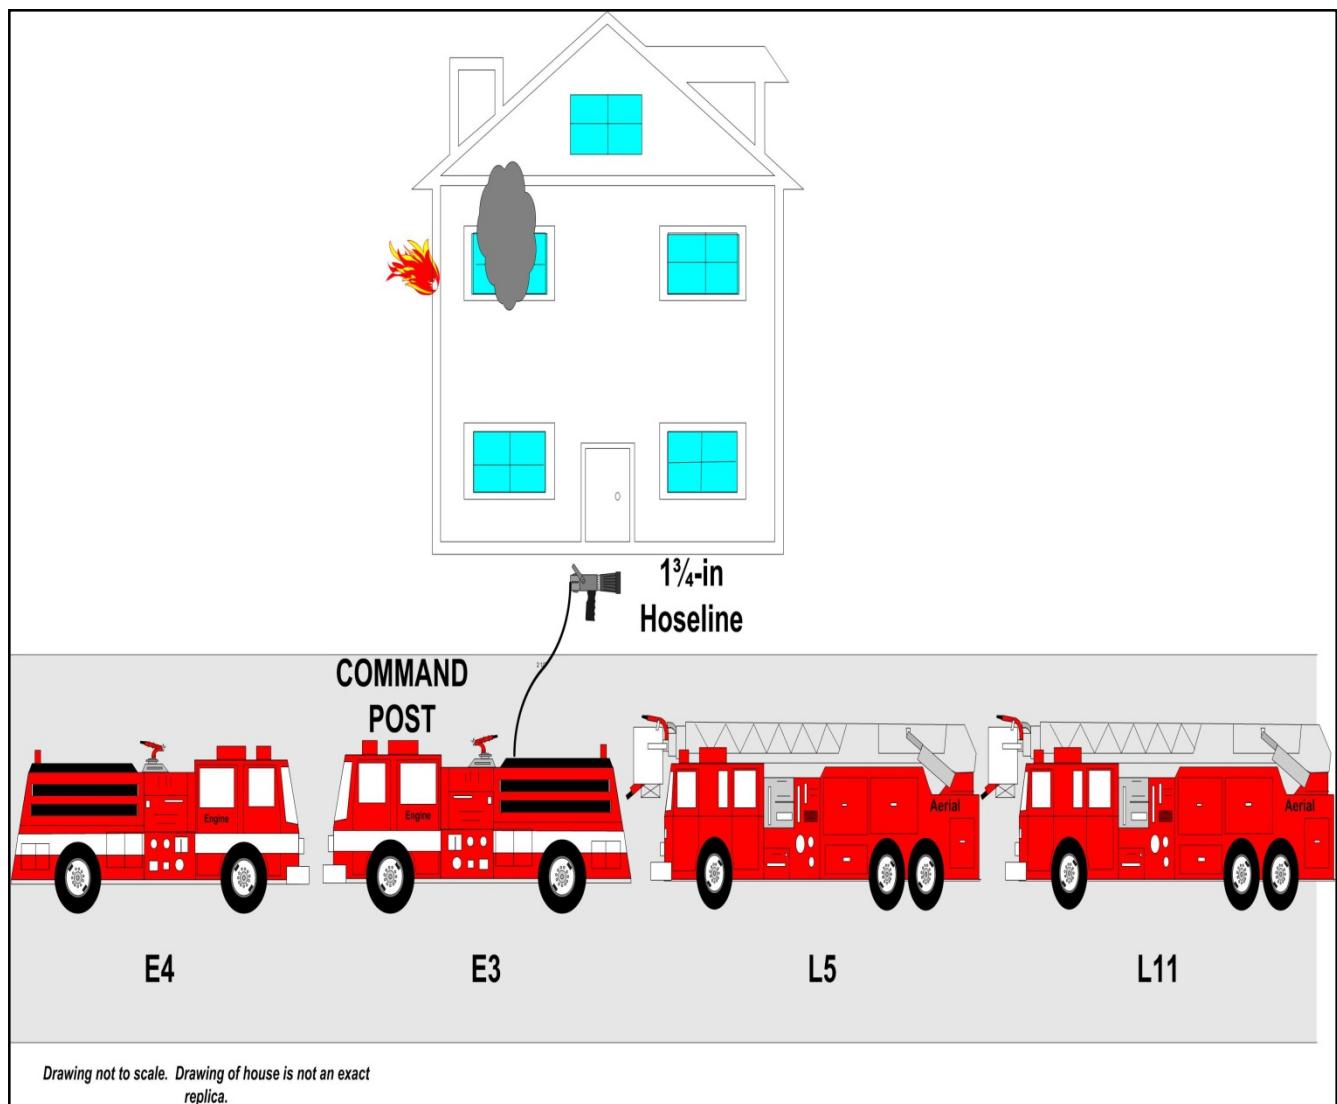
**Diagram 1. Initial conditions and fire apparatus on scene.** *Note: E4 and L11 arrived on scene after the initial room and contents fire was brought under control.*

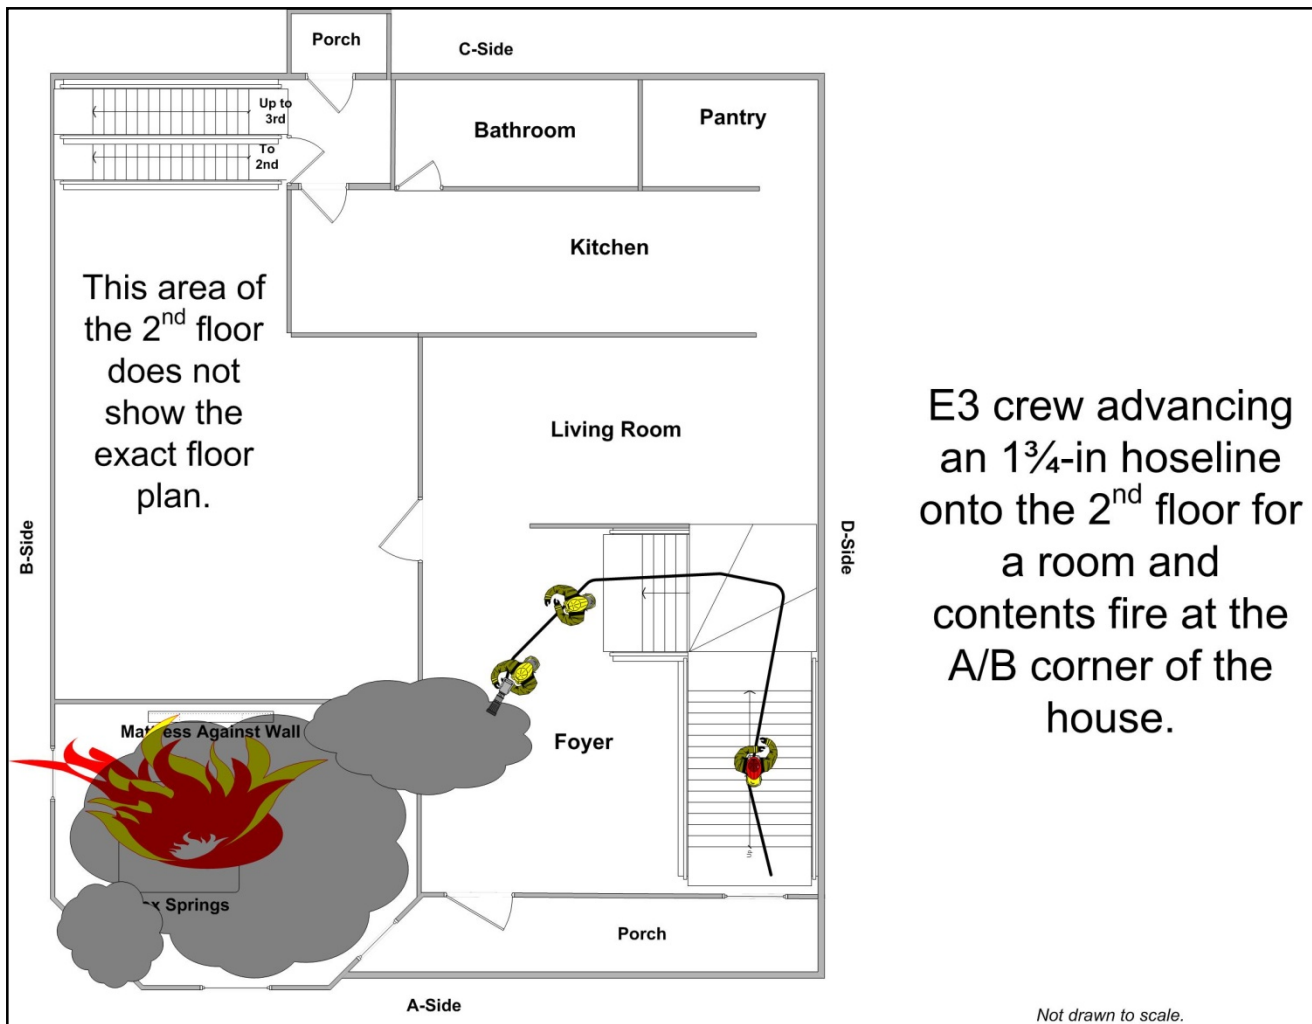
**Diagram 4.** E3 personnel discovered a room and contents fire on the 2<sup>nd</sup> floor.

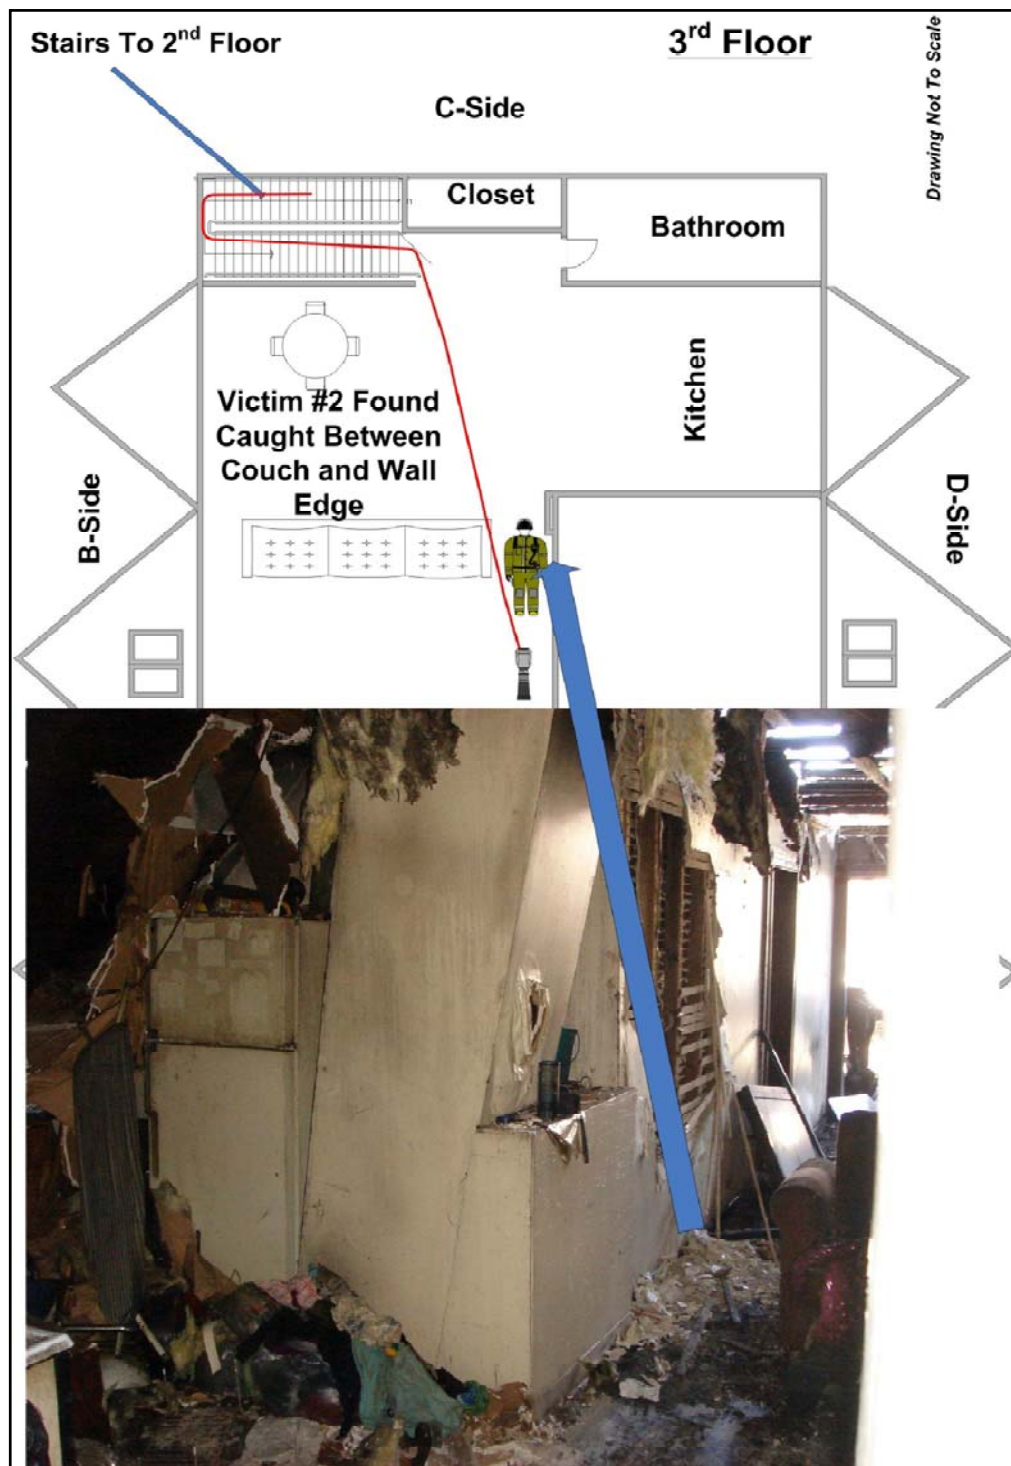
FF4 entered the rear stairwell and went to the 3<sup>rd</sup> floor (it is unclear if any personnel followed him into the house). He followed a hoseline into the 3<sup>rd</sup> floor and found Victim #2 apparently lodged between a wall and a piece of furniture (see Diagram 5). Victim #2's PASS device and indicator lights were alarming; he did not have his facepiece on. FF4 stated that he called a Mayday for Victim #2 and then heard evacuation tones over the radio and then air horns from an apparatus. He transmitted a second Mayday because the first one was not acknowledged by dispatch or the IC. Dispatch acknowledged the second Mayday for Victim #2 and set off the evacuation tones (not the Mayday tones), but no further radio traffic from dispatch or the IC confirmed the specifics of the Mayday. The ISO radioed the IC and advised him that they needed additional information on the Mayday that was just called. The RIT and other fire fighters located in the backyard were working on getting to Victim #2 and

**Diagram 5.** Shows location of where Victim #2 was found by FF4. *Note: Orientation of the picture differs from the diagram.*
