July 13, 2009

## **Two Career Fire Fighters Die after Falling From Elevated Aerial Platform – Texas**

## Fatality Assessment and Control Evaluation Investigation Report # F2009-06

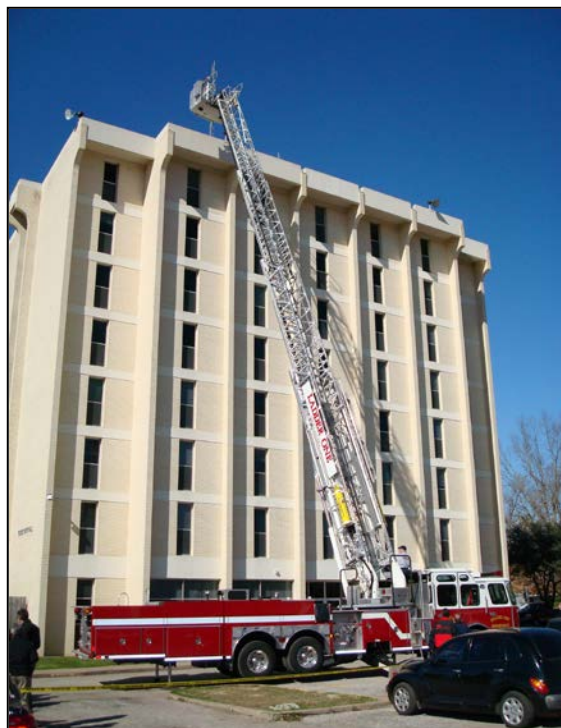
**Aerial platform positioned at dormitory building to recreate incident scene. Photo - NIOSH.**

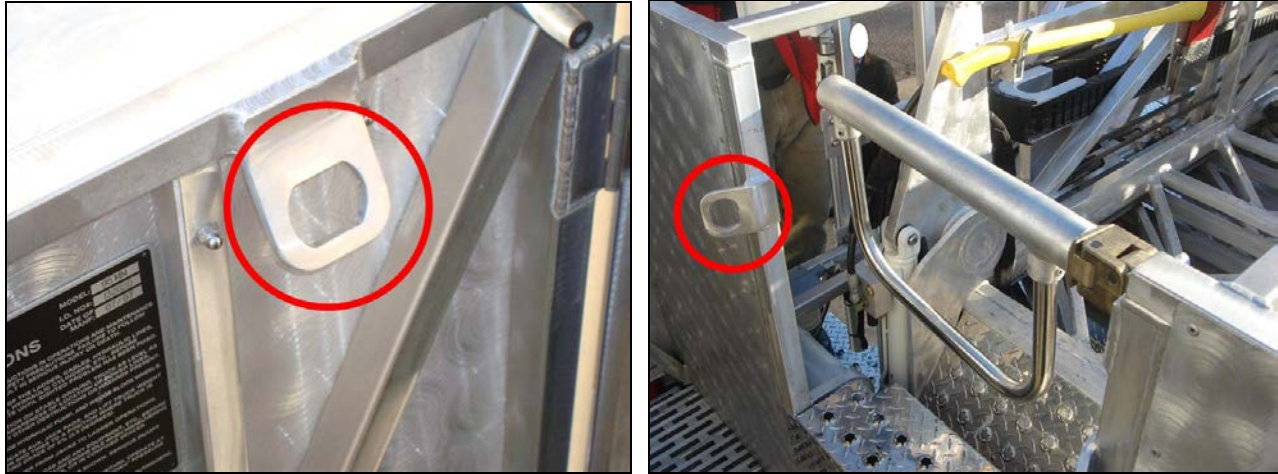
The platform is constructed of welded aluminum extrusions and aluminum sheet with approximately 18 square feet of floor space. The platform payload is rated at 1,305 pounds without water in the system (1000 lbs. - personnel and 305 lbs. - equipment) and 805 pounds wet (water in the system - 500 lbs. personnel and 305 lbs. equipment). A 42" high guard railing is provided around the perimeter of the platform. Two inward-opening, self-closing doors are provided at the two front corners of the platform. Six fall-protection anchor points are located in the platform, two in the front, two on the sides and two in the rear (see Photo 1 and Photo 2).

**Photos 1 and 2. Photo 1 shows anchor point on left side of platform (1 of 6 inside platform). Photo 2 shows the ManSaver™ Aerial Bar located to separate the platform from the ladder. Also note anchor point at rear of platform to left of the ManSaver™ Aerial Bar in Photo 2.**  
*NIOSH photos.*

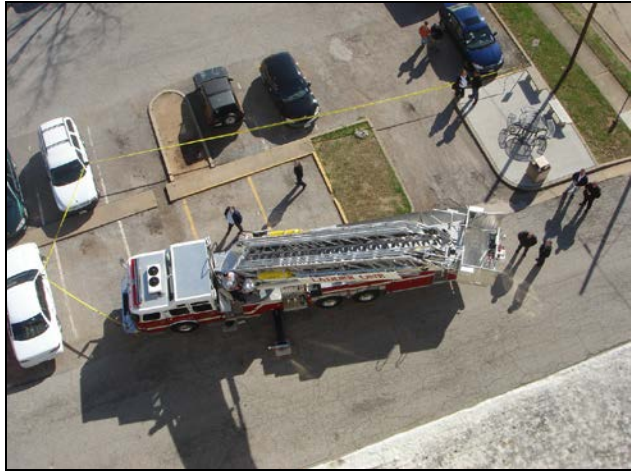
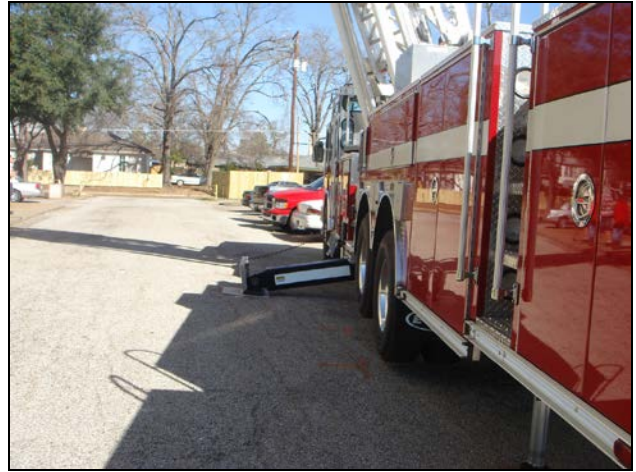
L-1 was positioned in the parking lot in front of the dormitory building (see Diagram 1 and Photos 3 and Photo 4). The training exercise involved setting up the apparatus for operation (extending and setting the outriggers and leveling the apparatus) and then raising the platform to the roof of the eight-story structure. The first group of three fire fighters entered the aerial platform and raised the platform to the roof (using the controls located in the platform) where the fire fighters got out of the platform and briefly walked around on the roof, noting construction features, utilities, and other information that might be useful in the event the fire department had to respond to a fire call at the dormitory. The fire fighters re-entered the platform and lowered the platform to the nested position on the back of the apparatus. Two of the fire fighters exited the platform while the operator remained in the platform to demonstrate the operation of the controls to the next group of three fire fighters who entered the platform. The second group (4 fire fighters) raised the platform to roof level and stepped out of the platform onto the roof. After briefly surveying the roof, the second group of fire fighters re-entered the platform and began lowering it. They decided to set the platform on the ground to simulate a rescue procedure. The apparatus was positioned too close to the building to set the platform down on the grassy area in front of the dormitory so the aerial ladder was rotated 180 degrees and the platform was set down in the parking lot on the officer's side of the apparatus where all four fire fighters stepped out of the platform.

**Photos 3 and 4. Photo 3 shows an overhead view of the location of Ladder One.**

**This is almost the exact position as at the time of incident.**

**Note that L-1 is not square to the building and the aerial is slightly rotated toward the building.**

**Photo 4 shows outrigger and rear stabilizer jack (driver side of Ladder One).**

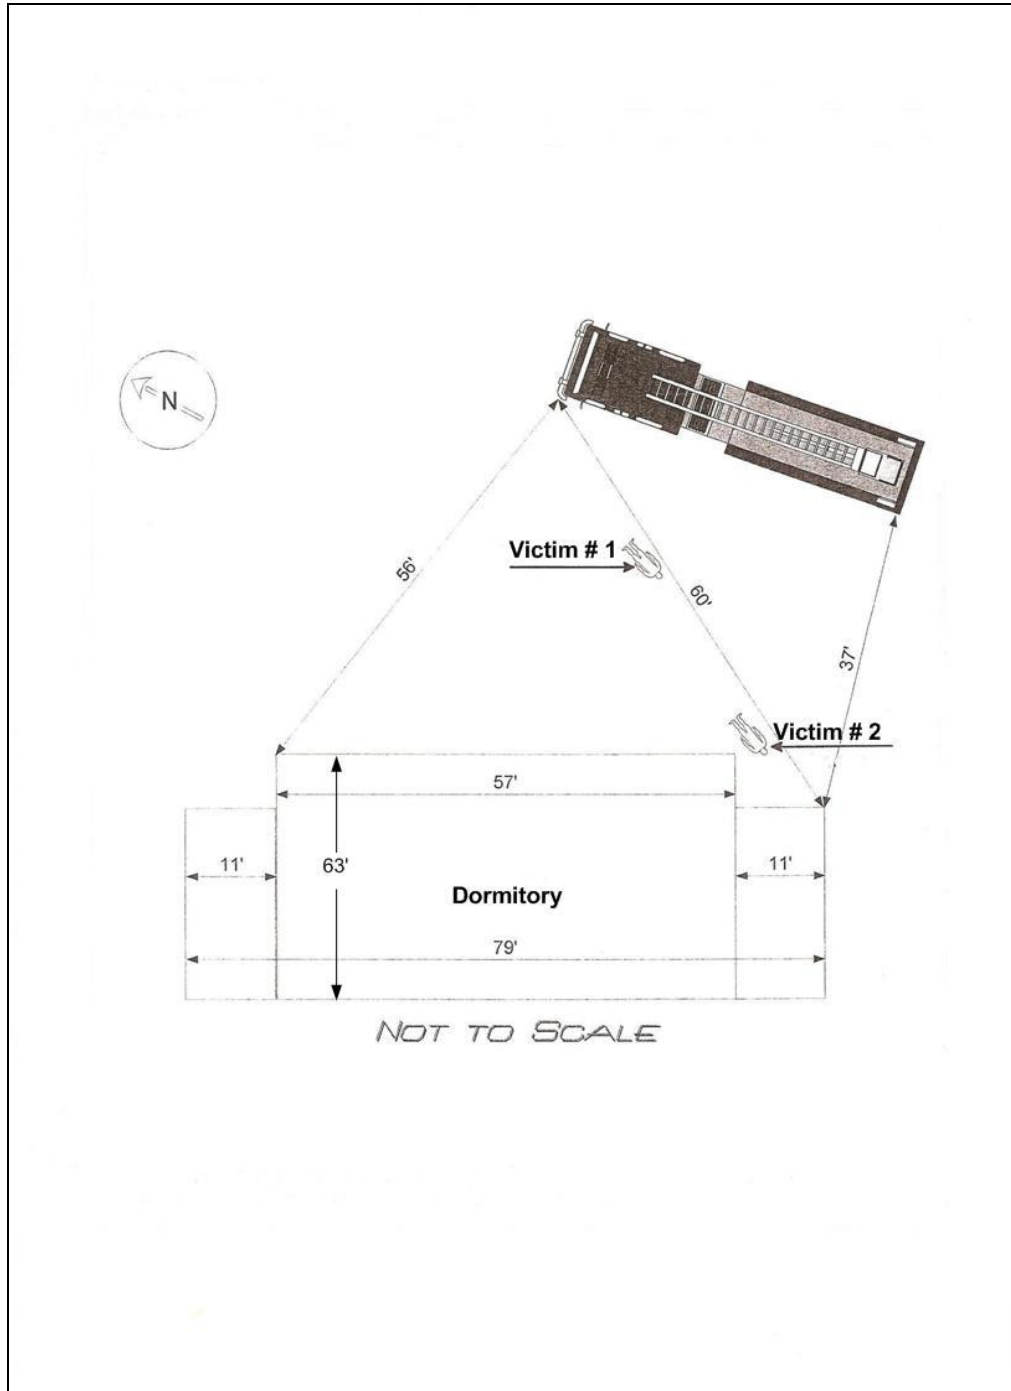
**Diagram 1. Simplified layout of incident scene. For reference only.**  
Note that diagram depicts a rear-mount ladder apparatus rather than a mid-mount apparatus as was involved in the incident.  
*Adapted by NIOSH from drawing provided by fire department*

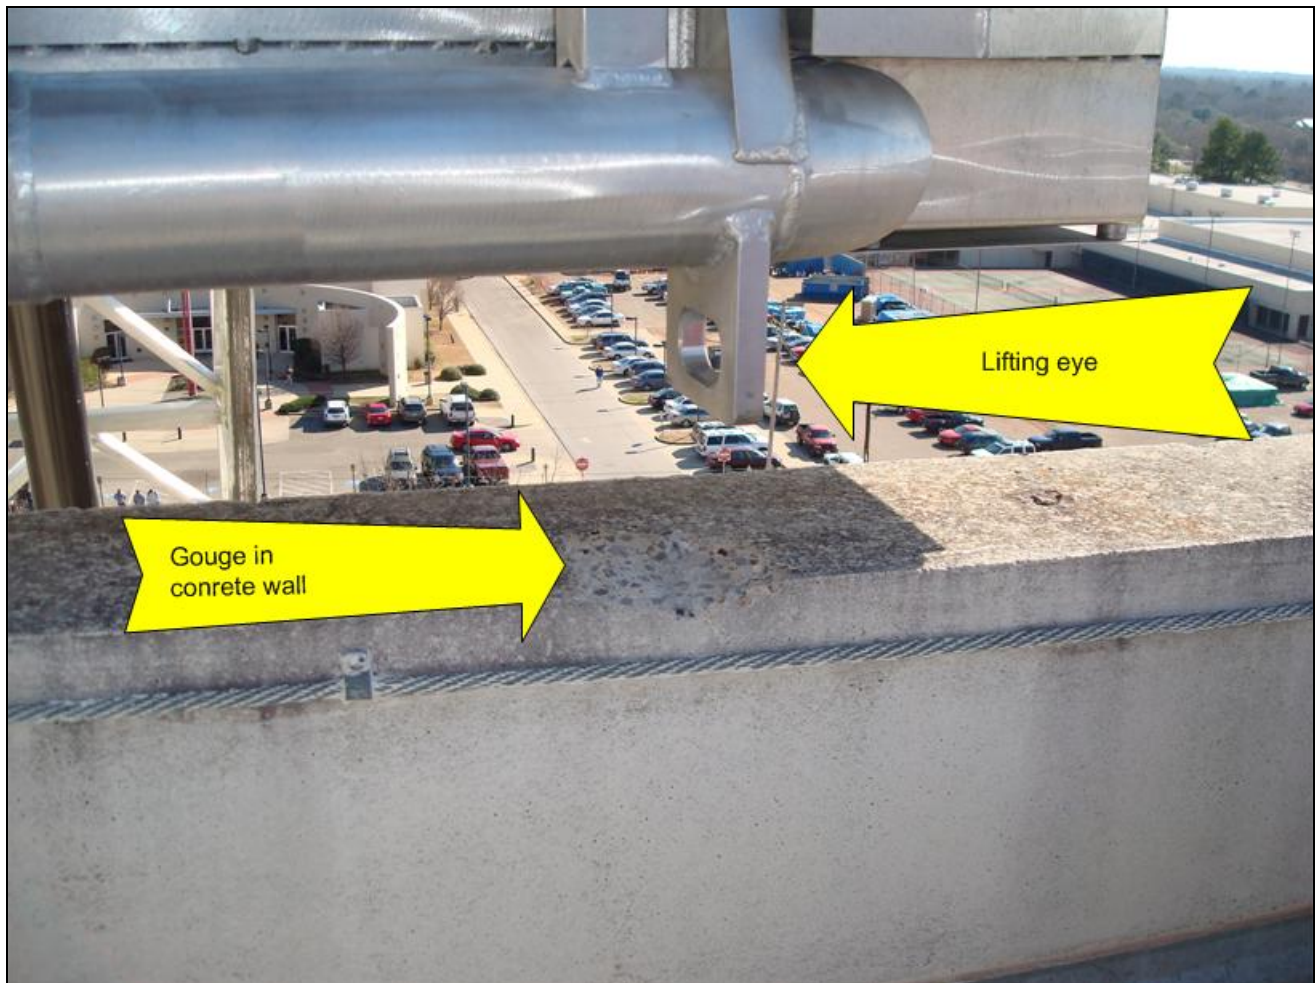
On the third attempt to raise the platform off the parapet wall, the top inside edge of the parapet wall that was holding the lifting eye suddenly and without warning broke (see Photo 9), causing the platform to spring away from the building and then whip back and forth violently (see Photo 11).

**Photo 5. Photo shows location where the lifting eye caught on the top of the parapet wall. The gouge in the concrete wall resulted when the inner surface broke as pressure was applied to the lifting jack to raise the platform off the parapet wall.**  
*NIOSH photo.*

***Recommendation #6: Fire apparatus manufacturers should ensure that aerial platforms and other aerial devices are designed to reduce or eliminate the potential for snagging on buildings or other elevated surfaces***

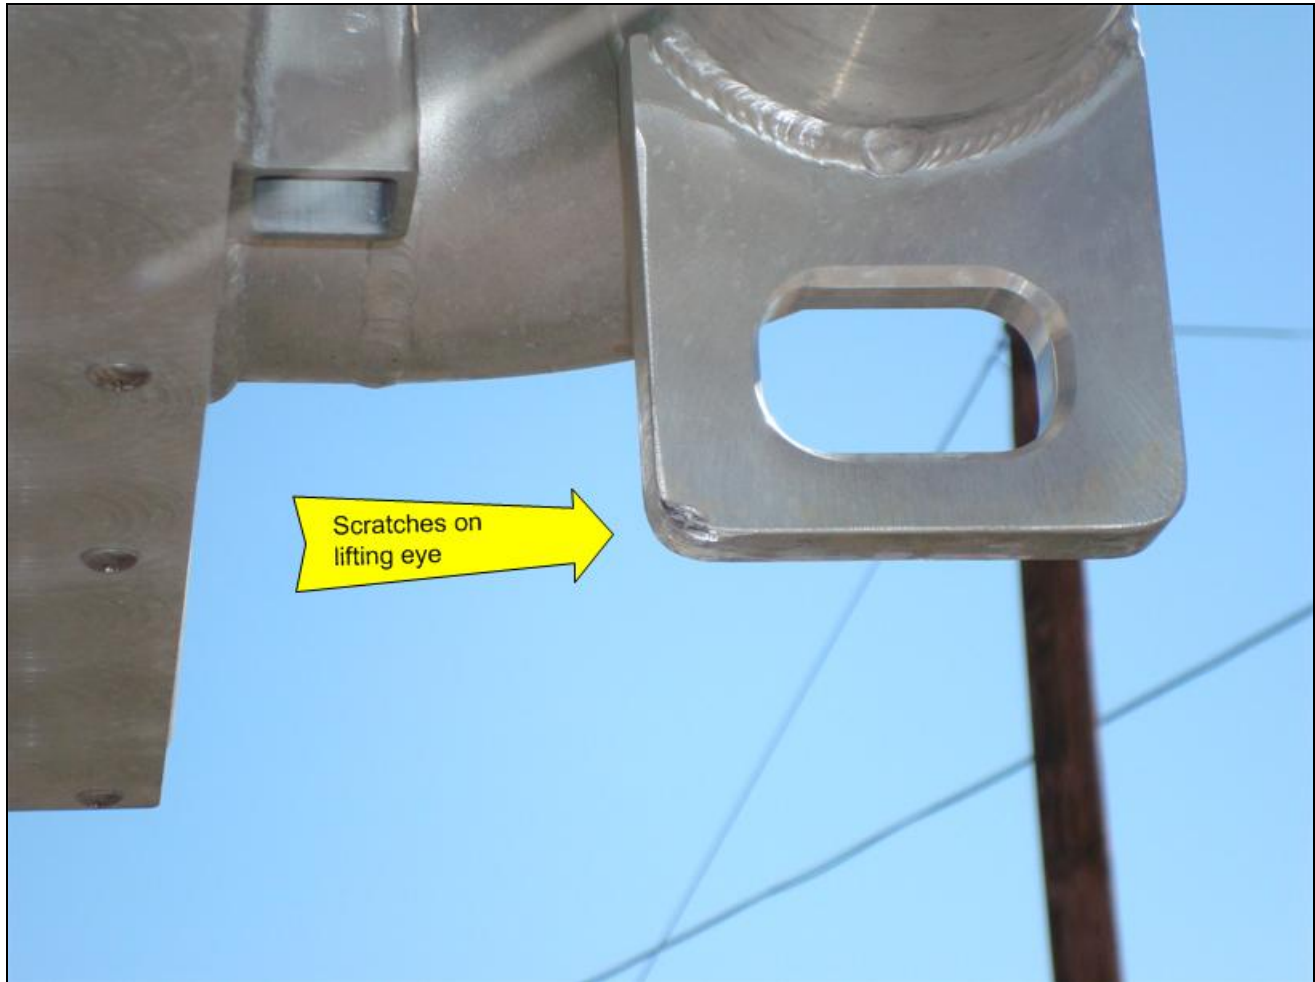
**Photo 7. Close-up of scratches and burrs on the inner bottom surface of the lifting eye.**  
*NIOSH photo.*

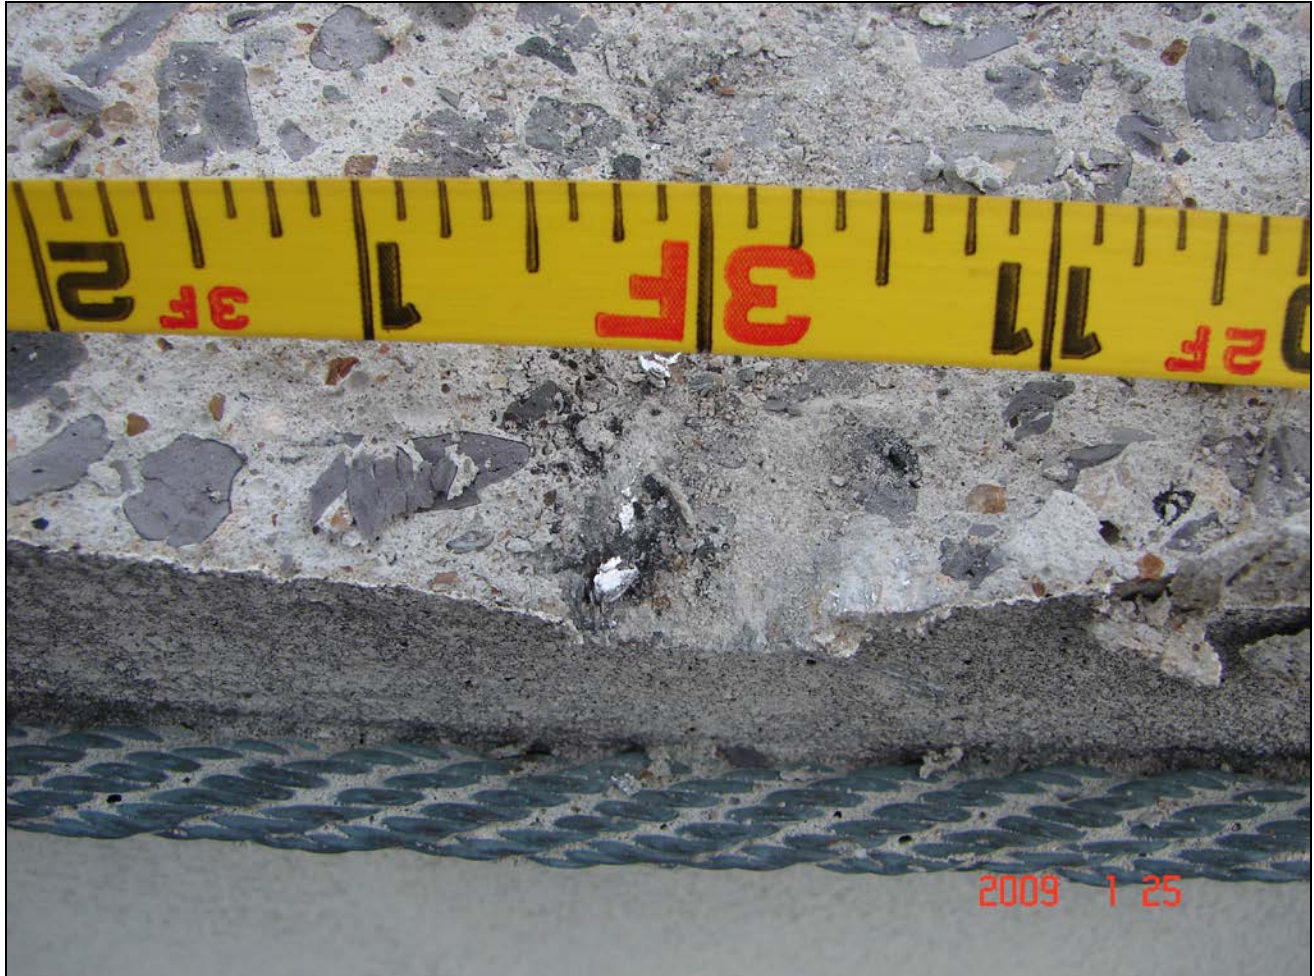
**Photo 8. Slivers of metal visible in the gouge on parapet wall.  
Photo taken immediately after the incident by police detectives.  
*Photo courtesy of police department***

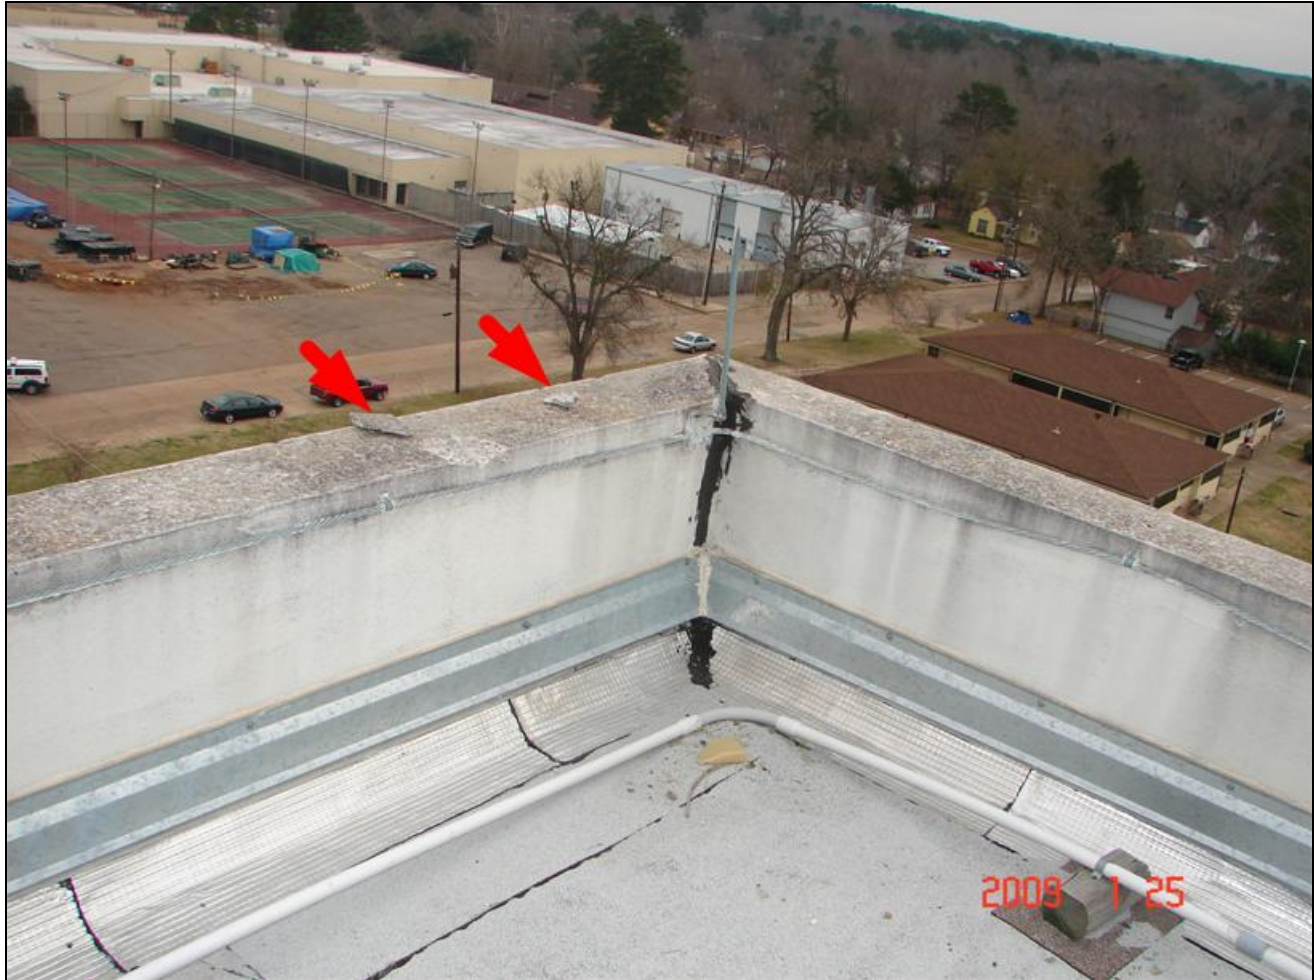
**Photo 9. Photo shows chunks of concrete on top of parapet wall beside the gouge where the lifting eye was caught. The concrete chunks were found on the roof by police detectives immediately after the incident.**

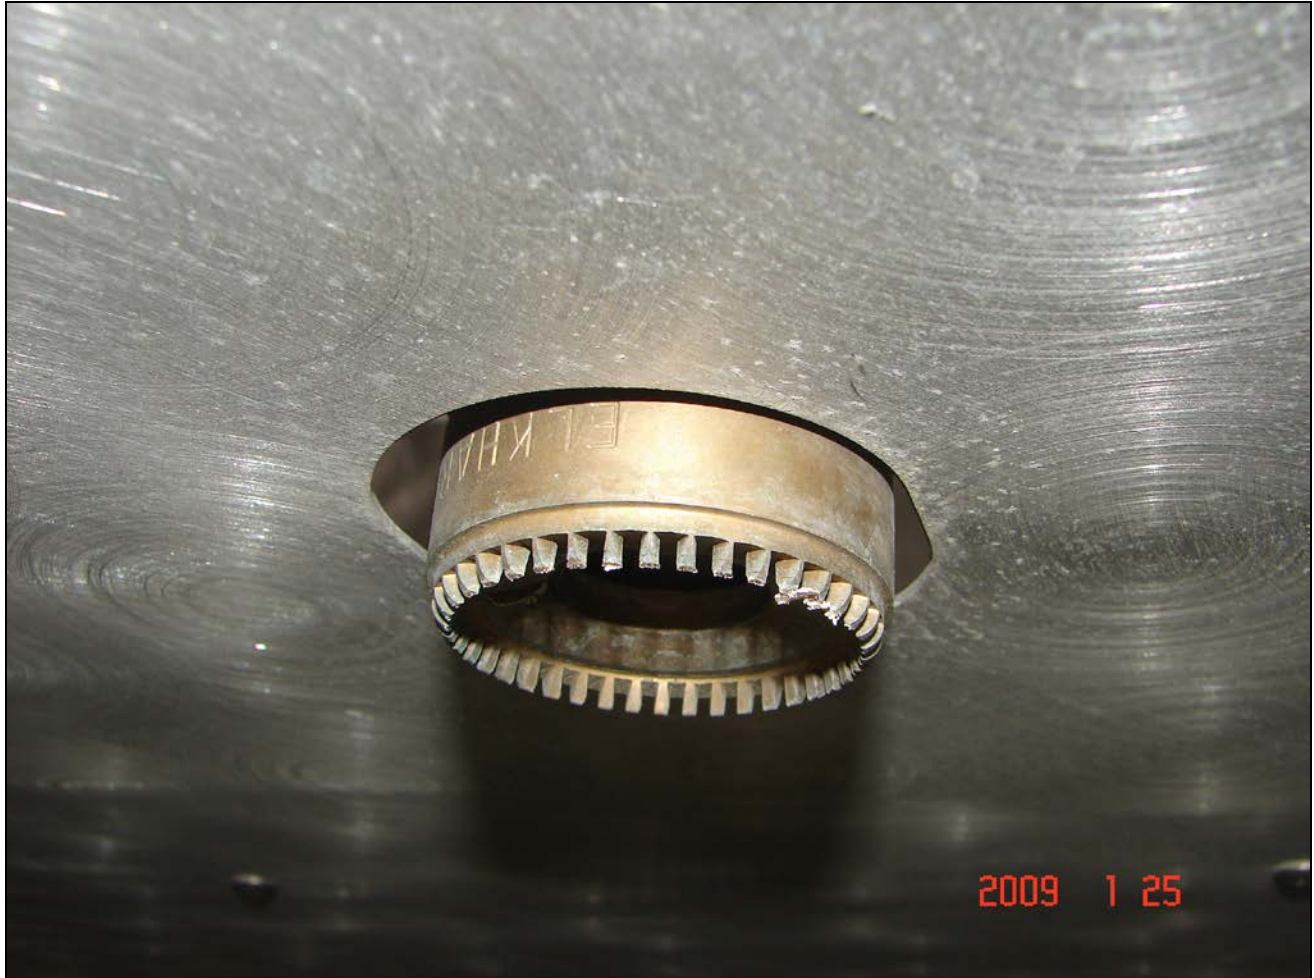
**Photo 10. Bits of concrete debris on water curtain nozzle located at bottom of platform.**  
*Photo courtesy of police department.*

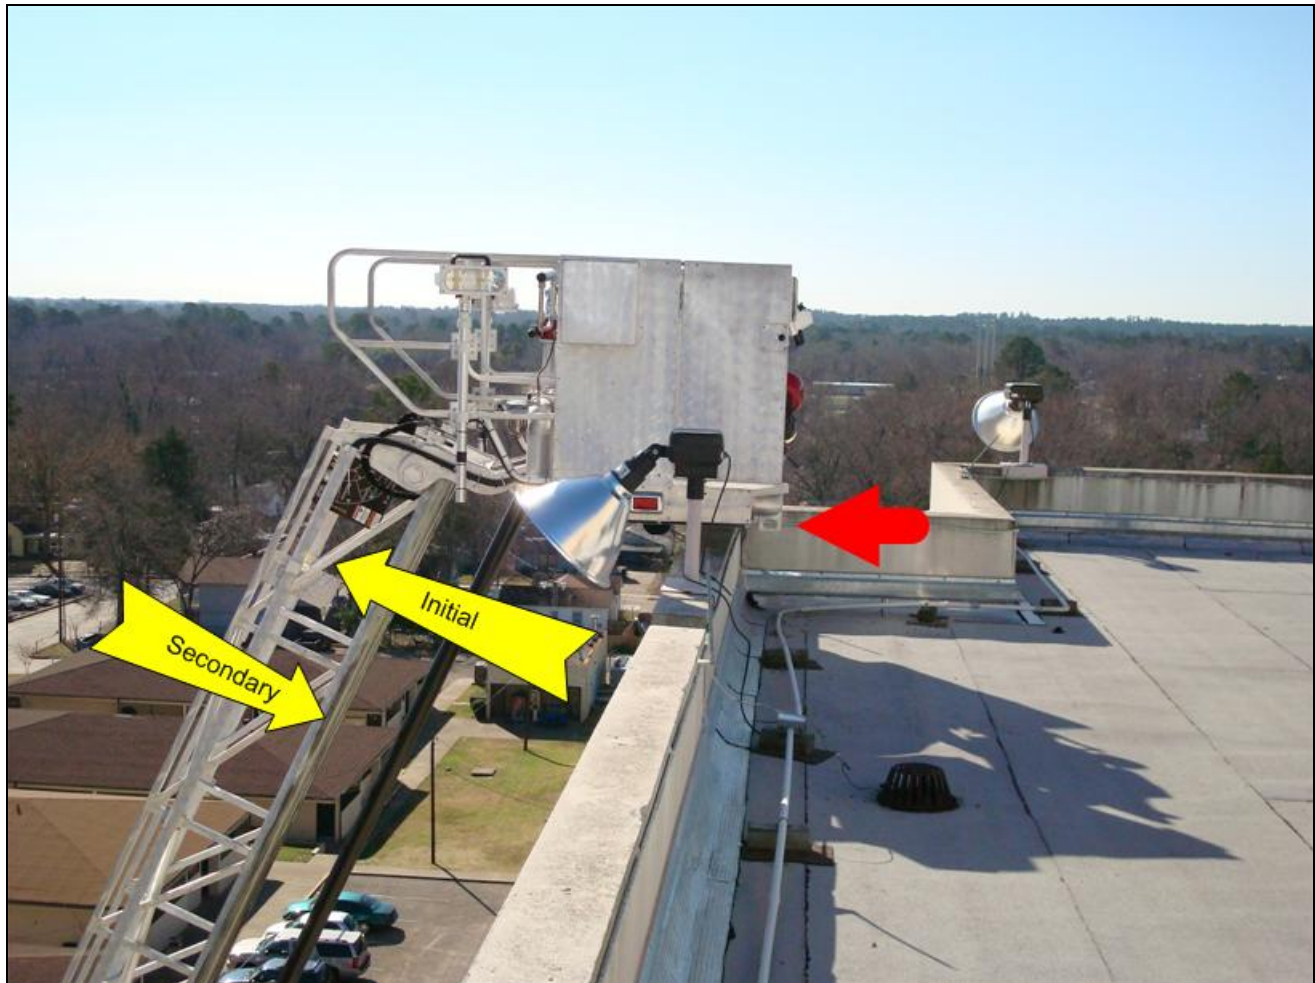
**Photo 11. Red arrow indicates location of lifting eye under platform that caught on inside edge of parapet wall. Pressure was applied to the lifting pistons in an attempt to raise the platform off the parapet wall. When the concrete surface gave way, the ladder sprung away from the building, then rocked back and forth several times. The yellow arrows depict the rocking motion that propelled the victims out of the platform.**

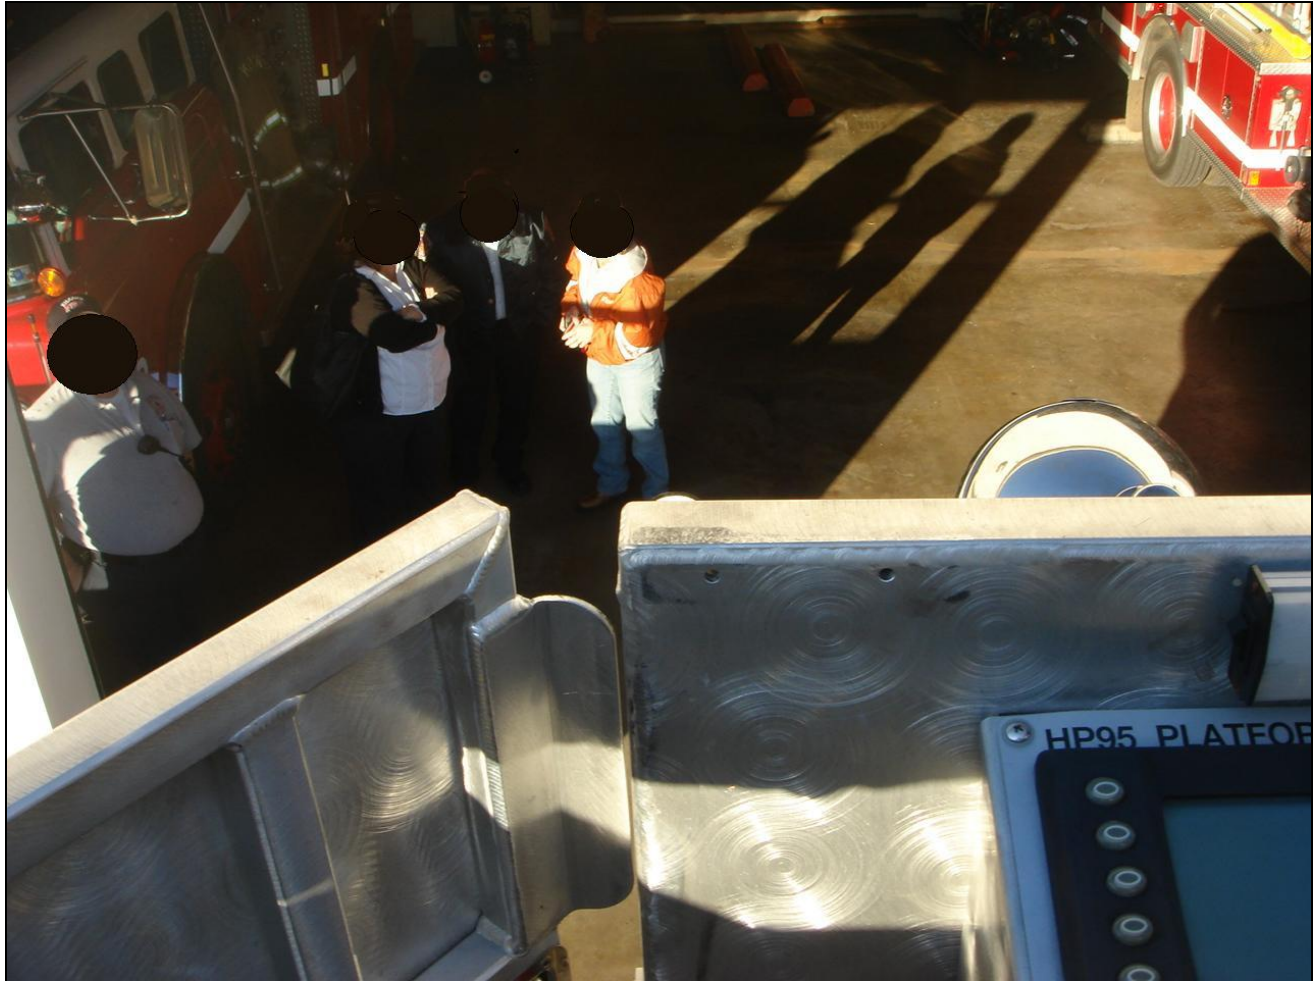
the platform. The aerial ladder then whipped forward (back toward the building), tossing the fire fighters in the platform forward. The operator was thrown against the control panel, striking his pelvis and again felt himself falling over the railing. As he struggled to remain in the platform by bracing his knee under the control panel, he observed Victim #1 falling through the right platform door, then he noticed a flash of blue in his peripheral vision to his left which he immediately realized was another fire fighter (Victim #2) falling through the left platform door. As the acting captain was tossed forward in the platform, he observed Victim #1 falling out of the platform through the right platform door. Just as Victim #1 was falling through the door, it appears the acting captain's chest struck the intercom speaker at the right side of the control panel, knocking the acting captain straight down onto the floor of the platform with his head and shoulders hanging outward through the open doorway (see Photos 12 and 13 showing damage to ManSaver™ Aerial Bar and the speaker). The operator pulled the acting captain back into the platform, and the two survivors huddled together on the floor of the platform as the aerial ladder continued to rock back and forth several times. They both observed that the platform doors were sprung outward (the doors are designed to only swing inward into the platform). When the aerial ladder came to rest, it was estimated by the fire fighters on the ground as well as the two survivors in the platform, that the platform was approximately 10 to 15 feet away from the building. *Note: The platform doors showed relatively minor damage after the incident. The door edge restraint strip was bent inward at the bottom of both doors indicating a force (applied from within the platform) had pushed the doors past the normal stopping point. The restraint strips are approximately 1 ½ inches wide and marks on the front railing show where the strips contacted against the door frame in the normally-closed position prior to the incident (see Photos 14 through 16).*

When examined by NIOSH investigators after the incident, it was possible to move the front railing (containing the door frame) approximately one-half inch without exerting much pressure on the railing. It is possible that when the operator struck the control panel and fell partially over the front railing as he was tossed about inside the bucket, this force moved the door frames on both sides to flex away from the door restraint strip, allowing both doors to be individually forced outward when struck by the two victims in rapid succession.

**Photo 14. Left platform door. Note door latch and retaining strip designed to keep the door from swinging outward and how door is sprung outward. The door is designed to swing into the platform and when closed, the door is designed to be an integral part of the guard rail system required by NFPA 1901, Chapter 20.7.6.1.2.**

***Recommendation #7: Fire apparatus manufacturers should ensure that aerial platform doors or gates are designed to prevent opening in the outward direction.***

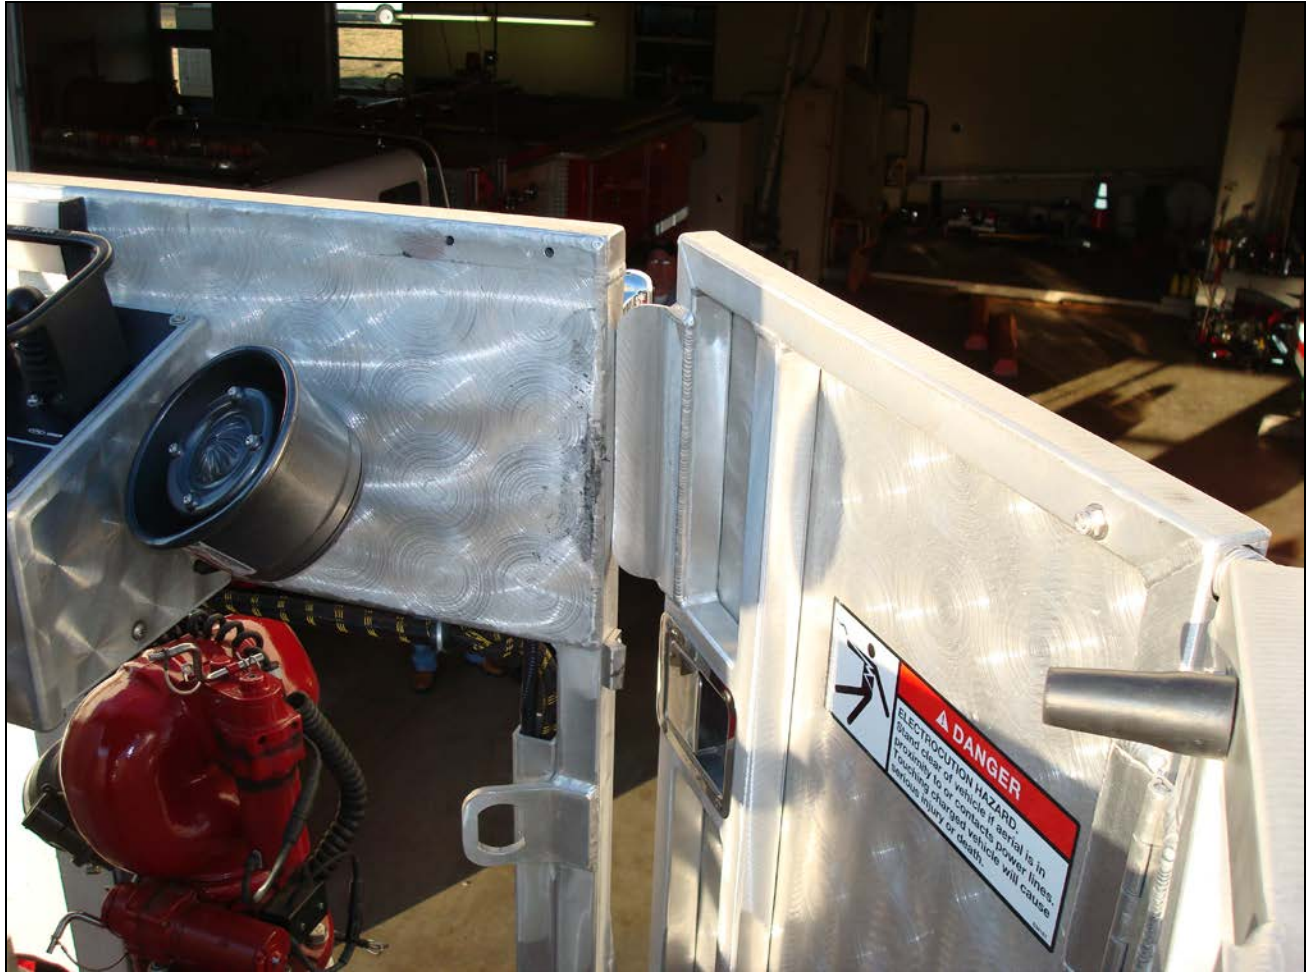
**Photo 15. Right platform door. Note the retaining strip to keep the door from swinging outward is located above the door latch only. There is no retaining strip below the door latch.**  
*NIOSH photo.*

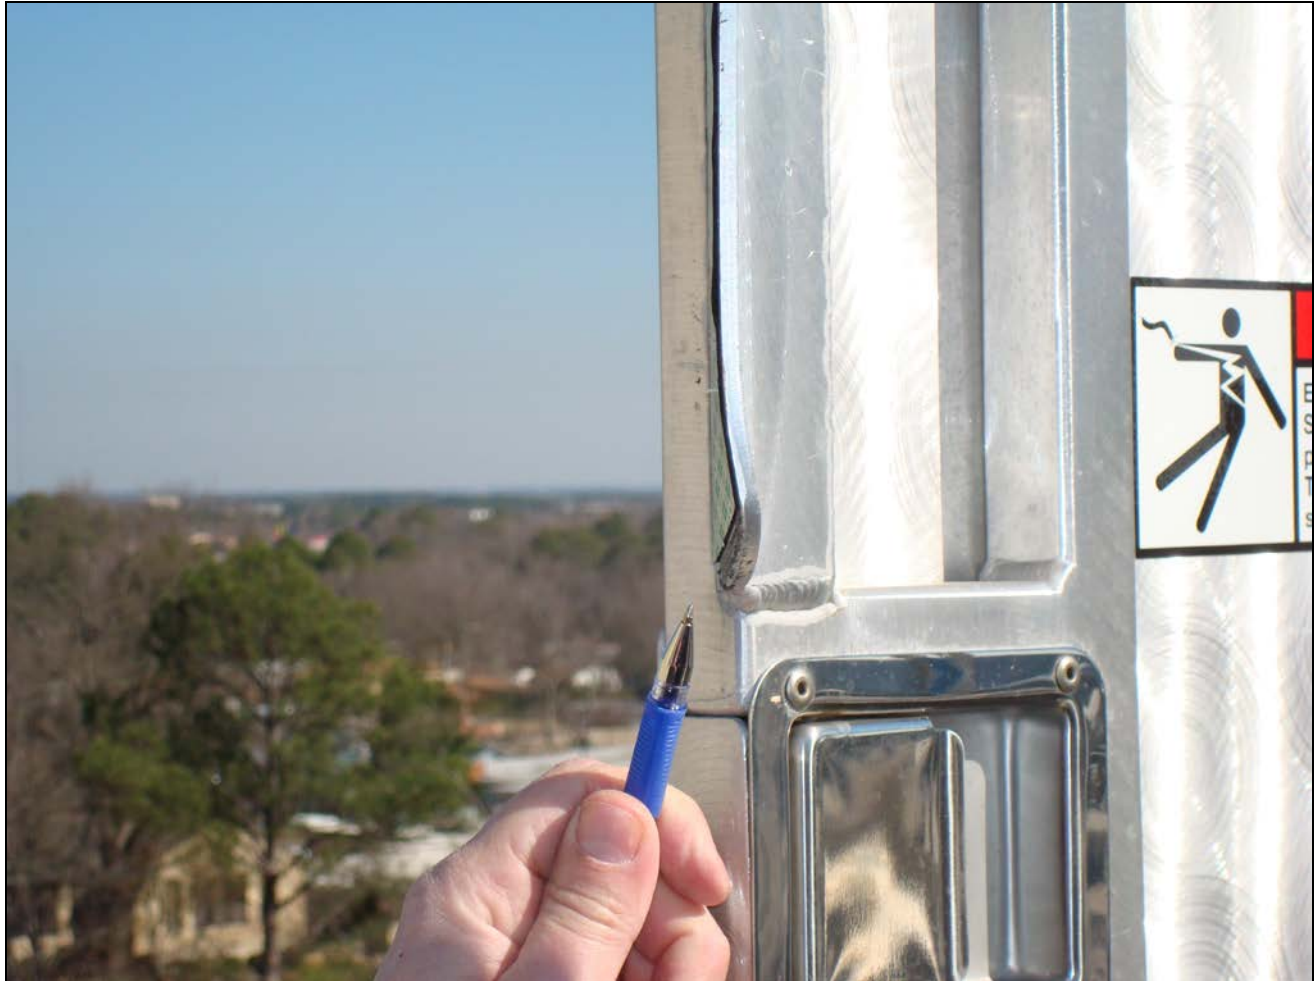
**Photo 16. Photo shows the retaining strip on the right platform door is bent inward. One possible cause would be a force applied to the door from within the platform when one of the fire fighters came in contact with the door, causing the door retaining strip to bend inward, allowing the door to open outward.**
