# Volunteer Fire Fighter Dies After Falling Through Floor Supported by Engineered Wooden-I Beams at Residential Structure Fire - Tennessee

## Death in the Line of Duty...A summary of a NIOSH fire fighter fatality investigation

F2007-07 Date Released: November 16, 2007

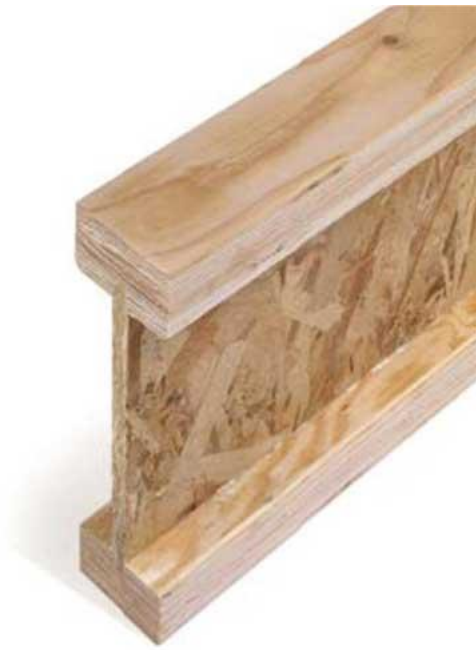
The floors of the structure involved in this incident consisted of a lightweight wooden truss system of engineered wooden "I" beams. Engineered wood "I" beams are typically formed with a 2- by 3-inch or 2- by 4-inch top and bottom cord with a sheet of plywood or particle board vertically sandwiched in between as a web ([Photo 1](#)).

Photo 1. Engineered wood I-joist. Photo courtesy of APA-Engineered Wood Association.

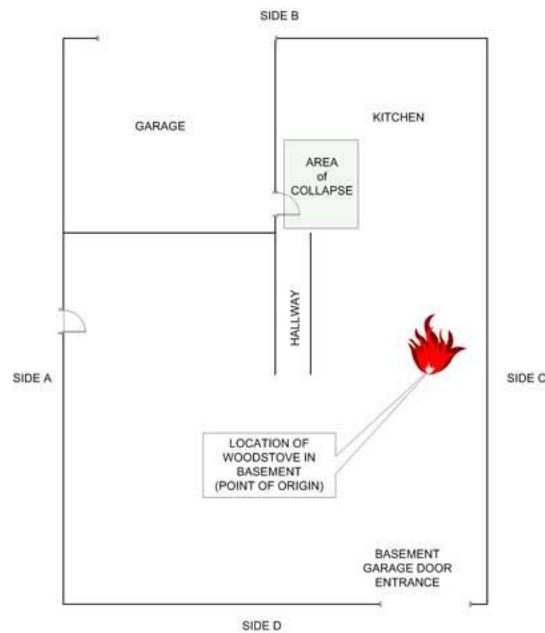
**Diagram. Aerial view**

The IC started to conduct a 360-degree size-up as the crew prepared to make entry through a door located in a second garage located on the main level at the A/B corner ([Diagram](#)). The IC was not aware if anyone was inside the house. The IC made it to the D-side where fire was extending from an entrance in the basement with probable extension through the first floor. He returned to the garage where the victim and his crew from E1642 were working. The crew made entry and proceeded down a hallway approximately 20 feet with zero visibility. They radioed the IC for a thermal imaging camera and for ventilation. A positive pressure ventilation fan (PPV) was set at the door in the garage where the crew made entry. The victim exited to retrieve the camera and by the time he returned, the heat conditions worsened and the floor was spongy. The crew exited the structure into the garage. The victim requested the nozzle and proceeded back into the structure within an arm's distance of one of his crew members who provided back up while he stood in the doorway. Without warning, the floor collapsed sending the victim into the basement at approximately 0059 hours.

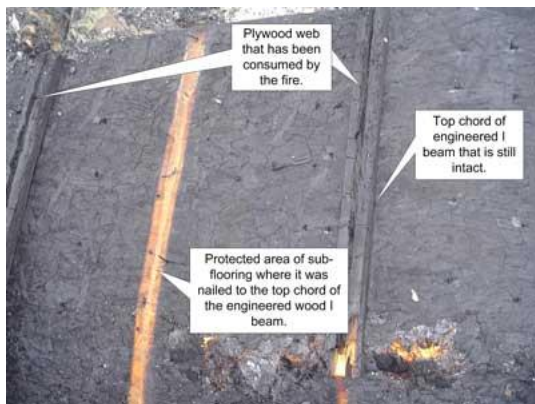
In this incident, the floor trusses for the first floor did not have any protection on the bottom cord, which immediately exposed the trusses to fire in the basement (Photo 2). Unfinished basements are very common throughout the country. Basements typically house additional fire exposures such as alternative heating sources, hot water heaters, clothes dryers, etc.. It is critical for trusses and lightweight engineered wood I beams that are used in a load-bearing assembly to be protected with a thermal barrier such as gypsum wallboard.<sup>10</sup> The function of the thermal barrier is a critical factor in the fire performance of the assembly.

**Photo 2. Engineered Wood I-Beam Webs Consumed by Fire**

**Recommendation #4:** Building code officials and local authorities having jurisdiction should consider modifying the current codes to require that lightweight trusses are protected with a fire barrier on both the top and bottom.
