One Career Fire Fighter Dies and Two are Injured in Apparatus Crash - California

One Career Fire Fighter Dies and Two are Injured in Apparatus Crash - CA

Fatality Assessment and Control Evaluation
Investigation Report # F2005-28

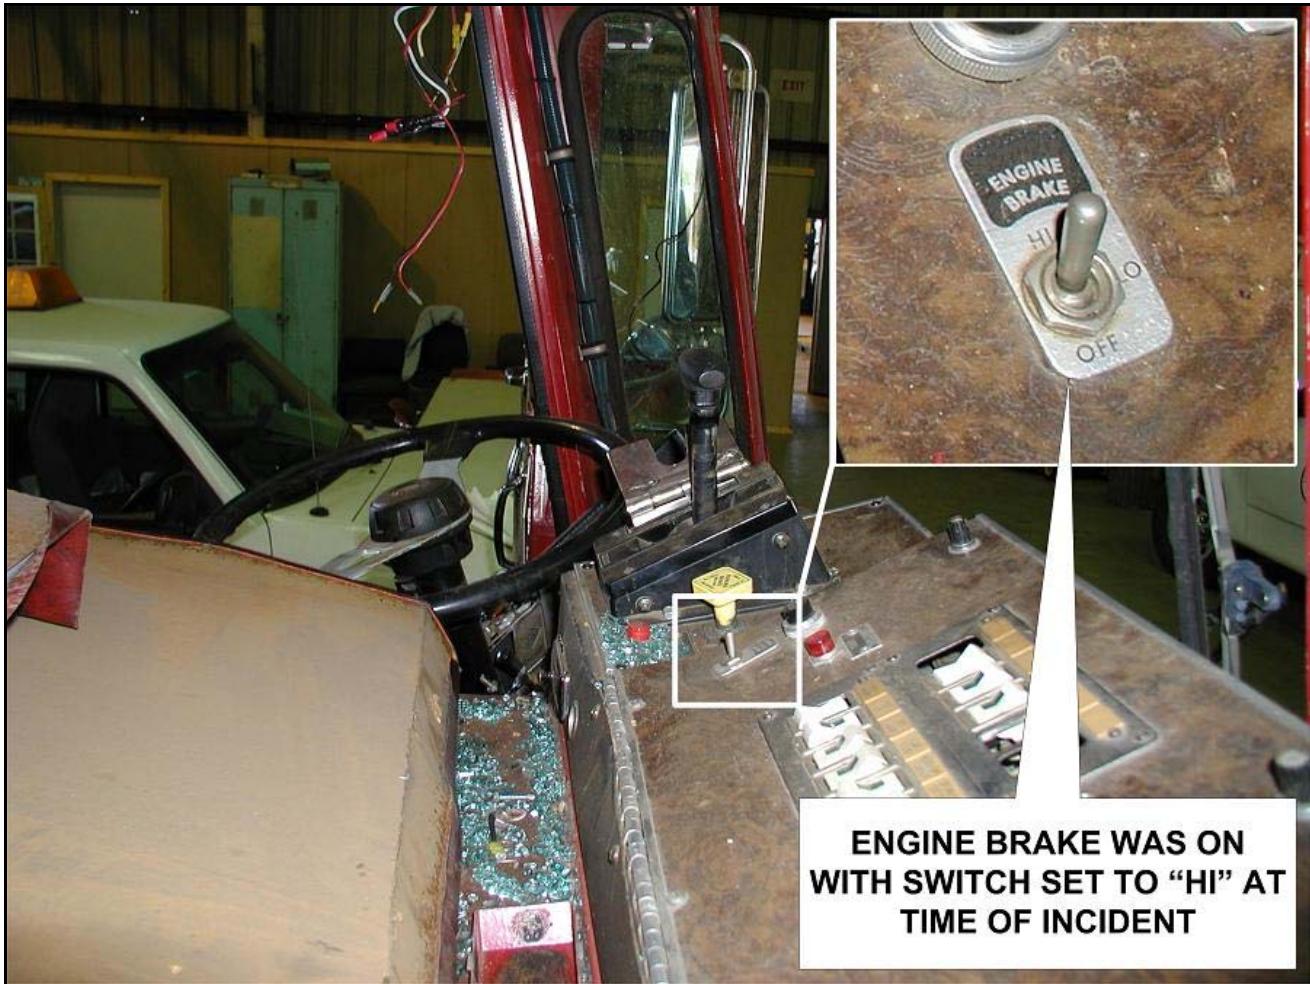
Photo 1. View of dashboard and engine brake switch

The apparatus involved in this incident was a 1987, 1,000 gallon-per-minute (GPM) engine with an automatic transmission and an auxiliary braking system (engine brake) (Photo 1). The engine's gross vehicle weight rating was 40,000 pounds (16,000 gross axle weight rating for the front and 24,000 gross axle weight rating for the rear). The engine had two axles with six tires (two in the front and four in the rear) all in good condition. The 500-gallon rectangular-shaped water tank was filled to capacity at the time of the incident. This was an open-cab engine that was equipped to carry six passengers with two front seat positions and four rear-facing seating positions. All six seats had lap belt restraints. The vehicle had passed a safety compliance inspection (required by the state) conducted at an area service station on June 15, 2005 and had traveled approximately 21 miles since the inspection.

The apparatus involved in this incident was equipped with a secondary braking system (a vehicle-slowing device, not a vehicle-stopping device). The apparatus involved in this incident had a secondary braking system switch inside the cab that allowed the driver to select either a low or high setting. The "low" setting activates three cylinders, yielding approximately 50% braking horsepower. The "high" setting will activate all six cylinders, providing full braking horsepower. The secondary braking system (engine brake) was set on "HI" at the time of the incident (Photo 1). Another driver/operator, who had driven this apparatus numerous times in the past was interviewed by law enforcement. He stated that the apparatus was "tail heavy" and felt that the rear end of the engine had a tendency to "come around" in rainy or wet conditions.

Fire departments should ensure that drivers are trained to carefully consider the use of auxiliary braking systems while operating apparatus on wet or potentially slippery roads.

Discussion: Fire Departments should ensure that drivers are trained to carefully consider the use of auxiliary braking systems (engine brakes) while driving on wet or potentially slick or slippery roadways. According to the manufacturer's operators' manual¹, "if the engine brake is new to the operator, it should not be used on slippery roads until some experience is gained on dry pavement." In addition, the following sequence is provided in the manual as a guideline when driving on wet or icy pavement: "When driving on wet or icy pavement, drivers are to start with the master switch in the "Off" position and use the same gear you would normally use under these conditions. Before activating the engine brake, be sure that you have plenty of distance between your vehicle and other vehicles and that traffic conditions allow for testing or vehicle braking." Drivers are also advised to "make sure that the vehicle is maintaining traction and stability using the natural retarding or the engine alone." If the retarding of the engine alone without the engine brake causes a loss of traction, the manual states that the driver should "not attempt to use the engine brake until road conditions improve." If the vehicle is maintaining traction, the manual states that the driver "may then activate

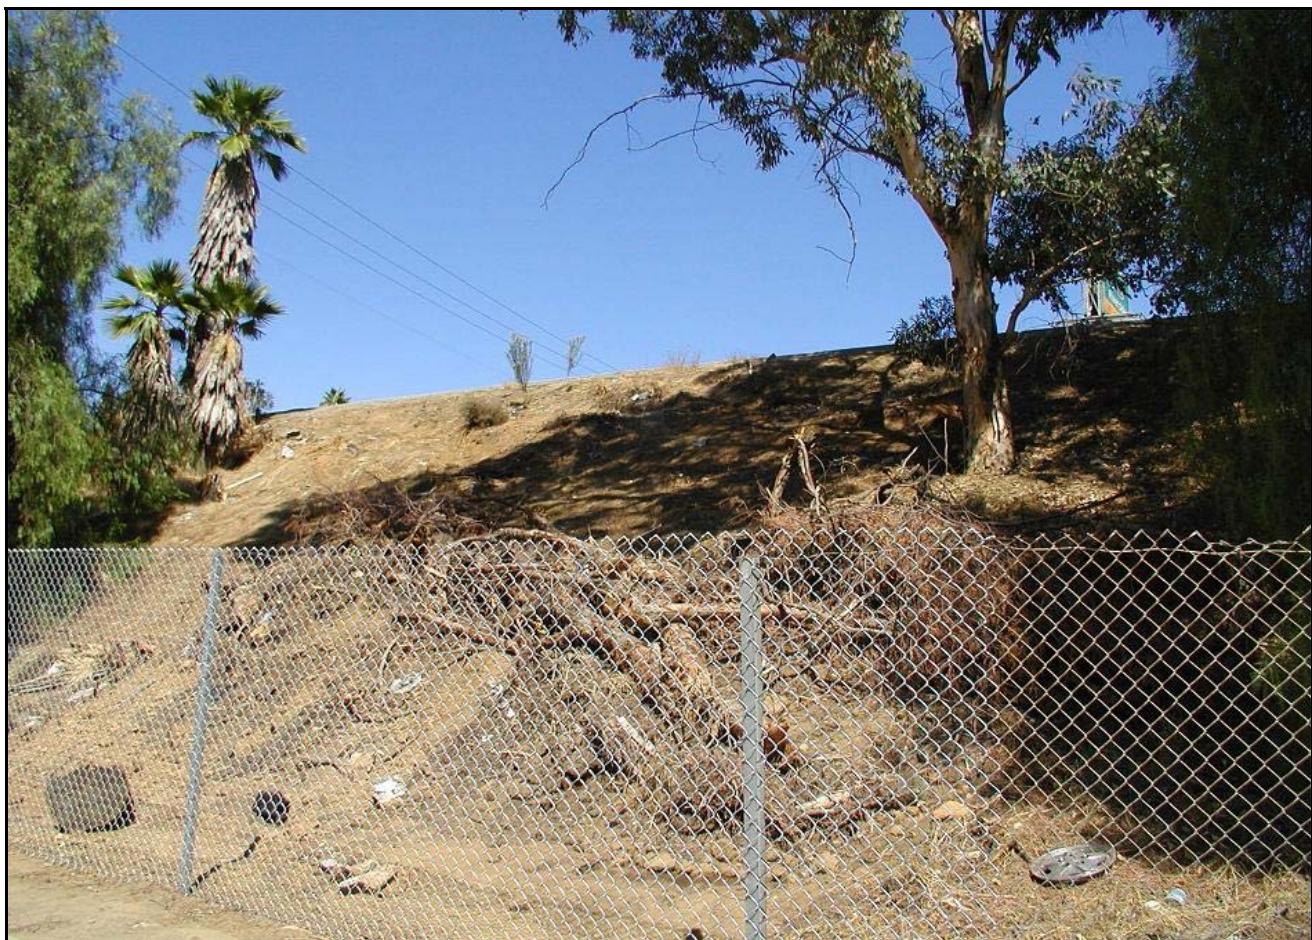
Photo 2. View of incident site

The engine was traveling eastbound on a two-lane blacktop state highway with a posted speed limit of 65 miles per hour (mph). The incident occurred at the interchange where the state highway meets a nine-lane (five lanes eastbound, four lanes westbound) interstate highway (Diagram). The interstate highway has a posted speed limit of 70 mph. The road surface was in good condition and was extremely wet from the sudden heavy rainstorm, but had no standing water.

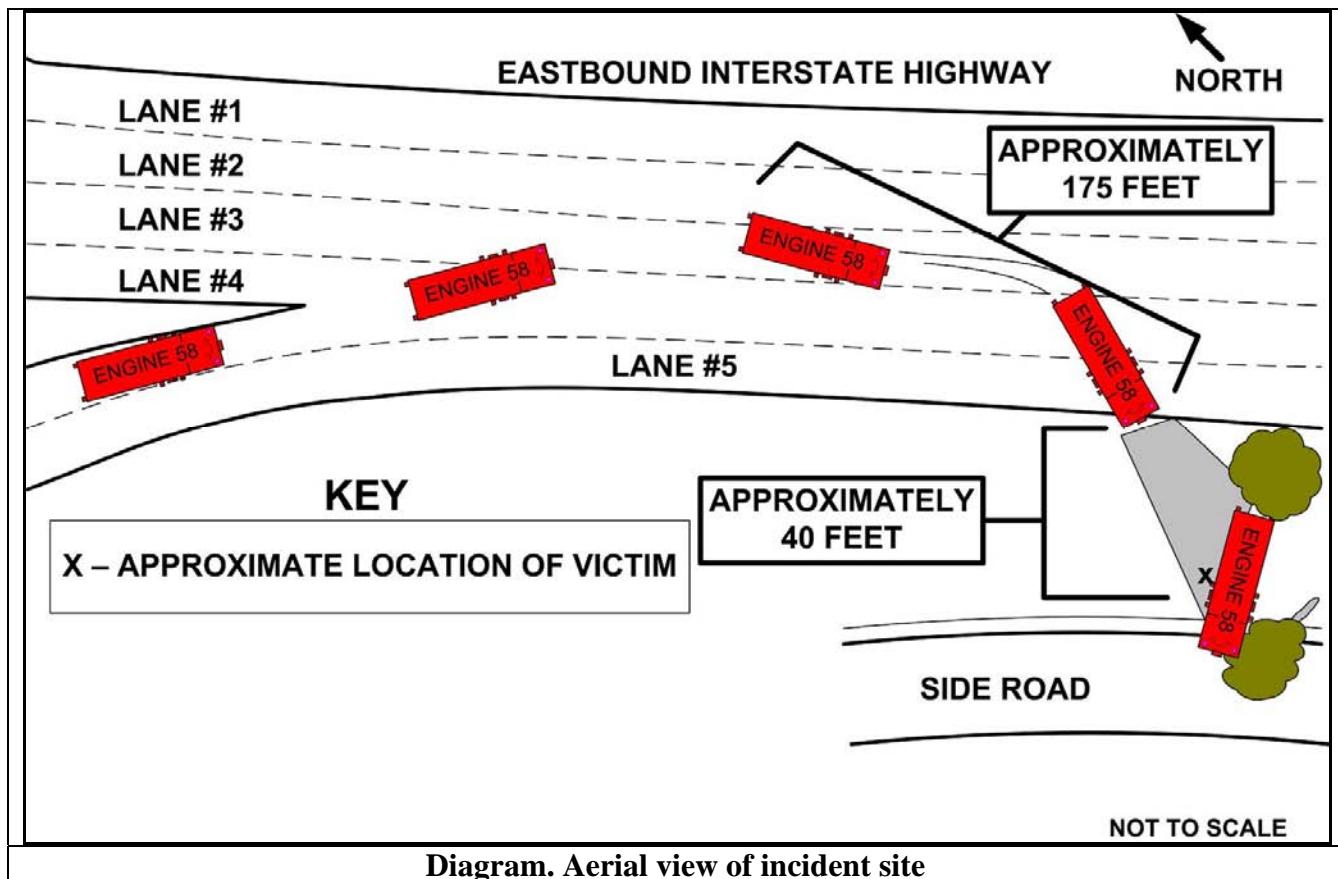
crew continued heading eastbound without lights or sirens when the rain changed from a light sprinkle to a heavy downpour as they approached the junction with the interstate highway. The driver/operator reported to the NIOSH investigator that he was traveling at approximately 45 mph as he merged onto lane #3 of the interstate highway (Diagram).

At approximately 1455 hours, the driver/operator eased off of the accelerator pedal as he felt the rear end of the apparatus shift on him. He felt he had regained control of the vehicle when the apparatus began to skid toward the concrete median barrier. The vehicle then turned and headed for the right-hand shoulder of the road. The apparatus traveled approximately 175 feet to the southeast rotating in a clockwise direction while traveling across lanes #3, #4 and #5. The vehicle struck an asphalt concrete drainage dike located on the south edge of the interstate highway. *Note: There was no guard rail present on the shoulder of the road* (Photo 2). The apparatus continued to rotate in a clockwise direction as it began to travel down the embankment. The rear driver's side of the vehicle struck a tree causing it to rotate in a counterclockwise direction about its vertical axis while rotating clockwise about its longitudinal axis, exposing the underside of the apparatus. The underside of the apparatus struck a second tree, uprooting the tree and dragging it down the embankment. The State Highway Patrol's report stated that it was during the longitudinal rotation of the apparatus that the victim was ejected from the right rear seat of the vehicle and was then struck by the vehicle. The vehicle came to rest on its wheels, with the rear wheels on the dirt embankment and the front wheels near the edge of the paved road (Diagram).
