One Probationary Career Firefighter Dies and Four Career Firefighters are Injured at a Two - Alarm Residential Structure Fire - Texas

Death in the Line of Duty...A summary of a NIOSH fire fighter fatality investigation

F2005-02 Date Released: September 16, 2005

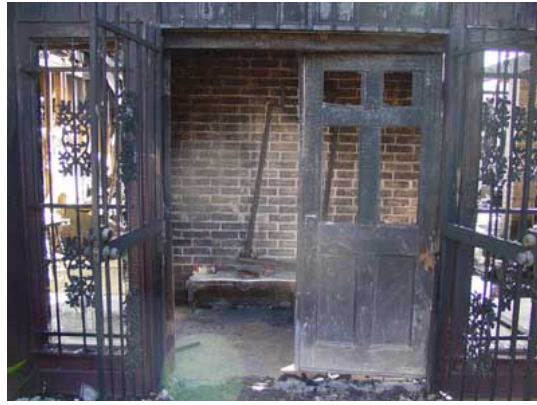
The crew from E-5 (staged at the front door, side-A) ([Photo 1](#)) stated that only minutes after entry was made, they heard muffled yelling and firefighters began crawling and running out of the structure. The E-5 crew began assisting the firefighters, as their gear was either smoking, or on fire. At this time, the E-3 (RIT) crew was approaching the front door. The

Photo 1. Illustrates the front door (side-A) and the burglar bars restricting entry. Note that this security measure was on every access door and window of the structure.

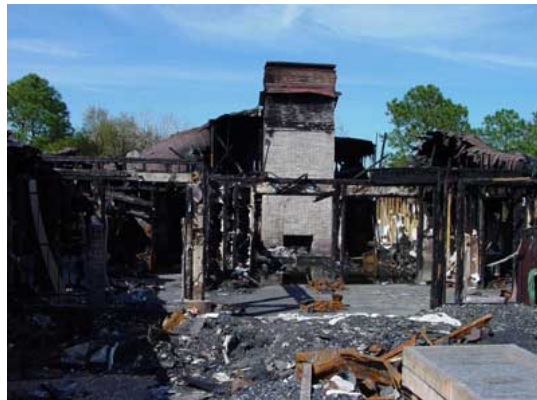
Photo 2. Depicts the rear (side-C) of the structure. Note the collapse area included the majority of the structure, including around the chimney near where the victim was found.

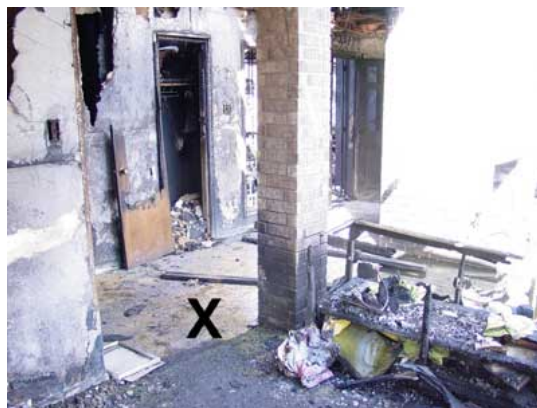
Photo 3. This photo shows (X) where the victim was found, facing toward the door. There was an approximate 4 foot distance between the brick column on the right and the corner of the wall on the left. This photo was taken from the interior of the house, looking toward the front door.

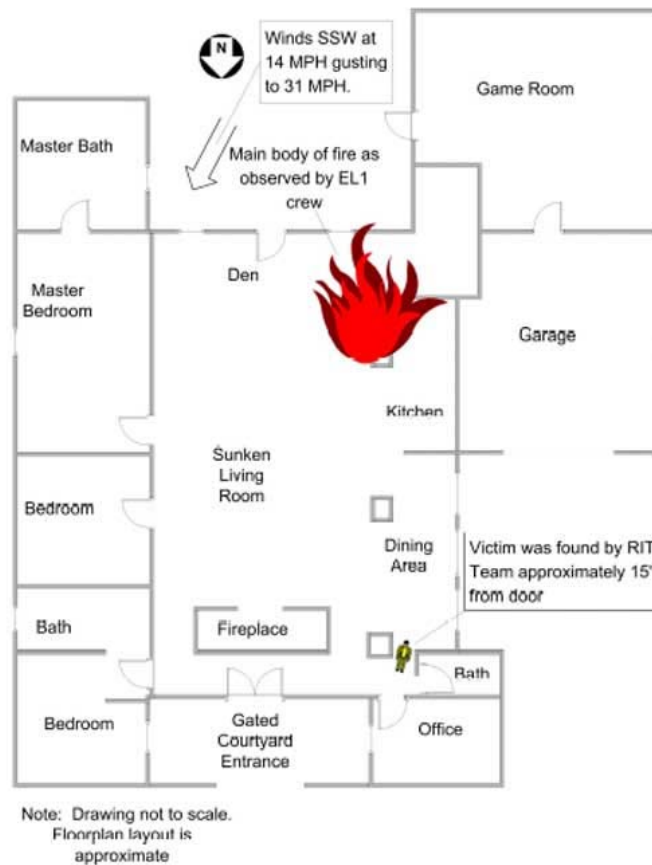
Meanwhile, due to congestion (6 firefighters) immediately inside the door, the E-5 crew staged at the entranceway on side-A. When the EL-1 and E-2 crews made entry, they came into contact with the back of the brick fireplace ([Diagram 1](#)) directly in front of and approximately 4 feet inside the front entrance of the structure. The crews (2 Lt's and 4 firefighters) both turned to the right of the fireplace to enter the structure, and began searching for the seat of the fire. Members from E-2 were operating a thermal imaging camera (TIC) in the immediate vicinity of the EL-1 crew / hand line. It was stated by the Lt. from EL-1 that he thought that the victim might have stayed at the front door to feed hose. The Lt. and firefighter from EL-1 (nozzle-man) advanced the line, and the nozzle-man reportedly hit a window with a stream at the west end of the house, which broke out. The EL-1 Lt. and the nozzle-man then advanced the hose line further into the structure, and the nozzle-man told his Lt. that it was too hot, and that his hands were "burning up". The EL-1 Lt. told him to hit the area to the left at ceiling level, which was done and the fire blackened down. The EL-1 Lt. then told the nozzle-man that the fire was also to the right. The hand line was opened again for a longer burst, then it was shut down again. It was at this point that the nozzle-man was forced to set down the hand line, handing the nozzle to the EL-1 Lt., and stating that he was too hot. The Lt. from EL-1 stated that fire immediately began rolling down to about knee level above the floor. All interior firefighters were immediately overcome by intense heat and flames. The Lt. from EL-1 stated that the Lt. from E-2 was trying to communicate with him, but he could not understand what he was saying. All he heard was yelling and a muffled voice. (Note: it was later stated by the Lt. from E-2 that he was trying to convey that they needed to bail out.) At this point, the fire intensified further to the left and right, and it was reported that all at once it sounded like firefighters were yelling "back out, back out" and "bail out." Also at that point, the EL-1 Lt. yelled to the E-2 Lt. that they needed to back out. The EL-1 and E-2 Lts. stated that they yelled for everyone to get out, and it was about that time that the EL-1 Lt. believed that he, himself, was on fire. The EL-1 Lt. then set the nozzle down and followed other firefighters and the hand line out.

In this incident, a total of six firefighters (and a charged 1 – 3/4 inch handline) simultaneously entered the structure through the same door – three firefighters from EL-1 and three firefighters from E-2. The access point and area where firefighters operated in this structure was not conducive to six firefighters operating, in that it was a small area. (Diagram 1).

Diagram 1. Depicts the overall floor plan of the structure, and where the victim was located.

Recommendation #10: Fire departments should instruct firefighters to not overcrowd the area of the interior attack team.

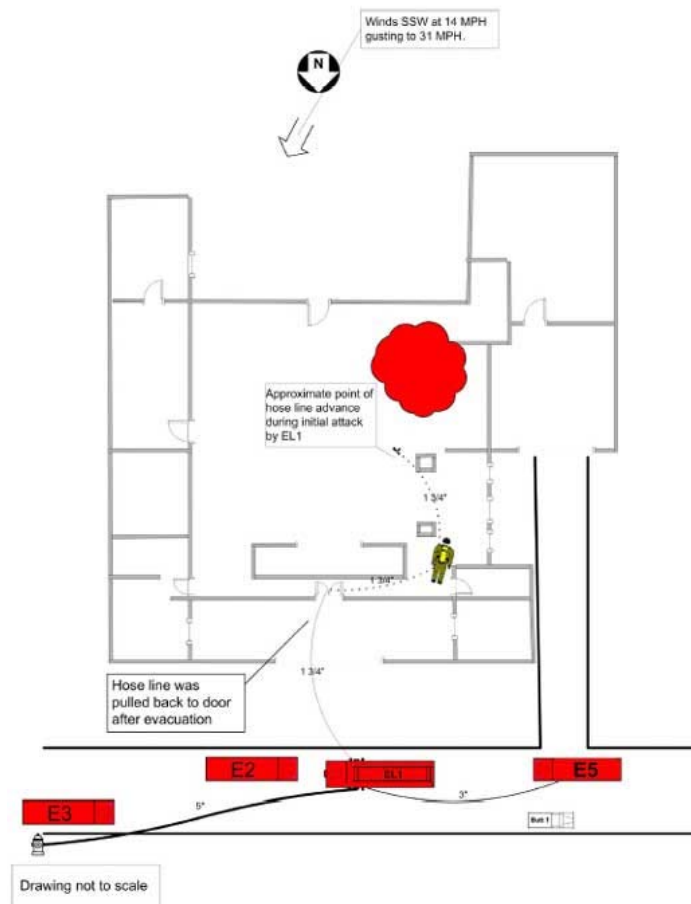
Diagram 3. Depicts the initial hose-line advance. Note the dotted line.
