**NIOSH**  
Fire Fighter Fatality Investigation  
and Prevention Program

July 26, 2004

## **Partial Roof Collapse in Commercial Structure Fire Claims the Lives of Two Career Fire Fighters - Tennessee**

## Fatality Assessment and Control Evaluation Investigative Report #F2003-18

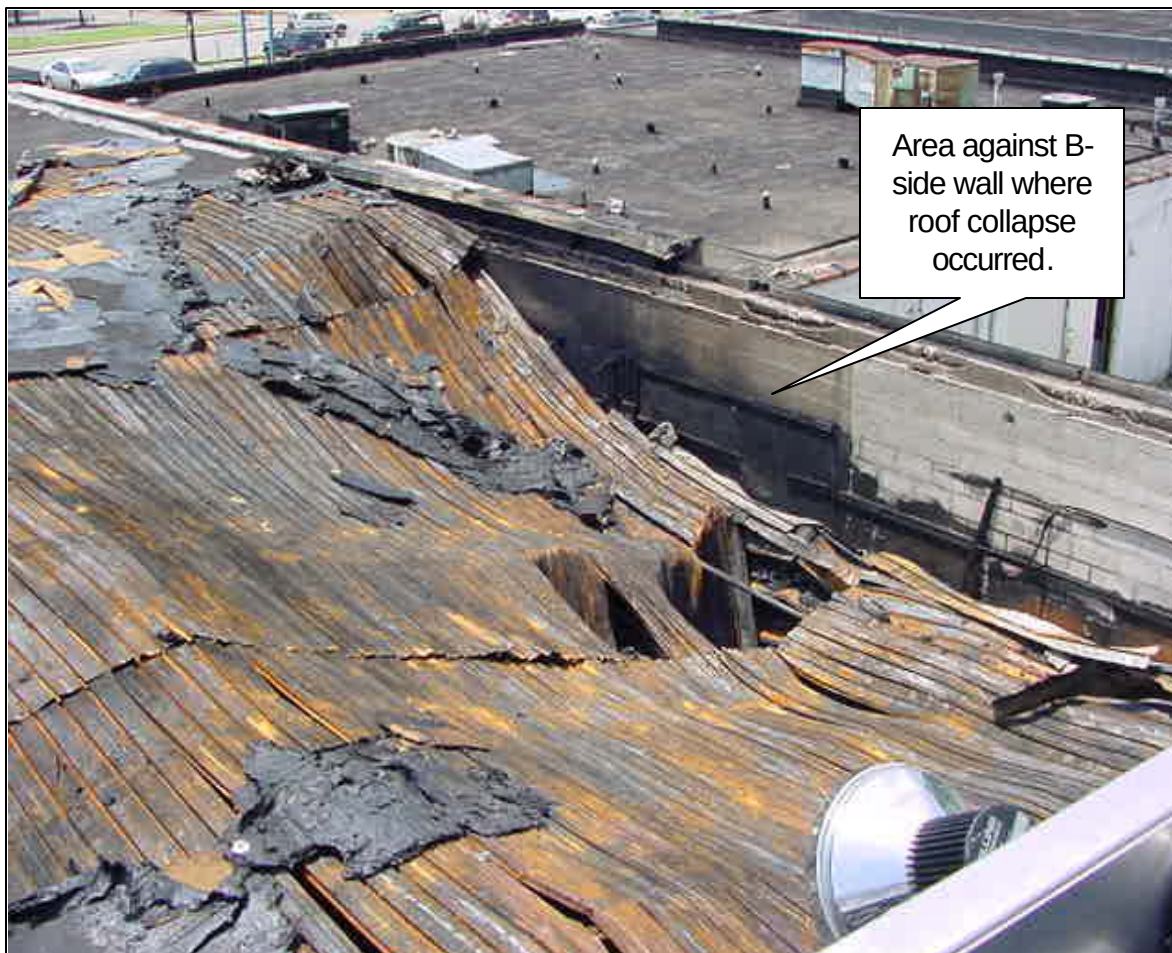
The two fire fighters on the roof from T6 reported a large roof sag at 2014 hours with fire extending through the roof on the B-side. They immediately exited the roof having completed only a partial ventilation hole. Additional attempts were made to rescue Victim #1; however, with conditions worsening it was decided to go to a defensive attack. Command sounded the evacuation horns at 2024 hours.

*Photo 2. Roof collapse B-Side*

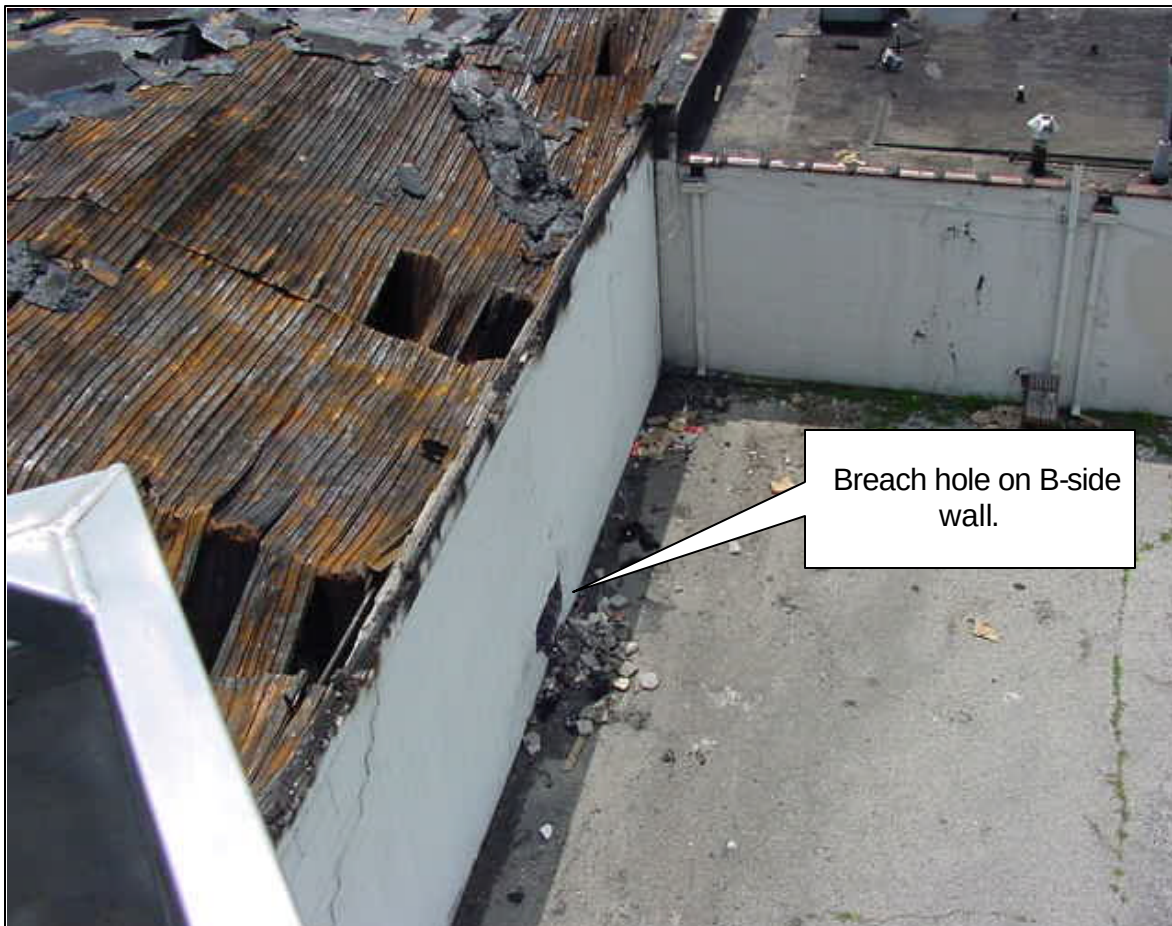
Crew members formed a rescue group and breached a hole in the B-side wall at 2110 hours (Photo 3). Victim #1 was removed and placed in an ambulance at approximately 2126 hours and transported to a local hospital where he was pronounced dead.

*Photo 3. Extrication point B-Side*
