A Summary of a NIOSH fire fighter fatality investigation

Junior Fire Fighter Killed Responding to Call in His Privately Owned Vehicle (POV)–Pennsylvania

Fatality Assessment and Control Evaluation Investigative Report #F2000-35

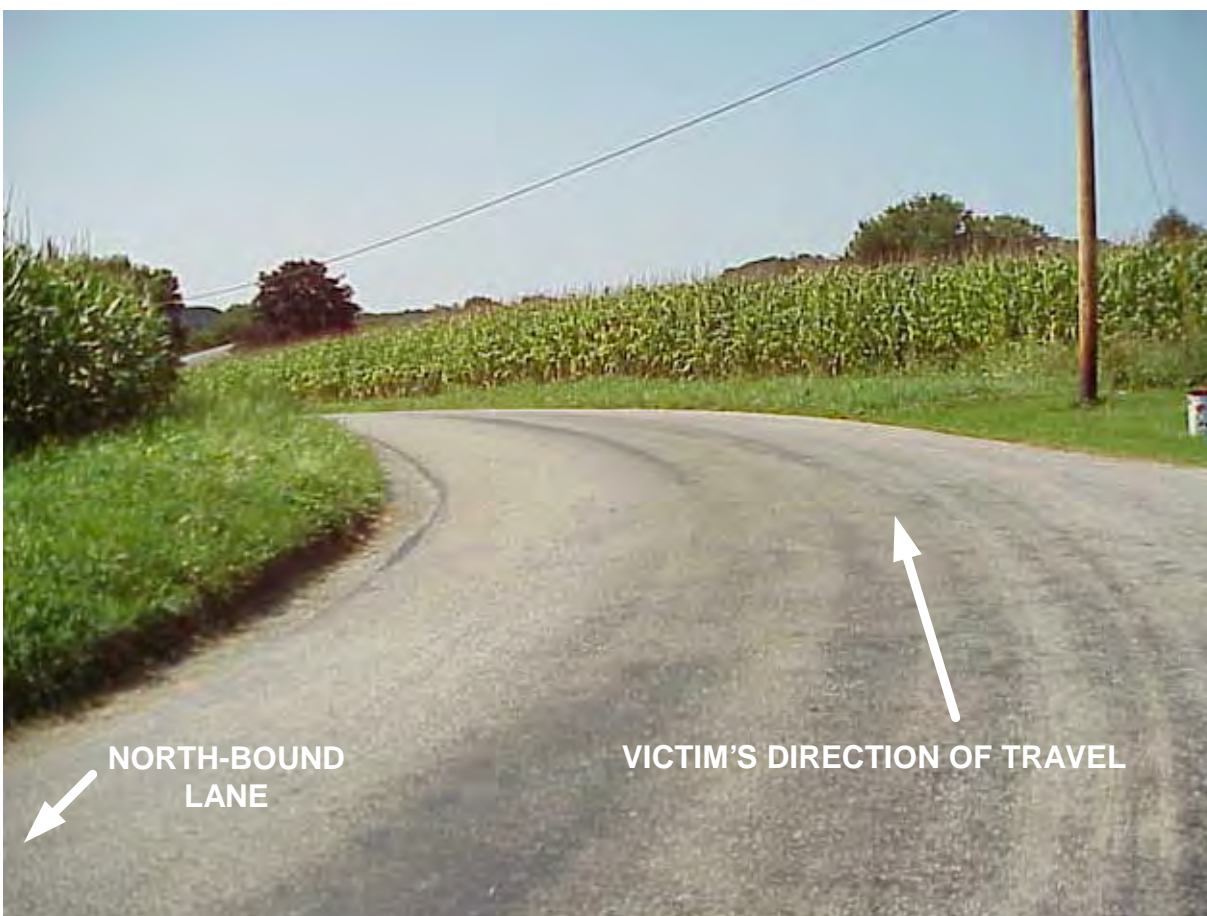
On July 2, 2000, at 1535 hours, the volunteer fire department was notified by Central Dispatch of a structure fire. The junior fire fighter (the victim) was responding to the fire station in his POV. En route to the station the victim was traveling in the southbound (right) lane on an unmarked, two-lane township road, approximately 2 miles from the fire station (see Photo). The posted speed limit was 35 mph with a posted caution speed of 15 mph at the curve. After making the curve the victim's POV (pickup truck) drifted into the northbound (left) lane of the road. *Note: At the time of the incident, next to the northbound lane, there was 3-foot tall standing grass from the edge of the road, and approximately 3 feet from the edge of the road, there was a field which had approximately 4-foot tall standing corn crop. It is believed that this may have prevented the victim from seeing traffic in the northbound (left) lane while making the curve. The state police were*

Photo. View of Curve Traveling Southbound

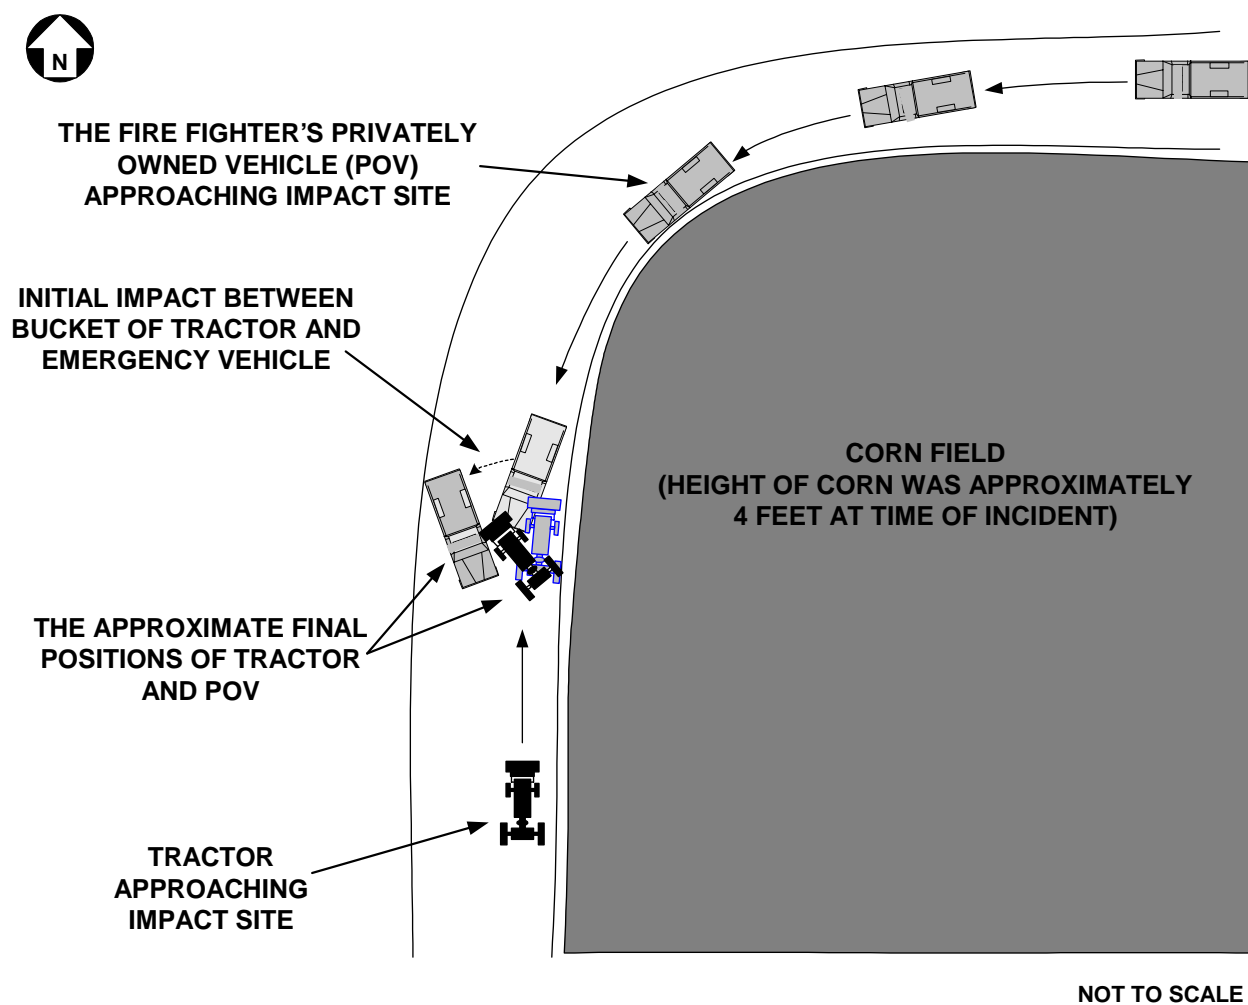
unable to determine an estimated speed of the POV. In the opposite direction traveling northbound was a driver of a farm tractor with an attached front-end loader which was in a raised position. *Note: The state police estimated that the front-end loader at the time of impact was approximately 2-3 feet off the ground.* The victim's POV struck the left side of the front-end loader attached on the farm tractor (see Diagram). The driver of the farm tractor was uninjured and got off the tractor and looked into the POV and saw that the victim was unconscious. The driver went to a nearby residence and made a call for help. At 1535 hours, Engine 34 with a Chief and 3 fire fighters and Rescue 34 with a Lieutenant and 3 fire fighters were dispatched to the structure fire. However, while en route at 1540 they were requested to respond to a motor-vehicle incident with injuries. Also at 1540 hours, Central dispatched the call to Rescue 71, who responded with a Chief, Assistant Chief, a Captain, a Lieutenant, and 3 fire fighters. At 1542 hours, Rescue 113-5 was also dispatched and responded with a Captain, a Lieutenant and 3 fire fighters. Also responding in separate POVs from Rescue 113-5 was a Chief and an Assistant Chief. An ambulance was also dispatched at approximately this time and was first to arrive on the scene. The Chief and Assistant Chief with Rescue 113-5 that responded in their POVs arrived next on scene. Once on scene they observed that an ambulance was already on the scene, and that the front-end loader on the farm tractor was in an elevated position, and on impact with the victim's POV had pushed through the windshield and the "A" post. The force of impact had pushed the driver's side roof, door, and floor area of the truck back toward the bed. They looked into the POV and observed that the victim was unconscious and was bleeding from his nose and was in a fetal position in the cab area with his back against the passenger side door. Ambulance personnel were providing

Diagram. Aerial View of Incident Scene
