A Summary of a NIOSH fire fighter fatality investigation

May 1, 2001

Volunteer Assistant Chief Dies During a Controlled-Burn Training Evolution–Delaware

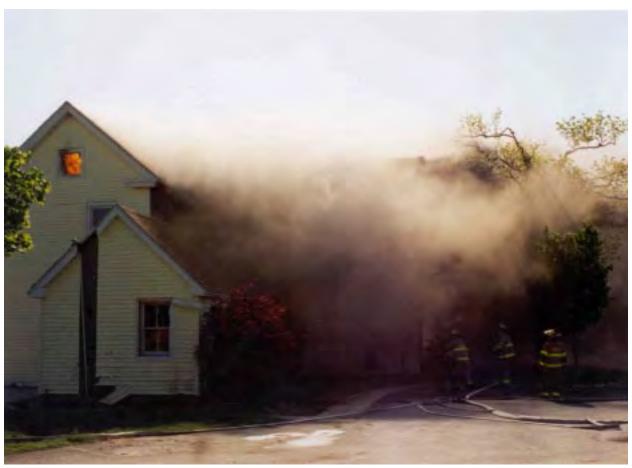
Photo. Structure Involved in This Incident

The structure involved in the incident was a $2\frac{1}{2}$ story farm house with an attic. The structure was built in the late 1800s. The foundation was constructed of masonry block and the structure was ballooned framed using 2- by 4-inch lumber. The roof system was raftered using 2- by 4-inch lumber and covered with ½-inch plywood. The exterior roof was comprised of cedar shake shingles overlapped with two layers of asphalt shingles. Vinyl siding covered the exterior walls and the insulation was fiberglass. The structure was approximately 3,000 square feet including the area of the attic.

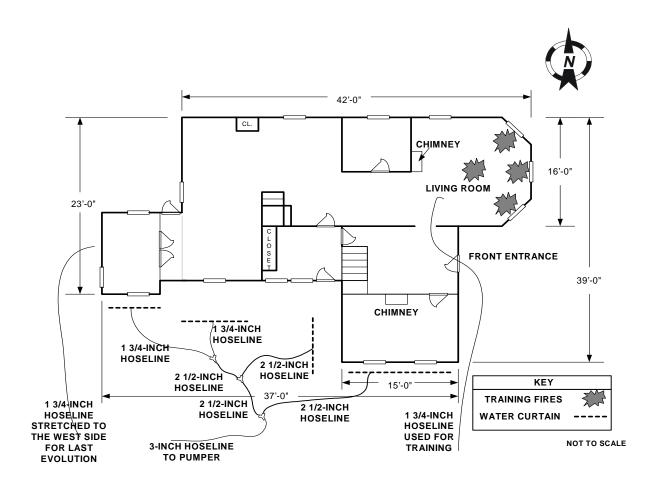
Diagram 1. First Floor Layout

In preparation to start the training evolutions, the fire fighters made the cuts as a part of their Fire Chief, victim, and the Second Rescue testing. The attic space was approximately 1,000 Lieutenant entered the first floor front door and placed hay in the living room, next to the walls (see Diagram 1). The Chief exited the house and briefed the fire fighters who would be performing the training. He told the fire fighters to enter through the front door, search for the fire, and knock it down. The Chief then ordered the victim to exit the structure and wait to reenter with the fire fighters performing the training, to evaluate their performance. The victim was equipped with full turnouts and a new self-contained breathing apparatus (SCBA), which the sales representative provided for him to use. Note: The sales representative had briefed the victim on the SCBA and the victim was familiar with its operation. The victim had also used this SCBA prior to this day. The Second Rescue Lieutenant was ordered by the Chief to start the first fire. Using a 1-gallon sprayer, filled with diesel fuel, the Second Rescue Lieutenant sprayed the hay and used a flare to start the fire. The Second Rescue Lieutenant then exited the structure. The fire fighters and the victim entered the structure in full turnouts and SCBAs. They stretched a 1³/₄-inch hoseline inside the structure, found the fire, and immediately knocked it down, completing the first evolution. Three additional evolutions were completed in the same manner. The evolutions lasted approximately 1 hour and the fire fighters then took a break. After the break, the sales representative provided the department with a new gasoline-powered chain saw to use for training. The fire fighters, including the victim, performed a series of cuts on the exterior of the house. Fire fighters then took the chain saw they were testing, along with one of their own chain saws, inside the house and proceeded to the attic to cut holes in the attic floor. They cut two holes, 2 feet by 2 feet, directly under a window on the west wall and a window under the south wall (see Diagram 3). Note: The

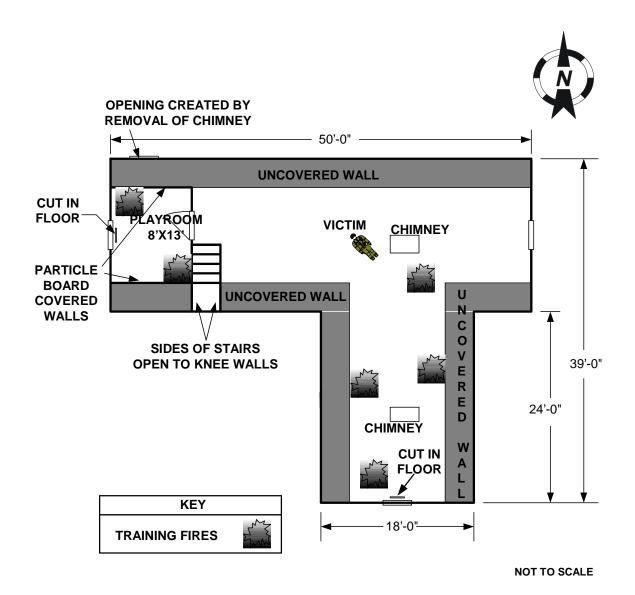
Diagram 3. Attic Layout

the floor (see Diagram 3). The Second Rescue Lieutenant struck a flare and started lighting the areas the victim had sprayed. The victim met with the Third Assistant Chief Engineer in the playroom (near the exit) and told him to strike a flare and ignite the room. Soon after, the Rescue Captain reached the attic floor. He stated that there was a breeze coming through the playroom, which he thought was coming through the playroom window. The Second Rescue Lieutenant confirmed that both windows on the south and west walls in the playroom were open before they started the final burn. The victim returned to the middle of the attic as the Third Assistant Chief Engineer lit various objects (e.g., a small, dried out shrub, a poster hanging on the ½-inch particle board wall, a piece of flex duct, and debris on the floor). The Engineer stated that the room quickly became engulfed in flames and the heat forced him to exit and shut the room's door. The Third Assistant Chief Engineer met back up with the victim and stated that he could see a small fire in the south section of the attic. The Third Assistant Chief Engineer told the victim that the playroom was lit and the fire was intensifying. The two of them remained in the middle of the attic before the Third Assistant Chief Engineer noticed that the smoke was starting to get heavy and the heat was intensifying. The Rescue Captain noticed the same conditions and exited down the stairs to the second floor. At approximately 0930 hours, the Third Assistant Chief Engineer exited the attic and met up with the Chief on the first floor, relating to him that the attic was lit. The Second Rescue Lieutenant finished igniting the south section of the attic and noticed the victim was spraying additional fuel on the small fires in the same section. The Second Rescue Captain stated that the smoke was banking down and there was moderate heat in that area. He told the victim that they should exit and he started toward the
