A Volunteer Fire Fighter Died and a Second Was Seriously Injured After Fuel Tank Explosion - Iowa

Fatality Assessment and Control Evaluation Investigative Report #F2000-25

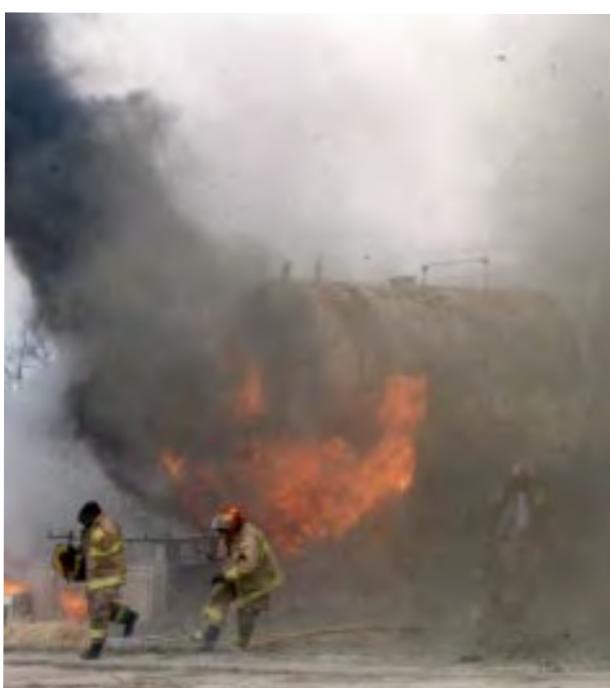
Burning Fuel Tank Immediately After Explosion

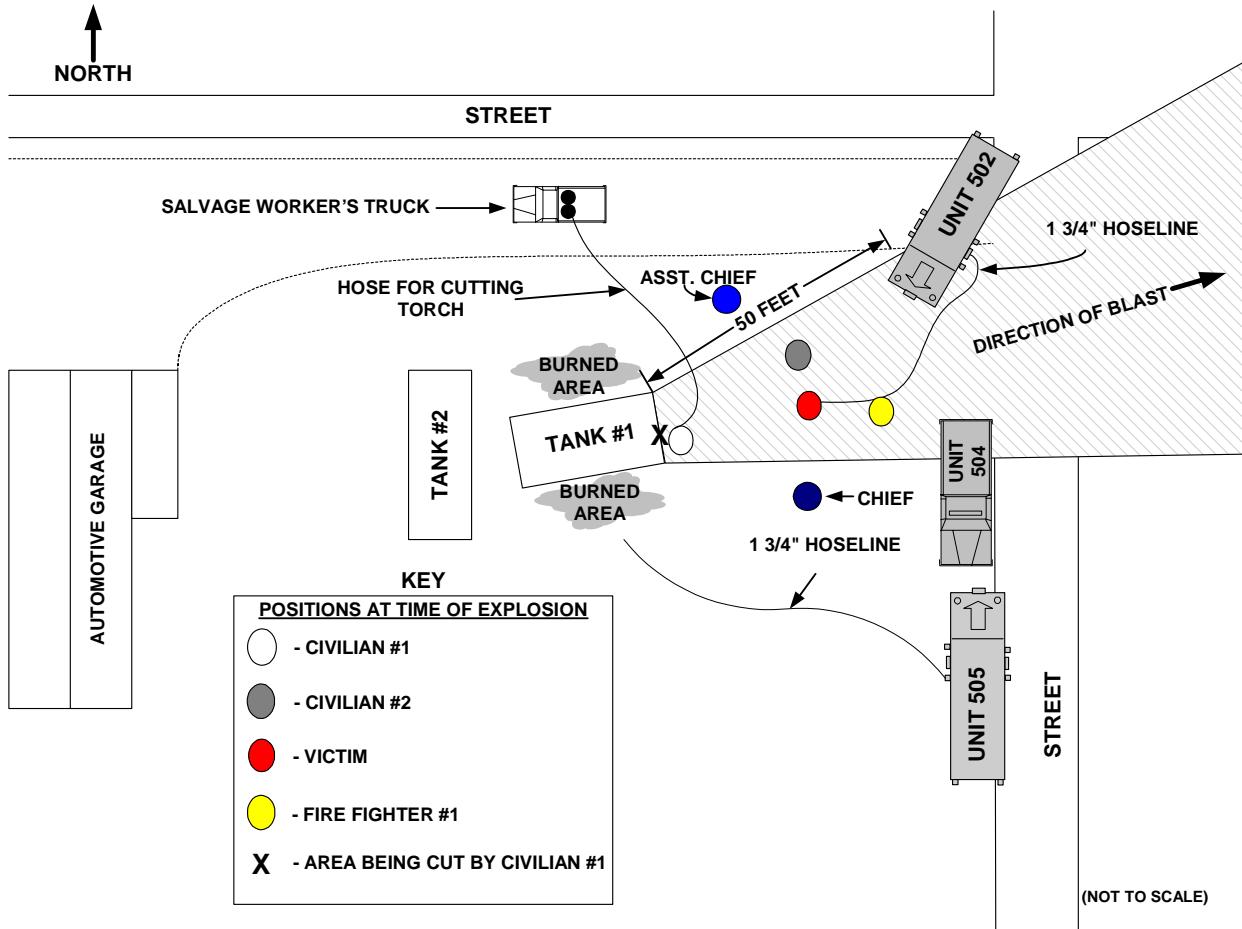
Diagram 1. Aerial View of Incident Site

On April 7, 2000, at 1056 hours, Central Dispatch received a call from the owner of the garage adjacent to the incident site, reporting a grass fire around a large fuel tank. Central Dispatch notified the volunteer fire department at 1056 hours. The units responding at 1056 hours included Unit 504 (Chief and Assistant Chief/driver), Engine 502 (victim, Fire Fighter #1, driver, and another fire fighter), Engine 505 (Captain, driver, and 2 fire fighters), and a police cruiser (1 police officer) to conduct traffic control. Unit 504 was the first to arrive on the scene, at 1059 hours. Unit 504 approached the fireground along the north side of the fireground and positioned the apparatus on the east side of the fireground (see Diagram

1). The Chief sized up the south, east, and north sides of the tank as they arrived on the scene and noticed a grass fire around the fuel tank. The Chief radioed for the other arriving units to pull a handline. The tank was lying on the ground, in an east-west orientation, with the east end of the tank slightly elevated. The grass fire, which consisted of grass and rubbish, was located on the north and south sides of the fuel tank. There was also a small fire, with very little smoke, underneath the east end of the tank (see Photo 1). Engine 502 arrived on the scene following Unit 504, and the driver positioned the apparatus on the northeast corner of the fireground. Engine 505 approached the scene from the south and the driver positioned the apparatus on the southeast corner of the fireground (See Diagram 1). The victim and Fire Fighter #1 pulled a 150-foot, 1 $\frac{3}{4}$ -inch preconnect from Engine 502 and began extinguishing the fire on the north side of the tank. The victim was the nozzle man and Fire Fighter #1 was his backup on the hoseline. The Captain from Engine 505 assisted a fire fighter from Engine 505 in pulling a 150-foot, 1 $\frac{3}{4}$ -inch preconnect from Engine 505. A fire fighter from Engine 502 backed up the fire fighter on the hoseline from Engine 505 and quickly knocked down the fire on the south side of the tank. The Captain, standing on the south side of Tank #1, noticed a civilian (Civilian #1) cutting on Tank #2's support legs with an acetylene torch. The Captain then told Civilian #1 to stop cutting and to move out of the area. *Note: The State Fire Marshal's Office determined that the grass fire was accidental and that the cause of the grass fire was the hot metal fragments produced from the hot work being conducted by Civilian #1 while he was cutting the support legs for Tank #2. The salvage workers had removed the support legs of the 10,000-gallon tank (Tank #1—the tank that exploded) prior to the grass fire. When Tank #1 was pulled to the ground, the drain pipe on the*

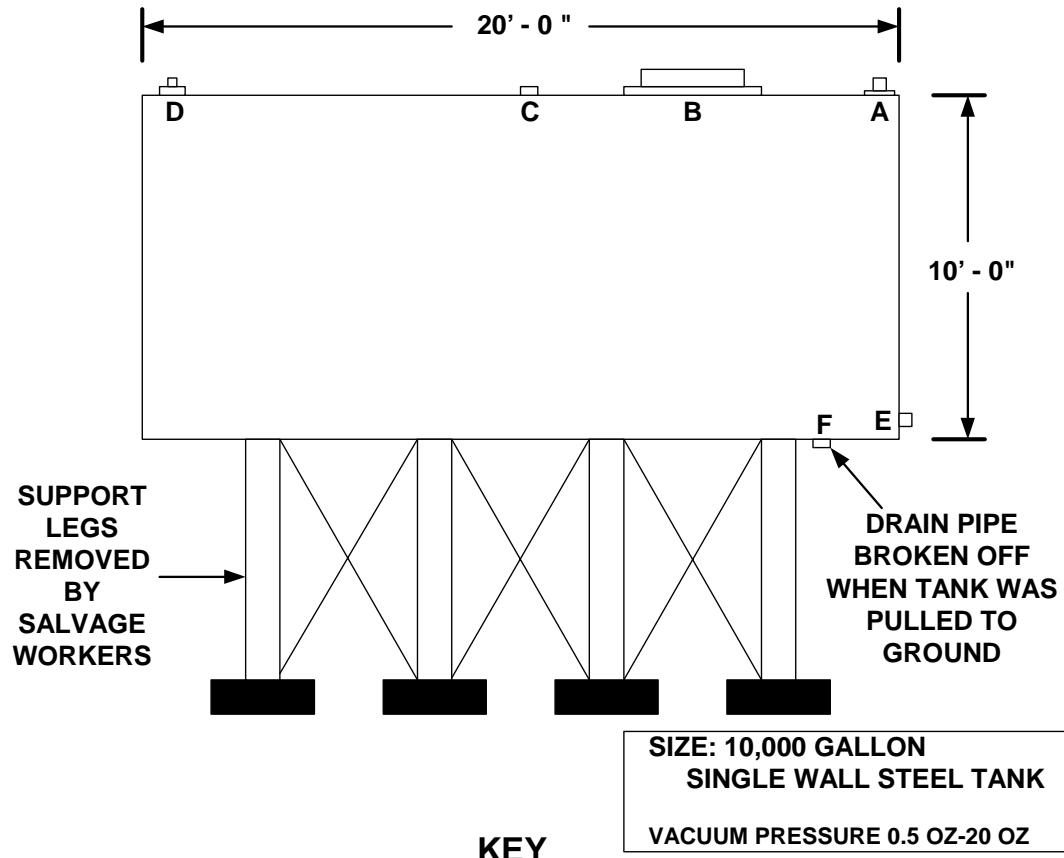
Diagram 2. Profile of Fuel Tank #1

The State Fire Marshal’s office found that Tank #1’s venting capacity consisted of two 3-inch vent openings that had both been sealed by a 2½-inch reduced caps. The 2½-inch reduced caps made the tank vapor tight. The pressure valve installed on Tank #1 was 6 inches in width. Pressure venting for a 10,000-gallon tank (Tank #1) requires valves 8 inches in width. Thus, the vapors were unable to escape the tank and venting did not occur. The emergency pressure valve acting alone did vent, but did not prevent the rupture of the tank due to the flame from the torch coming in contact with trapped vapors.

The civilian salvage workers involved with dismantling the aboveground tanks failed to render the tanks vapor free while they were cutting the supports of the two tanks. When the supports for Tank #1 were cut, the tank was allowed to fall freely onto the ground, which in turn broke off the drain pipe (labeled as F on Diagram 2). This allowed flammable liquid (gasoline and a heavy petroleum distillate [kerosene] were detected in samples taken from Tank #1 by the State Fire Marshal’s Office) to drain from the tank and saturate the grass and debris surrounding the tank. Cutting was continued on and around the storage tank with the hot pieces of metal from the steel frame

Recommendation #5: Ensure that aboveground tanks are in compliance with NFPA 30 2-3.6 “Emergency Relief Venting for Fire Exposure for Aboveground Tanks.”^{6,7}

Discussion: Except as provided in NFPA 30 2-3.6.2, “every aboveground storage tank shall have some form of construction or device that will relieve excessive internal pressure caused by exposure fires.” Under 2-3.6.4, “where entire dependence for emergency relief is placed upon pressure-relieving devices, the total venting capacity of both normal and emergency vents shall be enough to prevent rupture of the shell or heads of a horizontal tank.”

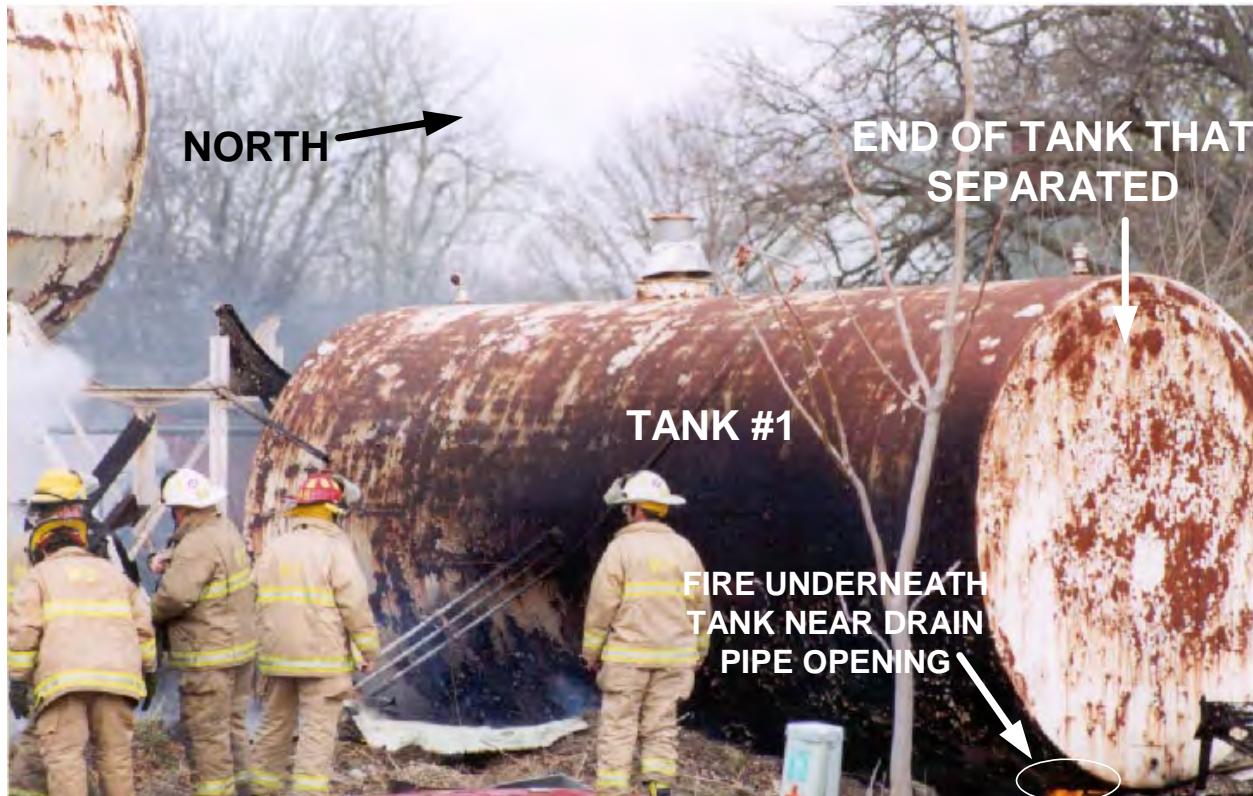
Photo 1. Photo of Tank #1 Prior to Explosion

Fire fighters arriving at the scene stated that there were no placards or warning signs on or near the tank. Photos of the tank at the scene of the incident did not reveal any information contrary to the fire fighters' reports that there were no placards or warning signs.

the fire hazards of the tank and its contents to the general public. The area in which the tank is located should be protected by fencing or some form of barricade to deter tampering or trespassing. The State Fire Marshal’s Office found that the tank was not properly labeled. The tanks were not secured or protected from tampering or trespassing. No placards or signs were visible in photographs taken of Tank #1 and Tank #2 at the incident scene.

Recommendation #6: Ensure that unsupervised, isolated aboveground tanks are secured and marked in such a manner as to identify the fire hazards of the tank and its contents to the general public.⁷

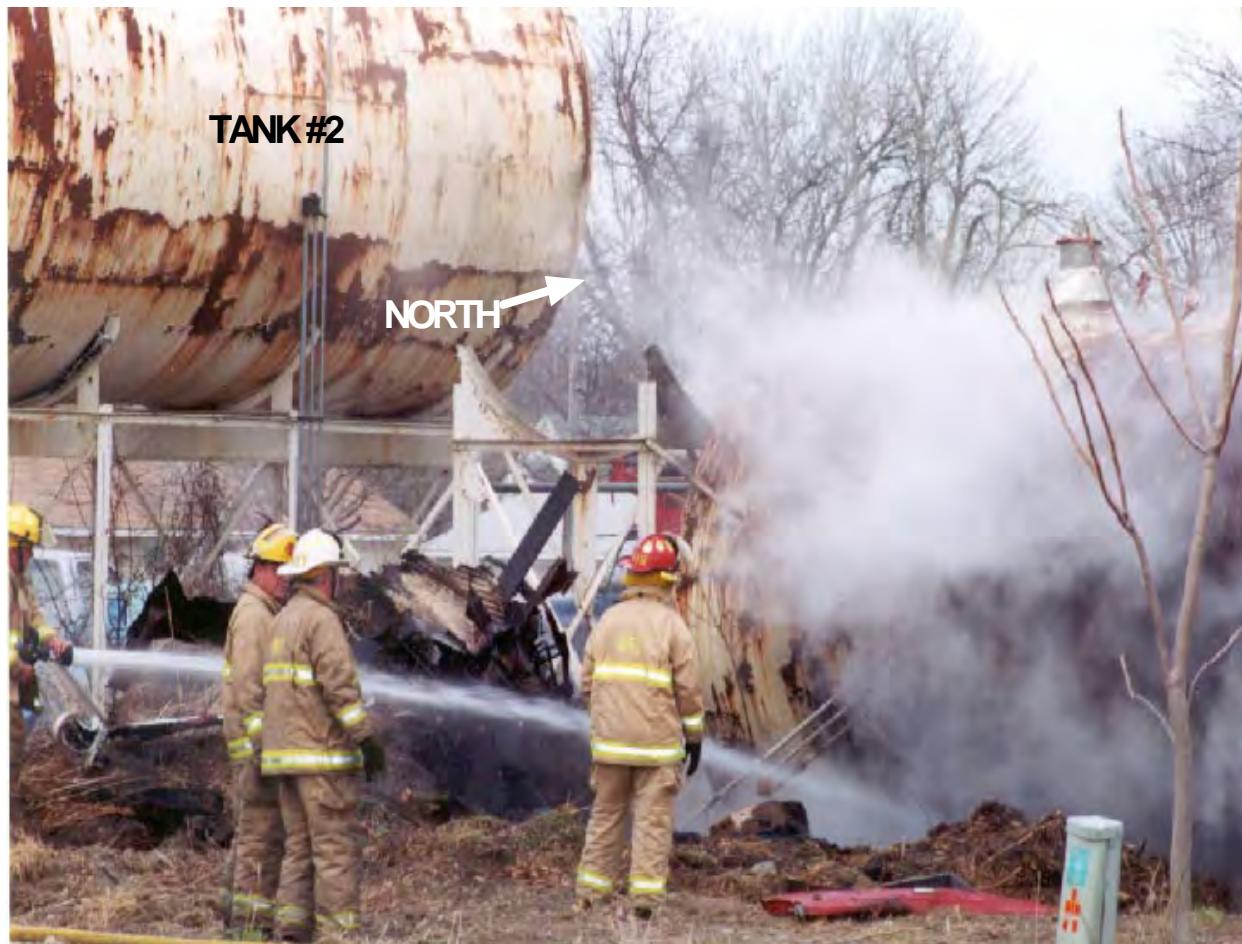
***Photo 2. Fire Fighters on the South Side of Tank #1, Prior to the
Explosion, Applying Water to Tank's Surface to Cool It Down***

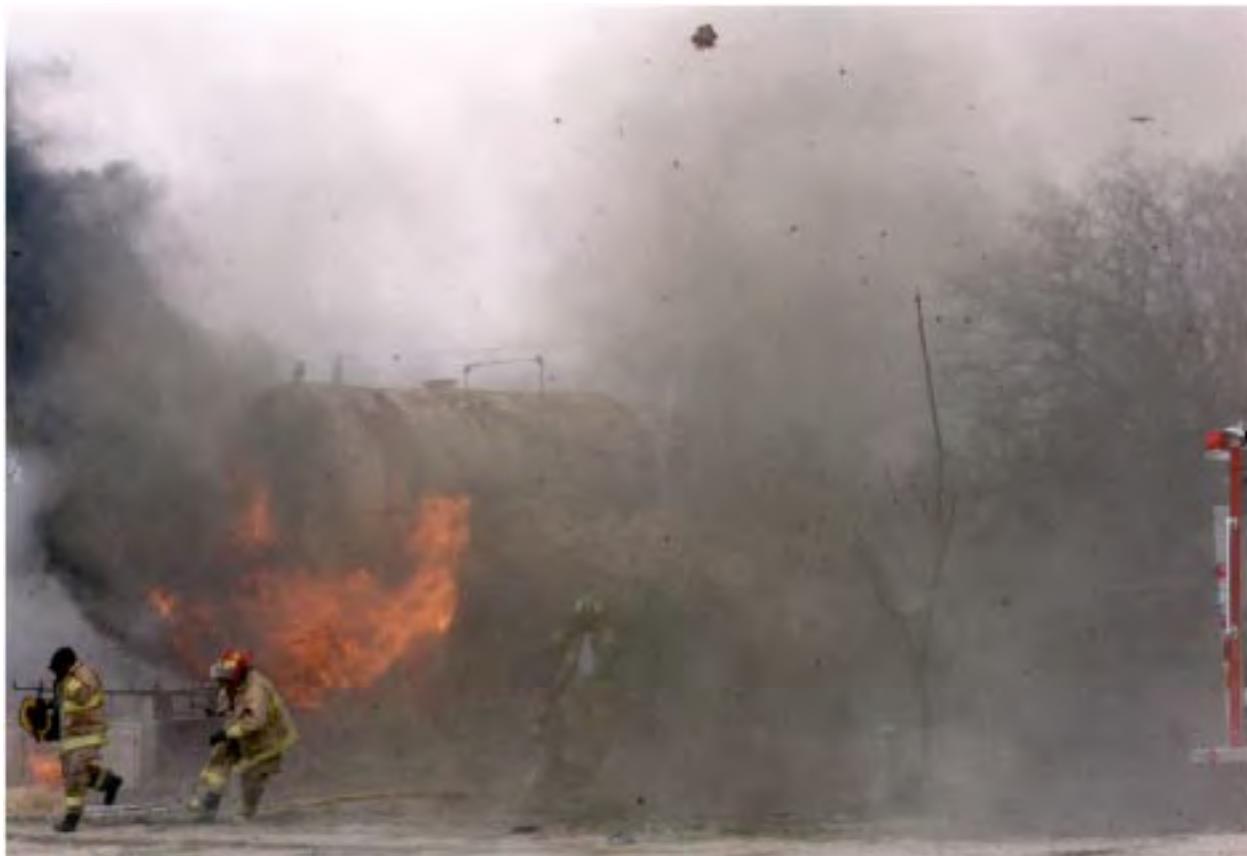
Photo 3. Burning Fuel Tank Immediately After Explosion

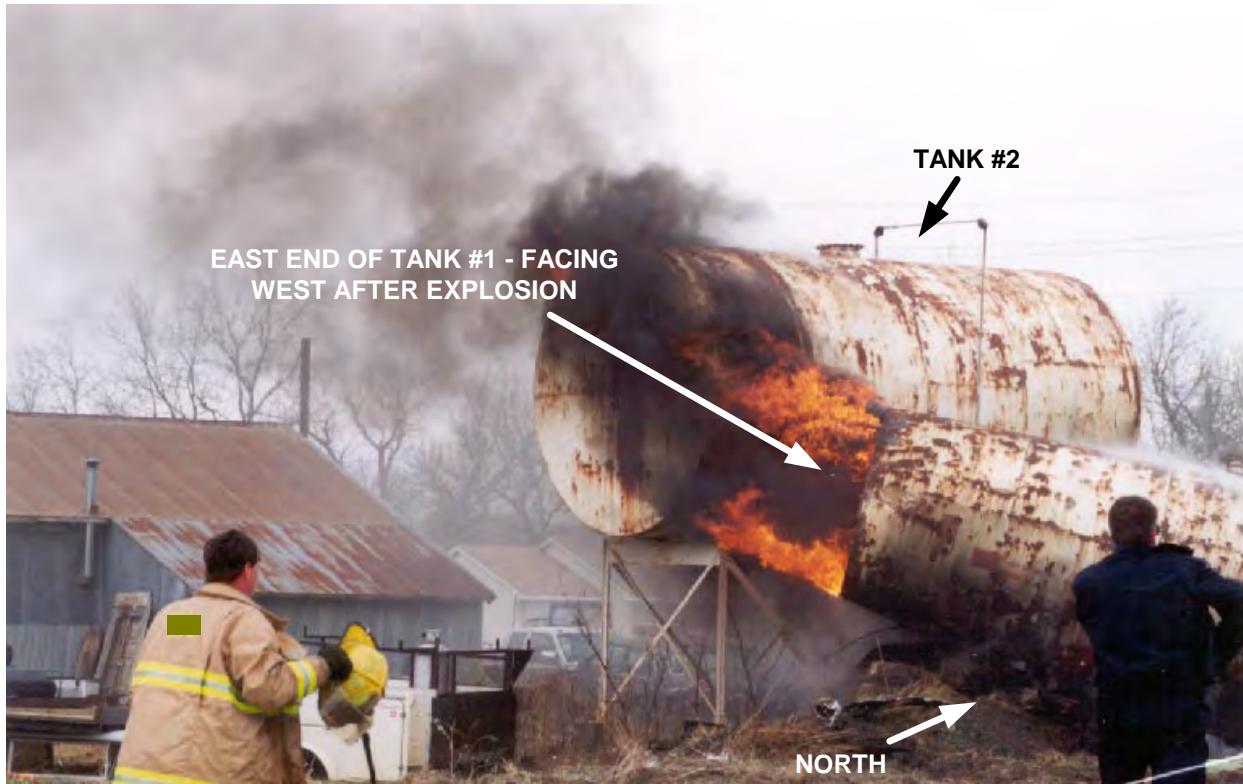
Photo 4. Incident Site Immediately After Explosion Occurred.

Note: Tank #1 turned 180 degrees on its axis.
