## **Downed Power Line Claims the Life of One Volunteer Fire Fighter and Critically Injures Two Fellow Fire Fighters - Missouri**

## Fatality Assessment and Control Evaluation Investigative Report #99F-37

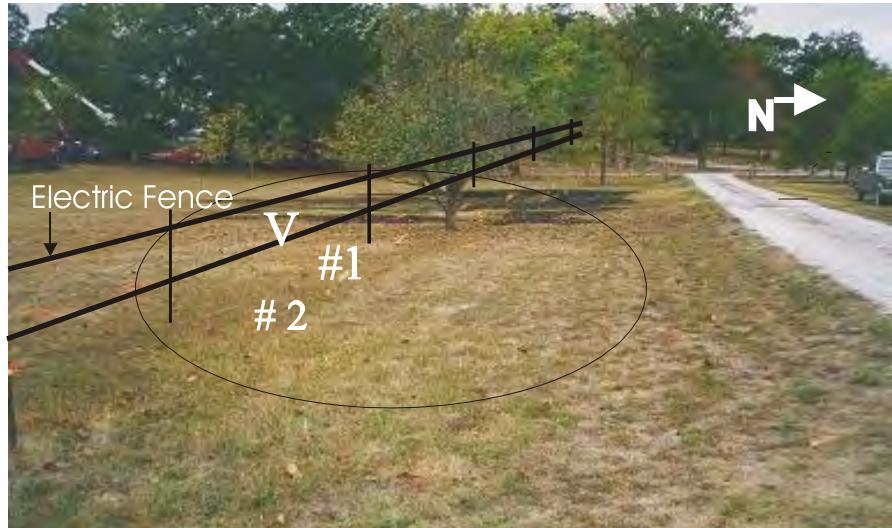
***Figure 1. Secondary Fire Site: Location of Victim (V) and Two Injured Fire Fighters (#1 and #2) in Relation to Electric Fence***

**Recommendation #2: Fire departments should ensure that fire fighters stay away from downed power lines a distance equal to at least one span between poles until the power line is de-energized.<sup>2</sup>**

Discussion: As stated in *Fundamentals of Wildland Fire Fighting*, when downed power lines come in contact with the ground, current flows outward in all directions from the point of contact (ground gradient), and the energized area can extend several feet from the point of contact. Therefore, walking in proximity to the energized area could electrocute fire fighters. To avoid this hazard, fire fighters should keep ample distance away from the downed power line (equal to at least one span between poles) until the power line is de-energized. If the fire has not burned past the distance equal to one span between poles, fire departments should delay their attack until the fire has burned past this recommended span.

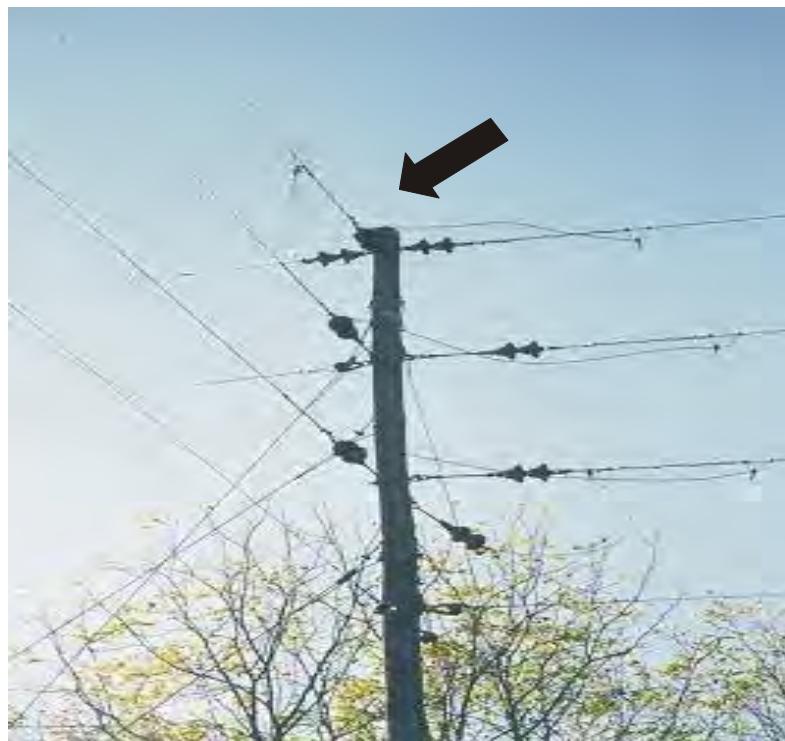
On October 4, 1999, at 0658 hours, a property owner notified Central Dispatch of a grass fire. The fire was started when one phase of a 3-phase, 7200-volt, overhead power line separated from the connection on a utility pole (Figure 2) and fell to the ground, igniting the surrounding grass area (Figure 1). When the power line fell, it crossed the road and a grassy field and came to rest on an electric fence, which it energized. At 0700 hours, Central Dispatch notified the fire department of a grass fire with a downed energized power line. At 0704 hours, the Chief was first to arrive on scene in his privately owned vehicle (POV) and parked approximately 20 feet from the end of the downed power line to alert arriving units of its location (Figure 3). The Chief conducted a scene size-up, and he reported a grass fire with a slow rate of spread and light fuel. He confirmed to the arriving units that a power line was down, and he indicated that the electric fence was energized due to the downed power line. (Note: This was an electric fence used to control live stock. However, the fence was not operable at this time.) He then radioed Central Dispatch and asked the power company to de-energize the line. Engine 1, which has a 1,000-gallon tank, arrived at 0706 hours with two fire fighters (the driver and Injured #1). The Chief directed the driver to pull the Engine into a driveway on the north flank of the fire (Figure 1). Truck 3 (brush/wildland truck with a 250-gallon tank), with a fire fighter/driver, arrived at 0707 hours and was directed by the Chief to a position on the south flank of the fire. Immediately after Truck 3's arrival, two fire fighters (the victim and Injured #2) arrived in their POVs, pulled into the driveway on the

***Figure 2. Point of Separation Between the Power Line and Connector***
