Journeyman Ironworker Dies Following a 22.5-foot Fall From a Walkway in Maryland

FACE 9118

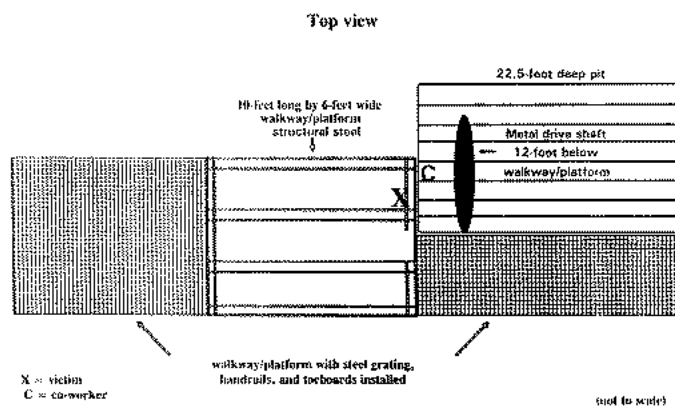
Figure. Walkway/platform

On the day of the incident, the victim and a co-worker had been assigned to continue their work installing additional sections of the walkway platform. The walkway platform section being worked on was approximately 6-feet wide by 10-feet long. Supports for the section were being welded by the victim, while the co-worker was welding brackets in a pit below the walkway platform. The victim was positioned on the structural steel supports next to a pit about 22.5 feet deep, while the co-worker welded brackets in the pit area about 8 feet below him (Figure). Although both workers were wearing safety belts and lanyards, neither worker was tied off.

While the fall was unwitnessed, the co-worker stated he was welding when something hit his welding hood, and as he looked around, he saw the victim falling. The victim fell about 12 feet and struck, face first, a metal drive shaft in the pit. The victim’s body then landed on the concrete floor of the pit about 22.5 feet below the walkway platform.

Recommendation #1: Employers should comply with existing OSHA regulations regarding fall protection for workers.

Discussion: 29 CFR 1926.28(a) states, “The employer is responsible for requiring the wearing of appropriate personal protective equipment in all operations where there is an exposure to hazardous conditions or where this part indicates the need for using such equipment to reduce the hazards to the employees.” Both workers were wearing safety belts and lanyards. However, neither worker was tied-off to a secure point, and no lifeline was present to use as a tie-off point.
