The National Institute for Occupational Safety and Health (NIOSH)

# Carpenter Dies After Falling From The Roof of a Carport Addition That Collapsed While Under Construction in South Carolina

FACE 9126

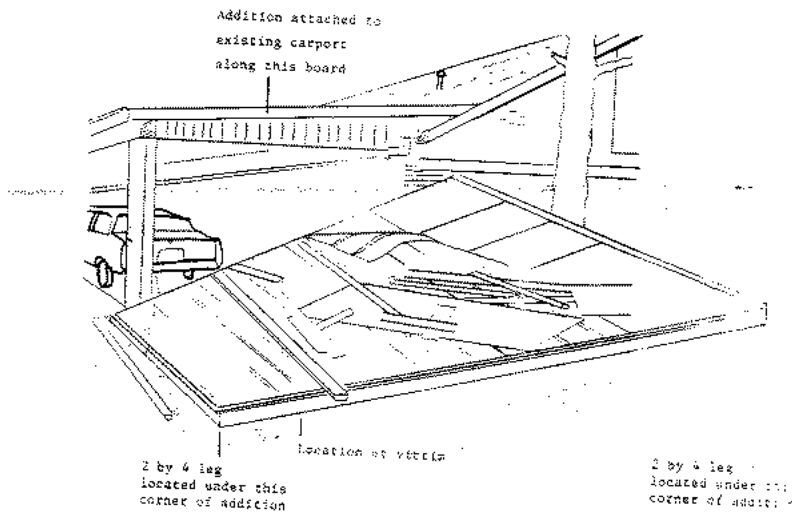
Figure.

On the day of the incident the workers were nailing roof felt to the top of the sheathing. The victim was standing on the lower corner of the addition roof farthest from the existing car port. Without warning, the 2 by 4 legs failed, causing the addition to collapse and pull away from the carport (Figure). The victim fell backward 8 feet off the roof and struck his head on the ground, breaking his neck. A telephone call to the emergency medical service (EMS) was made from the business. Upon arrival, EMS personnel initiated cardiopulmonary resuscitation (CPR) and transported the victim to the hospital where he was pronounced dead by the attending physician. None of the other three co-workers required medical attention.

**Discussion:** Prior to the start of work on an elevated work surface, employers should ensure that the surface is adequately supported. The work surface should have support sufficient to withstand the stationary and moving weights to which the overhead surfaces will be subjected. In this instance, the 2 by 4 legs and the two nailed sides were inadequate. The 6-inch-

square beams that were to be used as final supports were at the site and should have been installed around the perimeter of the addition before workers climbed onto the roof of the addition.

**Recommendation #2:** Employers should ensure that elevated work surfaces are adequately supported before workers climb onto, and work from, those surfaces.
