# Ironworker Dies in Ohio Following a 20-foot Fall Through a Skylight Opening

FACE 9111

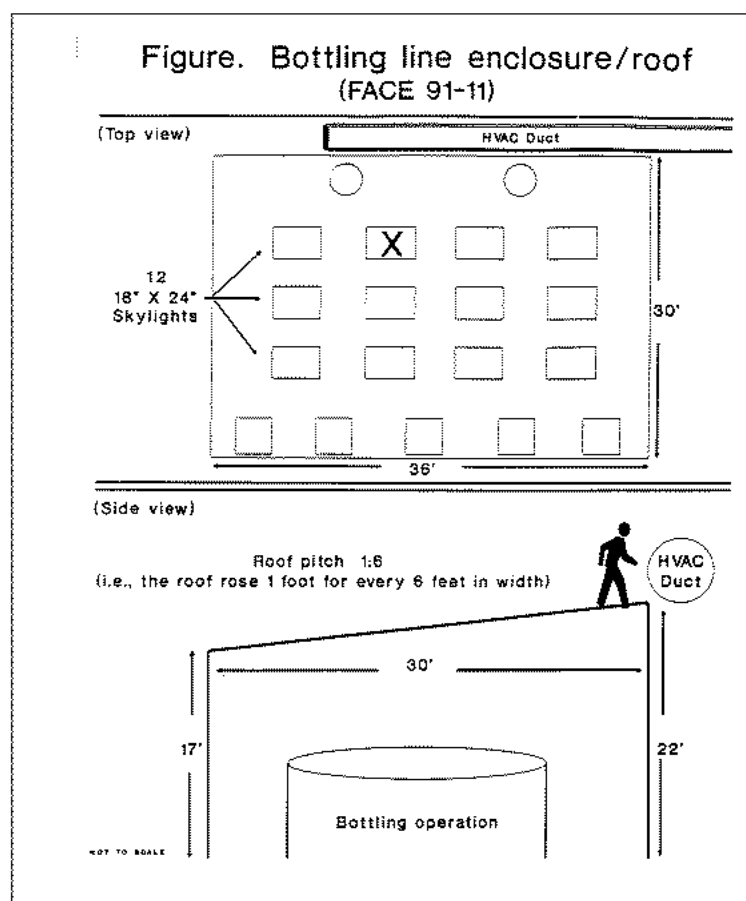
Figure.

A metal fabrication and erection contractor had been selected as a subcontractor to supply and erect an enclosure around a bottling operation located inside an existing building. At the time of the incident, the enclosure's steel skeleton and roof had been constructed. The roof frame was constructed with 3-inch angle steel, with 3-foot by 8-foot sheets of 14-gauge stainless steel welded to the frame. The roof area was 36 feet long, by 30 feet wide and contained twelve 18-inch by 24-inch skylight openings. The roof had a 1:6 pitch (i.e., the roof rose 1 foot for every 6 feet in width; see [Figure](#)).

Although no one saw the victim fall, evidence at the site suggests that the victim was in the process of covering the ductwork with a fire blanket and either tripped on the angle iron and fell into, or stepped backwards into, a skylight opening. The victim apparently fell 20 feet and landed on the concrete floor, striking the back of his head.

Discussion: The surface of the roof, 30 feet by 36 feet, contained twelve 18-inch by 24-inch skylight openings. Employers should ensure that all skylight openings be secured with a fixed standard railing on all exposed sides, or a cover which would support a worker's weight, and which would not be subject to displacement.

**Recommendation #1: Employers should implement 29 CFR 1926.500 (b)(4) and 1926.500 (f)(6), which require that skylight openings be guarded by a fixed standard railing on all exposed sides, or a cover capable of supporting the maximum intended load, and so installed as to prevent accidental displacement.<sup>1</sup>**
