The National Institute for Occupational Safety and Health (NIOSH)

Millwright Foreman Dies in South Carolina Following a 41-foot Fall Through a Platform Opening

FACE 9115

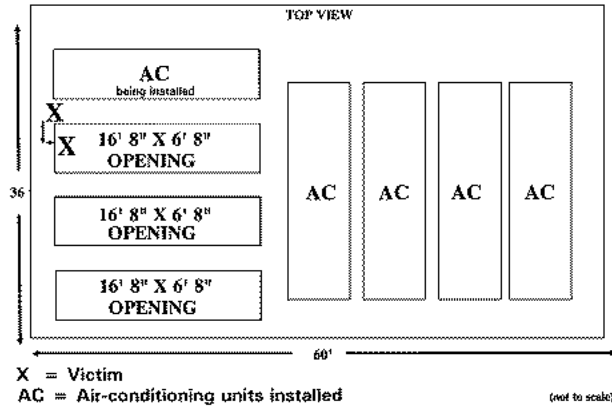
**Figure. Open-sided steel structure platform.
(FACE 91-15)**

The company had been sub-contracted to erect an open-sided steel structure and platform, about 40 feet high, and to install eight air-conditioning units on top of the flat platform. The steel structure and platform had been completed and four air-conditioning units had been installed at the time of the incident. The steel-grating platform was 36 feet wide by 60 feet long with eight openings, which were each approximately 17 feet long by 7 feet wide. Air conditioning units were installed in four of the openings, and installation of the fifth air conditioner was in process (see [Figure](#)).

At the time of the incident, the crew was working on all four sides of the air conditioner, positioning shims under the unit to level it. The foreman was kneeling on the steel grating between the air conditioner and an adjacent opening. When he tried to stand up, he apparently tripped or stumbled, and fell backwards, onto the steel grating of the platform walkway. Momentum from the fall caused the victim to roll into the opening. The victim fell through the opening, struck a steel crossbeam about 20 feet below, and fell an additional 21 feet to the ground.

Discussion: The floor surface of the platform, 36 feet by 60 feet, contained eight 16-foot 8-inch long by 6-foot 8-inch wide openings. Employers should ensure that all platform openings be secured with a fixed standard railing and toeboards on all exposed sides, or a cover which would support a worker's weight, and which would not be subject to displacement.

Recommendation #1: Employers should implement 29 CFR 1926.500 (b)(1) and 1926.500 (f)(5)(ii), which require that wherever there is danger of falling through a floor opening, it shall be guarded by a standard railing and toeboards on all exposed sides, or a cover capable of supporting the maximum intended load and so installed as to prevent accidental displacement. (1)
