Maintenance Technician Drowns After Falling From a Turbine Support-Ring Platform at a Hydroelectric Power Generation Facility in South Carolina

FACE 9116

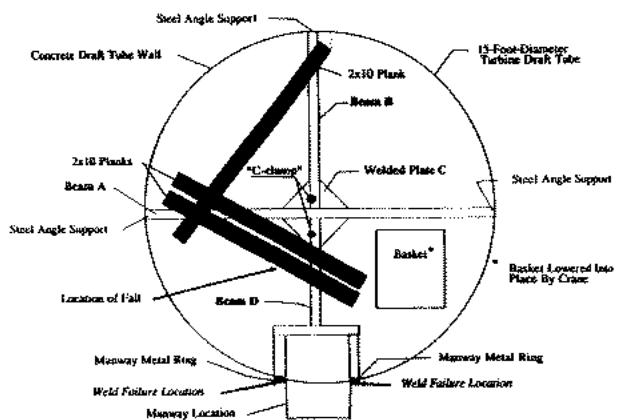
Figure - Plane View of the Hydroelectric Draft Tube

To install the support ring for the turbine, three steel angle supports were anchored into the concrete draft tube wall (Figure). A manway prohibited the installation of a fourth anchor. The beams were positioned at the supports and welded in place at the wall of the draft tube. A "C-clamp" was used to hold beams B & D (at the center of the draft tube) to a welded plate C. Beam D was configured as a "goal post" to enable welding on both sides of the manway. The technicians noticed that the metal around the manway was different than that of the steel being welded to it. Later, the metal was identified by a company technician as "gray" cast iron—"pot" metal—that had been in place since 1916. It was also discovered that the surface had not been properly prepared for welding.
