Lineman Electrocuted After Contacting 7600-volt Powerline During Attempt To Restore Electrical Power in Tennessee

FACE 91-10

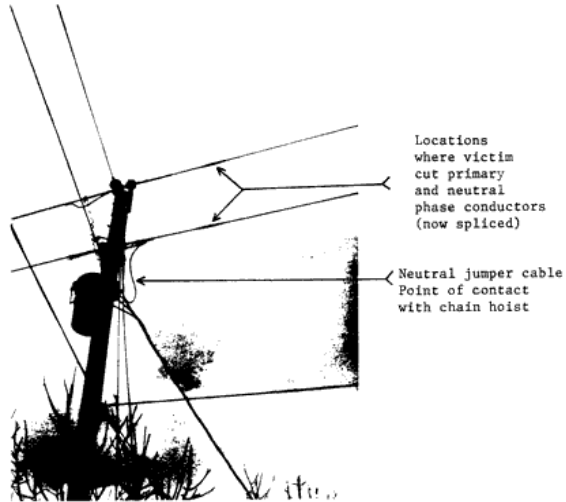
Figure 1.

3. The victim apparently did not attempt to ground the line. Instead, he began to work on a powerline which remained energized.
4. The victim first cut the neutral and primary conductors about 3 feet away from the utility pole (Figure 1). This caused the supply end of both conductors to dangle at the side of the utility pole.

5. With his **left hand**, the victim picked up the cable grip end of the come-along chain hoist, and reached up with it toward the dangling primary conductor.

6. The victim grabbed the dangling end of the primary conductor with his **right hand**. Presumably, he was attempting to attach the come-along grip to the supply end of the primary conductor in order to remove the slack for splicing the conductor later.

7. While the victim held the primary conductor in his right hand and the chain hoist in his left hand, the dangling end of the chain hoist apparently contacted the neutral jumper cable (attached to the dangling neutral conductor). The victim thus provided the electric current with a “path to ground” through his chest, and he was electrocuted.

Recommendation #1: Employers should ensure that linemen follow established safe work procedures to de-energize, ground, and verify through testing prior to beginning maintenance and repair operations on powerlines.
