Sheet Metal Worker Dies After Falling 35 Feet to a Concrete Floor

FACE 9107

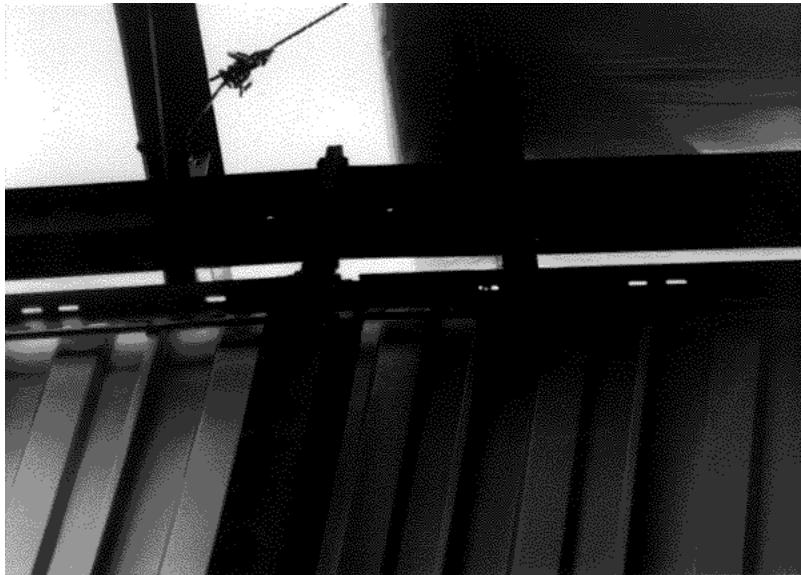
Figure.

The company had been contracted to construct a 74,000-square-foot mineral processing plant. Company employees had been working at the site for 7 months. On the day of the incident, the victim and a co-worker were attaching 10-foot-long sections of rake angle iron to the outer roof edge of the structure. The rake angle iron sets the wall line at the top of the structure and provides anchor points for the structure's exterior siding panels. The rake angle iron was being attached to the outer side of 5-inch-wide I-beams. The I-beams were attached to the top of 35-foot-high, 8-inch steel "H"-shaped support columns ([Figure](#)). The bolts attaching the I-beams to the support columns protruded 2 inches above the top of the beam.

The victim was walking along the 5-inch I-beam flange carrying a piece of angle iron. A co-worker was walking behind him. Both men were wearing safety belts with lanyards, but neither man was tied off to a lifeline. No lifelines or catenary lines were present on the roof. The men would tie off to the 4-inch steel purlins (ceiling joists) only when sitting and making connections. The co-worker saw the victim suddenly lose his balance and fall to the concrete floor below, landing on his face.

The co-worker stated that the victim had been in an area where bolts were protruding through the I-beam, when he lost his balance. The co-worker was not certain whether the victim tripped over the bolts or lost his balance for some other reason.
