Construction laborer Dies After Falling 61 Feet From Work Platform in Virginia

FACE 9106

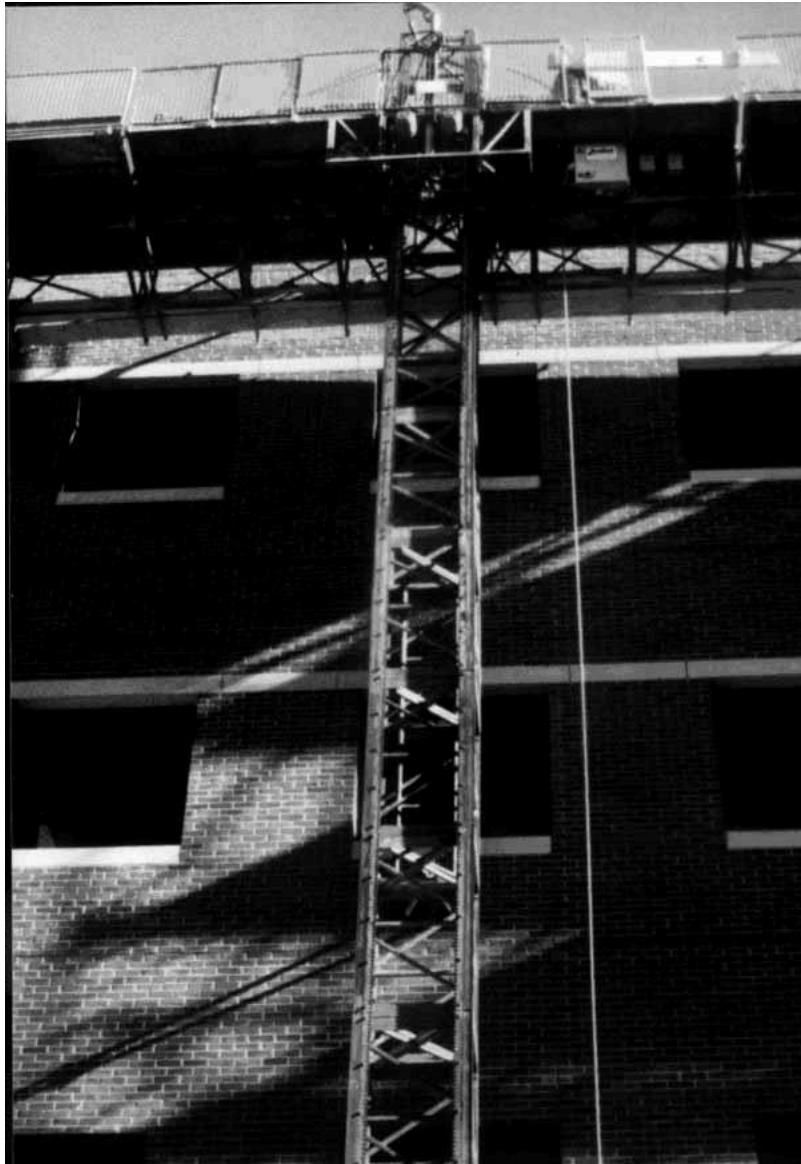
Figure 1.

The brick work was done from an electric-powered, mast-climbing work platform (Figure). The platform was supported by a steel-frame mast secured to the building with cross members. The base of the mast was supported on an I-beam frame trailer (26 feet by 5 feet) with outriggers. The center of the main platform rode up and down the mast on a rack and pinion carriage, and was powered by two, 4-horsepower electric gear motors. The platform was operated with a remote pendant controller located on the platform.

The work surface of the steel-frame platform measured 7 feet wide by 50 feet long. It consisted of a plywood-surfaced main platform for holding materials (bricks, mortar, etc.), 5.5 feet wide by 50 feet long, and a wood-planked walkway platform ("foot boards") 20 inches wide by 50 feet long where workers stood to lay the brick. The walkway was positioned 18 inches below the surface of the main platform and extended along the working face of the building at about 4 inches clearance. The outboard side and ends of the entire work platform were surrounded by a 42-inch-high steel frame/wire mesh guardrail and fence. Under normal working conditions, a guardrail is not installed on the walkway side of the platform.

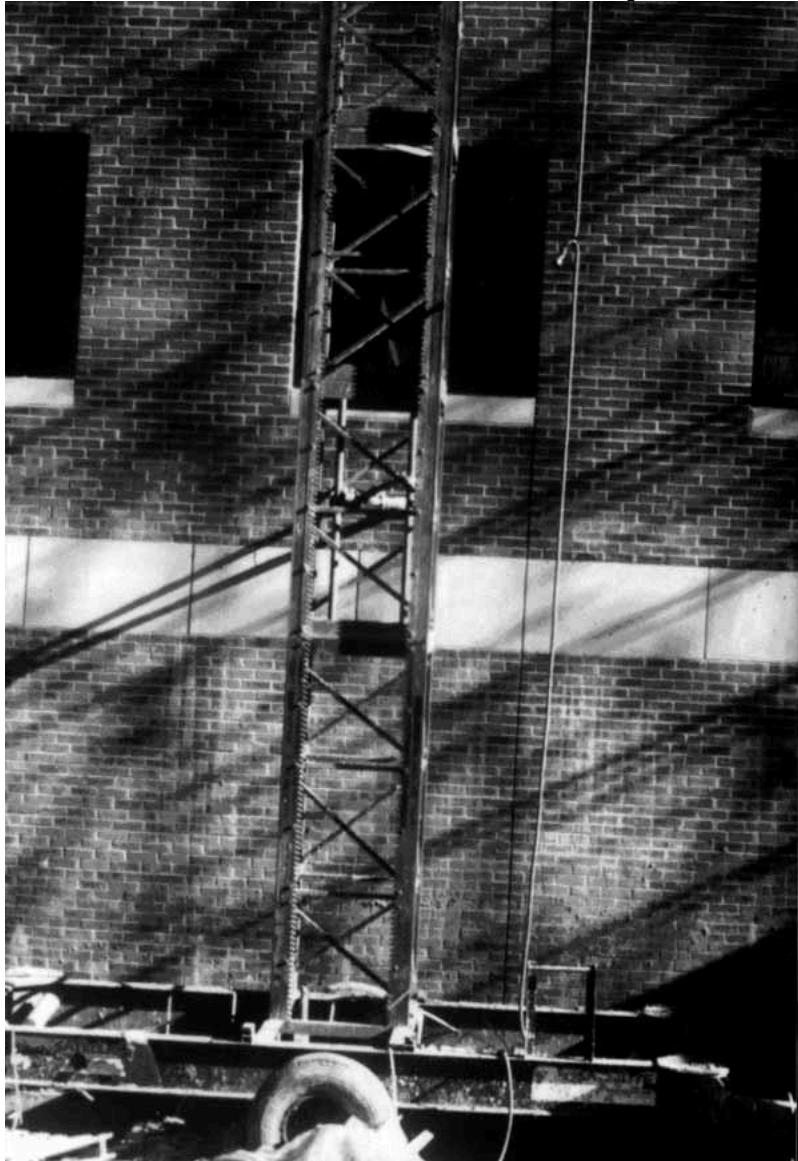
Figure 2.

As the platform descended, the victim attempted to enter the building through a window opening (measuring 4 feet wide by 5 feet high) on the fourth floor (Figure). When the platform walkway cleared the top of a window opening, the victim sat down (facing the building) on the walkway edge and began to step onto the window sill frame. When he did this, the walkway was still about three feet above the sill. At this moment, the co-worker yelled to the victim, "Wait a minute ... Wait a minute." The victim responded, "That's okay Buddy, no problem."

The victim supported himself with his elbows on the walkway foot boards. As he placed his feet on the sill and pushed off with his elbows, he slipped, falling forward. The victim struck his chin on the window sill, fell 61 feet, struck a horizontal I-beam on the trailer base, and landed 18 inches below the I-beam on the ground in the center of the trailer base.

Workers on this type of work platform (or scaffolding) at positions in front of open areas (e.g., windows, cantilevered sections, etc.), are exposed to a fall hazard. Fall protection consisting of a guardrail or other appropriate fall protection equipment (e.g., safety belt and lifeline) should be provided in accordance with OSHA Standard 29 CFR 1926.451(a)(4), and ANSI Standard A.92.6-90, Self-Propelled Elevating Work Platforms.
