Tree Trimming Groundsman Electrocuted after Contacting an Energized Aerial Bucket Truck in South Carolina

FACE 91-03

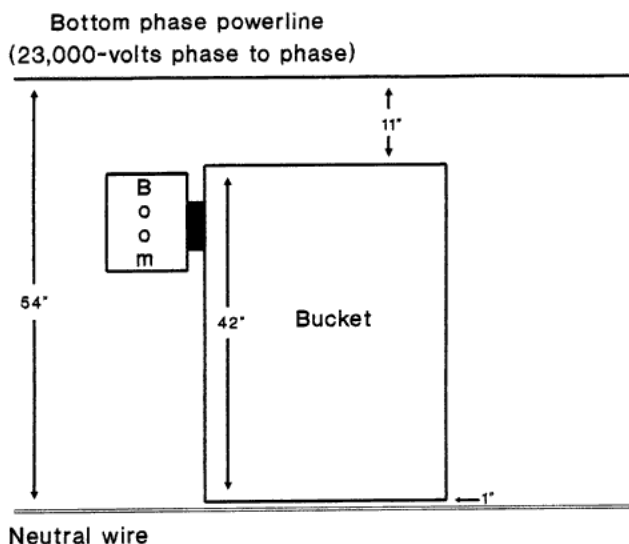
Figure 1. Boom/bucket Clearance Between Powerline and Neutral Wire

¹ The distance between the neutral wire and powerline was approximately 54 inches, and the height of the boom/bucket was 42 inches. This condition, assuming that the bottom of the bucket was at least 1 inch above the neutral wire, allowed for only an 11 inch clearance between the top of the occupied boom/bucket and the 23,000-volt powerline ([Figure 1](#)).

Discussion: Employers should review and revise, where applicable, written safety rules and procedures that address working in close proximity to energized overhead powerlines. In this instance, alternative work procedures to positioning the boom/bucket between energized powerlines and the lower neutral wire included instructing the tree trimmer/bucket operator to either: a) climb the tree without the use of the boom/bucket truck, or b) position the boom/bucket beneath the neutral wire thereby maintaining the minimum working distance from the energized powerline.

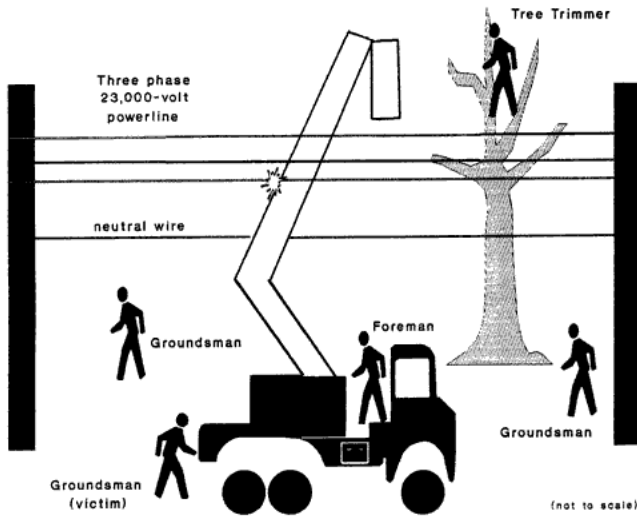
Figure 2. Tree Trimming Operations Boom Contacting Powerline

Discussion: Employers should comply with 29 CFR 1926.556 (b)(ix), which states that “Controls shall be plainly marked as to their functions.” The control levers used by the foreman to retract the boom/bucket, were mounted on the boom pedestal. The four control levers were close to each other and not marked for the function they controlled. The apparent inadvertent movement of the lever controlling the upward motion of the boom brought it into contact with the energized powerline.
