Maryland Steelworker Electrocuted When He Contacted Energized Toaster Oven Casing in Employee Lunchroom

FACE 90-37

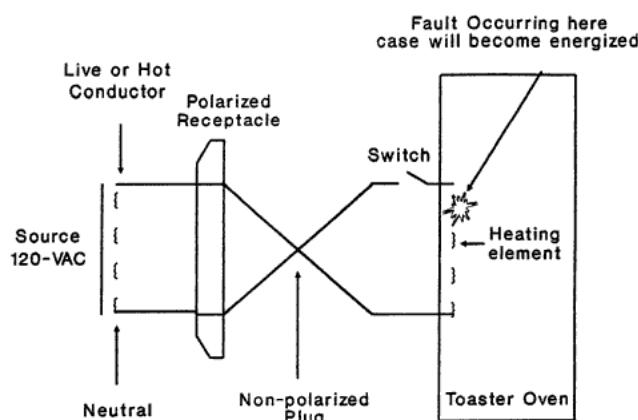
Figure. Reversed Polarity

Investigators learned that the toaster oven's power cord had a non-polarized plug which, sometime prior to the incident, had been inversely inserted into a polarized receptacle.¹ The heating element in the toaster oven had been previously damaged and was in contact with the oven casing. Reverse insertion of the plug in the polarized receptacle created a condition known as reversed polarity. Electrical current flowed through the heating element without the switch being turned to the ON position and energized the toaster oven casing (Figure

When the Live/hot conductor and Neutral wire are reversed, the current path is also reversed.

Recommendation #1: Employers should periodically inspect all areas of their facility for electrical hazards and apply appropriate control measures.

Discussion: Employers should periodically inspect all areas of their facilities, especially non-production areas, lunch rooms, break rooms, rest rooms, etc., to identify non-polarized plugs, improper grounding, and any other electrical hazards that may be present, and then apply appropriate measures to eliminate the hazard. Additional information pertaining to electrical hazards can be found in the NIOSH Alert "Request for Assistance in Preventing Fatalities of Workers Who Contact Electrical Energy (1)."
