Three Ironworkers Die and One was Seriously Injured in the Collapse of a Structural Steel Framework in Ohio

FACE 9033

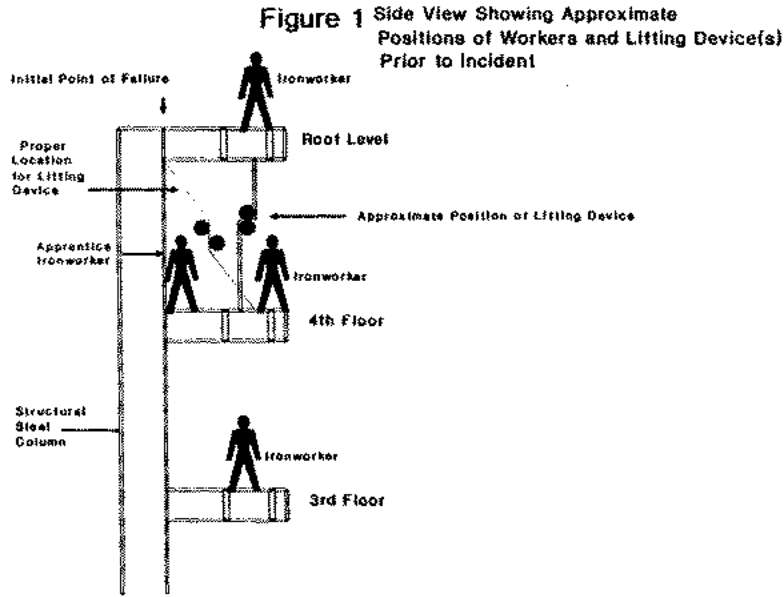
Apparently, the crew had anchored the lifting device(s) to one of the cantilevered I-beams located at roof level that had been only temporarily attached with three bolts. While the fourth floor section was being raised to a level position, the bolts securing the roof beam to the column failed. A section of the roof (including the supporting beam), a section of the fourth floor where two of the victims were working, and other supporting steel members, collapsed in a domino fashion, causing a portion of the third floor to collapse onto the second floor. The apprentice ironworker and the journeyman ironworker on the roof beam, both of whom were tied off to the roof beam, were thrown to the ground when the beam collapsed. The roof beam and attached joists landed on top of the journeyman ironworker. The journeyman ironworker working on the end of the fourth floor beam, landed on the second floor decking and was crushed by falling steel. The journeyman ironworker who was placing decking on the third floor level, was struck by falling steel and forced through the decking. He was found dangling upside down from the collapsed third floor section.

Discussion: Using the roof-level cantilevered I-beam as an anchor for raising the fourth floor section did not provide sufficient support, particularly since the beam was only temporarily secured with three bolts. The adjoining column could have provided adequate support for lifting the floor section (refer to Figure 1, which shows a more appropriate location for attaching the lifting devices). The preparation of a construction process plan prior to the start of work, detailing the proper construction procedures in appropriate sequence, may have revealed the potential hazards posed by this construction procedure. Upon identification of hazardous procedures, control measures can be developed and implemented prior to the start of work.

Recommendation #1: Project client/owners and contractors should develop detailed construction process plans that specify the construction sequences and procedures for safe construction for each site.
