Laborer Dies from Electrical Injuries Sustained in an Electrical Distribution System Substation in Virginia

FACE 90-31

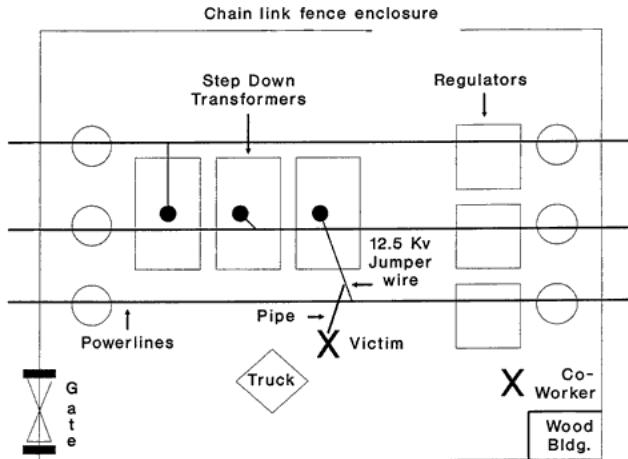
Figure. Electrical Distribution System Substation[Return to In-house FACE reports](#)

The crew arrived at the substation in two vehicles. One vehicle, containing reels of wire, a reel rack, and a 10.5-foot-long galvanized pipe that was going to be used as a reel rack spindle, was driven into the substation by the victim. The victim positioned the back of the truck approximately 8 feet from the transformers, unloaded the reel rack and placed it near the regulators. Although no one witnessed the incident, it is assumed that the victim lifted the galvanized pipe from the back of the truck and turned toward the transformers. As the victim turned holding the pipe in a vertical position, the pipe contacted a 12,500-volt energized jumper wire, which was attached between a step-down transformer and an overhead powerline (approximately 11 feet from ground level). The current passed through the pipe and victim to ground seriously injuring the victim (Figure
