# Laborer Touching Suspended Cement Bucket Electrocuted When Crane Cable Contacts 7200- Volt Powerline in North Carolina

FACE 90-29

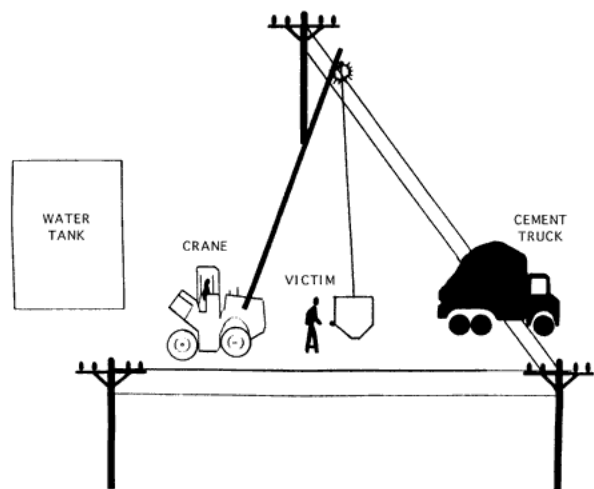
Figure.

The company was contracted in 1988 to construct a large addition that would upgrade an existing wastewater treatment plant. The victim's crew was pouring concrete for the back wall of an underground water holding tank that measured 20 feet long by 29 feet wide by 23 feet high. Prior to the start of construction on the holding tank, the company safety director contacted the local electrical utility and requested that they relocate a 7200-volt powerline at the site. The powerline presented a serious hazard, since a crane would be used to position a 1-yard bucket during the pouring of the concrete. Electrical utility engineers determined that the powerline could not be relocated because the adjacent swampy ground would not permit the proper anchoring of the utility poles. Instead, the powerline was covered with insulated line hoses in the vicinity of the worksite. In order to comply with OSHA regulations pertaining to clearances between cranes and powerlines, the safety director had markers placed in the ground that identified the spot where truck drivers would back the cement trucks for the unloading of the bucket. This action ensured that the crane boom would come no closer than 14 feet to the powerline, greater than OSHA's required minimum clearance distance of 10 feet. Because of subsequent damage caused by Hurricane Hugo, the insulated hoses were removed from the powerline so that the slack in the powerline could be adjusted. The insulated hoses were not replaced by electrical utility workers after the slack in the powerlines was adjusted.

On the day of the incident, the victim was working on the floor of the holding tank cleaning up spilled concrete. After the last bucket was poured, the truck driver cleaned the loading chute on the truck with a truck-mounted water hose. The victim joined the rest of the crew at ground level. When the driver finished cleaning the truck, he began to pull away. The supervisor called for him to stop and asked if the crew could use the water hose to clean the concrete bucket. The driver stopped the truck under the powerline. The supervisor signaled the crane operator to swing the bucket around to the truck. Without realizing the truck had been moved, the crane operator positioned the bucket behind the cement truck. The victim grasped the door handle on the bucket and pushed down to open it, causing the crane cable to contact the powerline. The electrical current traveled down the cable and through the bucket and victim to ground, causing his electrocution. The supervisor detected a pulse, but the victim was not breathing. The supervisor immediately began mouth-to-mouth resuscitation while one of the crew members summoned the emergency medical squad (EMS). The EMS transported the victim to the hospital where he was pronounced dead-on-arrival by the attending physician.
