# Electrician Electrocuted after Contacting an Energized 480-volt Bus Bar in South Carolina

FACE 90-22

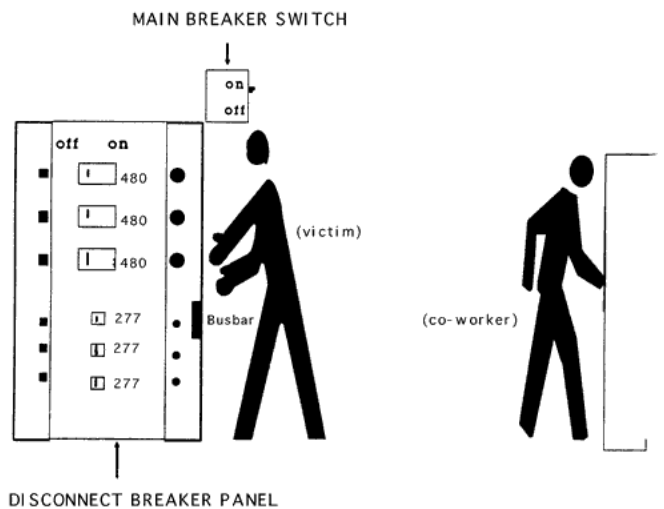
**Figure.** Main Service Disconnect Breaker Panel 480/277-Volt

The two employees switched all of the breakers, including the main breaker, to the off position, and then removed the breaker panel covers. The next phase was to check the continuity of the conductors leading to a branch circuit panel located in another room. As the co-worker turned away from the victim to place one of the panel covers on the floor, he heard what sounded like the click of a breaker being switched on/off. He then heard a spitting sound and turned around to see the victim's right hand in contact with a conductor and his left hand in contact with a bus bar (Figure 2). The co-worker kicked the victim causing him to fall and break contact.

Note: For unknown reasons, the victim switched the main breaker from the off position to the on position and then inadvertently contacted the energized bus bar, which remains energized even though the other breakers were switched off. A subsequent investigation by a local electrical consultant confirmed that the main breaker switch had been in the on position at the time of the incident.

**Discussion:** In this incident the victim switched the main breaker from an on position to an off position, removed a panel box cover, and for unknown reasons switched the main breaker back to the on position. This procedure exposed an energized bus bar, which the victim contacted. Employers should evaluate the tasks performed by workers; identify all potential hazards; and then develop, implement, and enforce a comprehensive safety program addressing these issues as required by OSHA standard 1926.21. (1) This safety program should include, but not be limited to, worker training in electrical hazard recognition.

**Discussion:** The breaker panel was not de-energized before the repair work was attempted. The circuitry may have been left energized in order not to inconvenience the other repair workers. A job of this type should be scheduled at a time (a weekend or before or after hours) when the incoming power could be de-energized without disrupting operations. Employers should develop specific job procedures for tasks that are performed by employees, including de-energizing electrical circuits before beginning to work on them, and verifying that the system has been de-energized. These procedures should detail the various safety hazards associated with each task. Once these specific procedures have been developed, employers should ensure that they are implemented and enforced by a qualified person at each jobsite. Additionally, when employees need to work away from the control point (i.e., the breaker panel in this incident), lockout and tagout procedures should be implemented (2).

**Recommendation #1: Employers should develop, implement, and enforce a comprehensive safety program which includes worker training in recognizing and avoiding hazards, especially electrical hazards.**

**Recommendation #2: An electrical system should be de-energized, and tested to verify that it has been de-energized, prior to any work being performed on it.**
