# Electrical Lineman Electrocuted by Contact with Energized Powerline in Puerto Rico

FACE 90-06

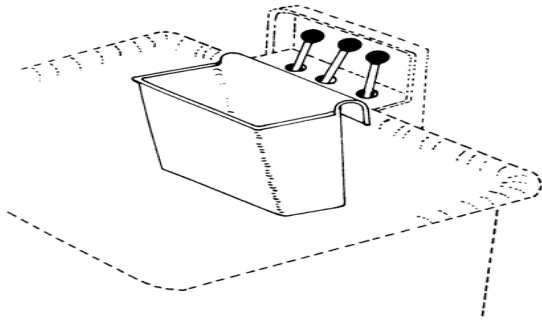
**Figure 1.** Tool Basket as Originally Installed

The victim, a third class (highest level) lineman with 6 years' experience, was a member of an electric utility work crew that for 10 days prior to the incident had been working extremely long hours to restore electric service to an area devastated by a hurricane. On the day of the incident, the crew had been working since early morning. At approximately 8:30 p.m., the crew decided to restore power to one more area before quitting work for the night. The victim went up in a bucket truck to open a two-phase line on a transformer and install a jumper between that line and another two-phase line on a second transformer. As the victim prepared to start work in the bucket, he noticed that a plastic tool basket mounted on the side of the bucket was full of water. The mounting bracket for this basket had broken and had been replaced with two copper wire hooks which slipped over the edge of the bucket to hold the basket in place (Figures 1 and 2).

**Discussion:** Failure to inspect both the worksite and the equipment to be utilized can result in unnecessary worker exposure to hazards. Equipment which has been damaged must be either repaired to factory specifications or replaced. Makeshift, on-site repairs, such as the repair of the plastic tool basket in this case, can create hazardous conditions. Had the tool basket been properly replaced, this incident might have been prevented.

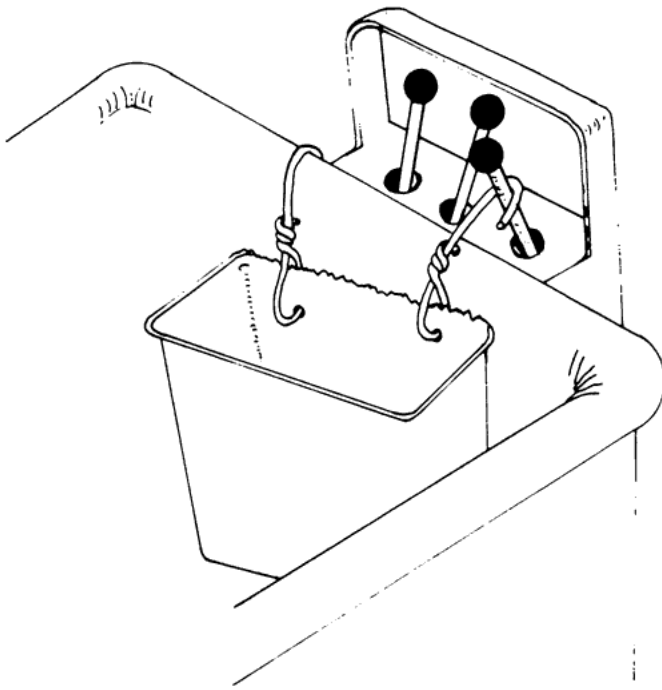
**Figure 3.** Position of Tool Basket at Time of Incident

The victim removed the plastic basket from the bucket to empty the accumulated rainwater. When he attempted to reinstall the basket in the darkness, one of the copper hooks became caught on one of the three bucket-mounted control levers (Figure 3). This lever controlled the horizontal rotation of the boom. The weight of the tool basket engaged the control lever and caused the boom to begin to move toward the powerlines. (Had the original mounting bracket been in place, the basket could not have engaged the control lever.) The victim tried in the darkness to manipulate the controls and stop the rotation. A ground crew worker, who observed the bucket moving toward the powerlines, attempted to reach the master control panel on the truck, but slipped and fell before reaching the controls. The victim made contact with an energized 4800-volt powerline and a secondary fuse box. The bucket hit the line with such a jolt that the victim was thrown from the bucket to the ground approximately 30 feet below.

**Discussion:** Adequate lighting of the worksite is vital if workers are to function in a safe manner. Darkness can obscure obvious hazards and thereby dramatically increase worker exposure to these hazards. Truck-mounted spotlights and portable lanterns must be available and utilized to minimize risks. The use of such lighting might have prevented this incident.
