# Lineman Trainee Electrocuted after Contacting an Energized Pickup Truck in South Carolina

FACE 91-20

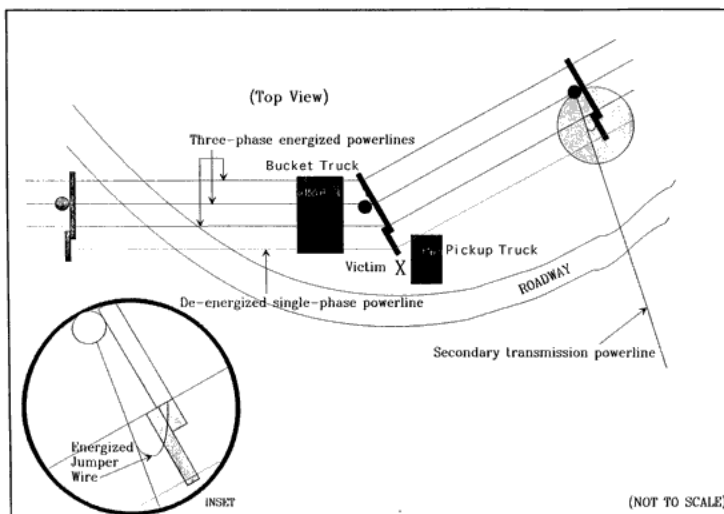
On the day of the incident, a four-man crew consisting of a jobsite foreman, truck operator, lineman, and lineman trainee, arrived at the jobsite to remove the single-phase de-energized powerline from the utility poles. The single-phase de-energized powerline had been previously offset away from the energized powerlines by mounting an additional section of crossarm to the permanent crossarm on the utility pole, and attaching the de-energized powerline to an insulator on its end. Two of the crew members were working as a team, four spans away. The victim and jobsite foreman were working as a team at the incident site. An aerial bucket truck was being used to provide access to the overhead powerlines, while a pickup truck was being used as a utility vehicle. The trucks were parked close to the utility pole, and beneath the overhead powerlines ([Figure](#)).

**Figure.** Conversion of Single-phase Powerline to Three-phase Powerlines
