# Apprentice Electrician Electrocuted

FACE 89-50

On August 23, 1989, a 23-year-old male apprentice electrician was electrocuted while making a connection for a light fixture in a junction box.

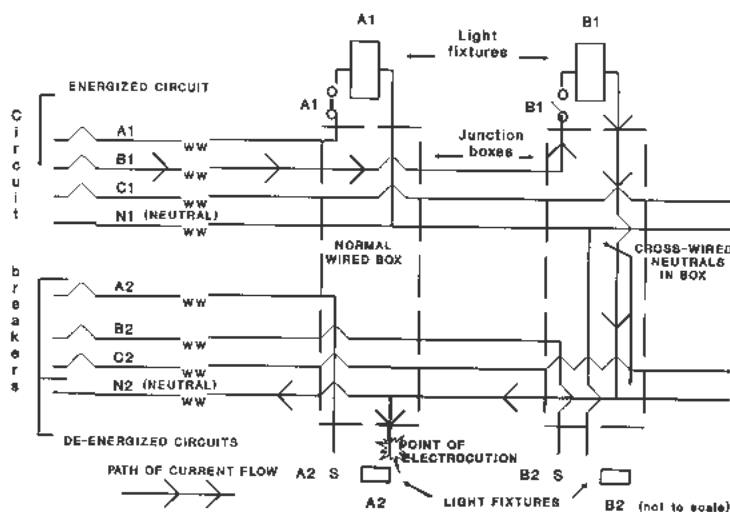
Work was stopped for that day and the area secured until an investigation could be made by the company. The next day no energized lines could be detected in the junction box where the victim was working when he received the fatal shock. The panel box was in a closet, but was not locked. After work in the area was finished, further investigation revealed that the two neutral conductors in the same conduit run had been cross-wired at a junction box. That is, the neutral wire in the de-energized circuit was mistakenly connected to the neutral wire of an energized circuit back at the junction box. Company officials believe that the victim had previously, inadvertently cross-wired the neutral conductors, which subsequently allowed electricity to flow from the live circuit on the completed side of the building through a light fixture, to the circuit on which the victim was working. When he handled the energized neutral conductor to make the connection, his body provided a path to the metal gridwork he was touching, which was connected to the building structural steel.

The [Figure](#) on page 5 demonstrates how it could be possible for the victim to be electrocuted due to the crossed neutral wires. The circuit breaker had to be closed and the light switch in the "on" position on the live circuit to allow current to flow through the light fixture to the neutral line wire of the parallel circuit.

Figure. Cross-wired Neutrals
