Truck Driver Dies When Crane Boom Contacts Powerline

FACE 89-48

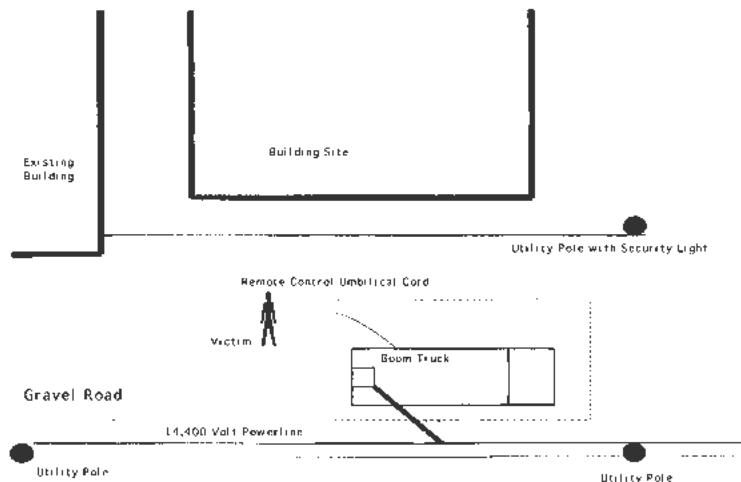
Figure.

The victim unloaded blocks on three sides of the building site, and then moved the crane truck to the fourth side of the site to unload the last pallet of blocks. A driveway ran parallel to the new building at this location. Also parallel to the new building, but across the driveway, ran an overhead powerline. On the building side of the driveway another powerline ran to a security light at the rear of the property. (See [Figure](#)). The victim positioned his truck in the driveway between these lines and lowered the outriggers of the truck to stabilize it. Then, standing at the rear of the truck the victim began to raise the crane boom to a vertical position using a remote control device attached to the truck by a 15-foot-long umbilical cord. As the boom crane was raised, it contacted the uppermost wire of the powerlines across the driveway from the building site. When the boom contacted this energized 14,400-volt line, the truck-mounted crane, the umbilical cord, and the remote control device became energized. A "path to ground" was established through the victim's body, entering his hands (holding the remote control device) and exiting his feet to ground. The victim collapsed clutching the remote control device to his chest. By the time the automatic disconnect device in the powerline deenergized the circuit, the victim had received massive electrical burns over most of his body.
