Laborer Falls to His Death Through a Skylight Opening

FACE 8947

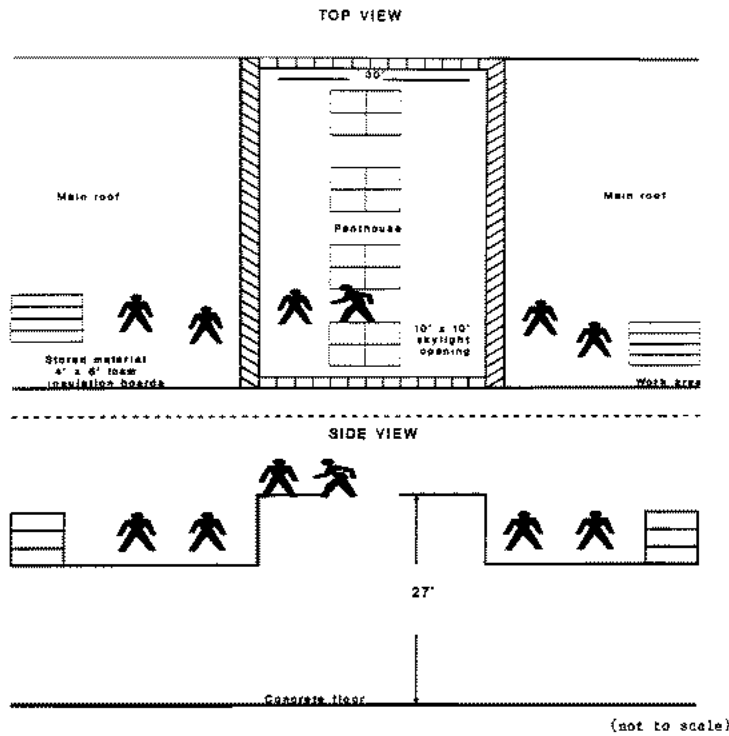
Figure 1.

On the day of the incident, the victim was part of a six-person crew assigned to move insulation boards from a storage area on one side of the main roof, over the penthouse roof, to the other side of the main roof where the boards were to be installed. The subcontractor had intended to place the boards on the same side of the main roof where they were to be installed, but wet ground conditions precluded moving the crane to that side of the building and the boards were unloaded on the opposite side of the roof. Two members of the crew carried insulation boards from the storage area to the penthouse area. Two other crew members, including the victim, carried the boards to the opposite side of the penthouse where the remaining two crew members moved the boards to the work area. At some point during the task, the victim was walking backwards dragging insulation boards when he fell through the skylight opening to a concrete floor 27 feet below (see [Figure 1](#)).

Recommendation #2: The prime contractor or subcontractor should have implemented 29 CFR 1926.500 (f)(6), which requires that all skylight openings that create a fall hazard be guarded with a standard railing, or covered with a material capable of supporting the maximum intended load and so installed as to prevent accidental displacement.

Discussion: Employers should assume the responsibility of providing for the safety and health of the workers. Neither the prime contractor nor the subcontractor took the necessary precaution—guarding the skylight opening. If the skylight had been guarded in accordance with 29 CFR 1926.500 (f)(6), the incident may have been prevented.

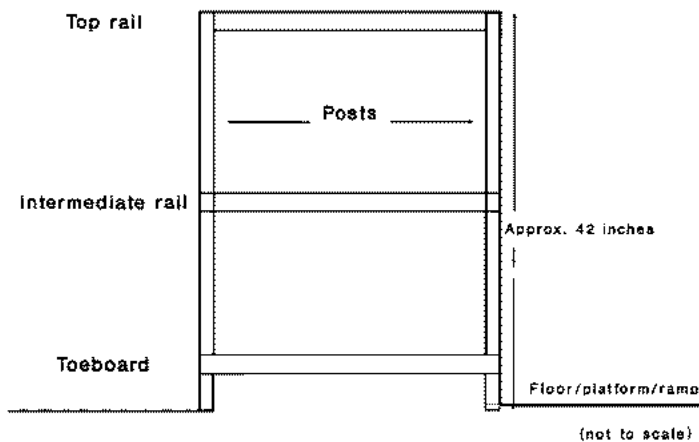
Figure 2.

[Note: During the DSR investigation, it became apparent that guards had been installed around the skylight openings subsequent to the incident. These guardrails, however, did not appear to meet the requirements specified in 1926.500 (f)(1) (see [Figure 2](#)

). The guardrails, as erected, did not include an intermediate rail midway between the top rail and toeboard.]
