# Sheet Metal Mechanic Dies Following a 22-Foot Fall Through a Roof Opening

FACE 8925

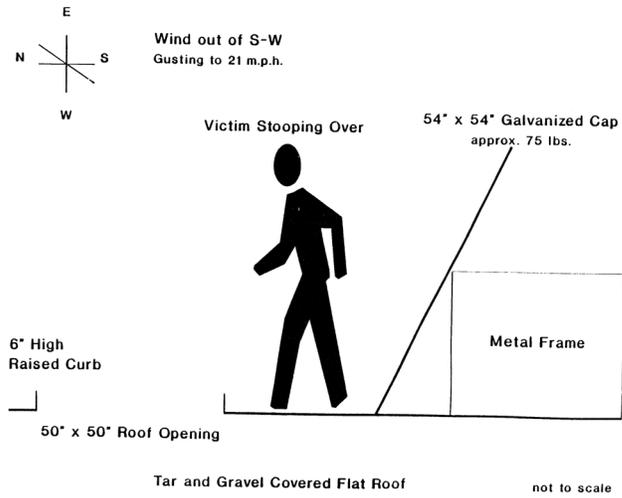
Figure.

On the day of the incident the victim and a co-worker were preparing to install the cap. The victim and the co-worker leaned the cap against a 30-inch-high by 48-inch-wide metal frame that had been previously used to support the air conditioning unit. The frame, located approximately 34 inches from the roof opening, is constructed of 3-inch angle iron. The victim positioned himself between the leaning cap and the roof opening, while the co-worker positioned himself on the other side of the opening. Neither worker was wearing any type of fall protection equipment. The co-worker was kneeling and the victim was stooped over applying caulking to the 6-inch raised curb bordering the opening. A gust of wind blew the cap over. The cap struck the victim, causing him to fall headfirst through the roof opening, to a concrete floor 22 feet below (see [Figure](#)).

**Recommendation #1: Whenever any work is performed at an elevation where the potential for a serious or fatal fall exists, the employer should ensure that fall protection equipment is provided and used by all employees.**

Discussion: The victim was working 22 feet above ground level in an area where the potential for a fall existed. According to 29 CFR 1926.28 (a), "the employer is responsible for requiring the wearing of appropriate personal protective equipment in all operations where there is an exposure to hazardous conditions." If the employer had provided and required the use of fall protection (i.e., safety belt, lanyard, and lifeline) this incident may have been prevented.
