Electrician's Helper Falls to His Death Through a Skylight

FACE 8930

On April 18, 1989, a 39-year-old male electrician's helper died after falling 16 feet through a skylight to a concrete floor.

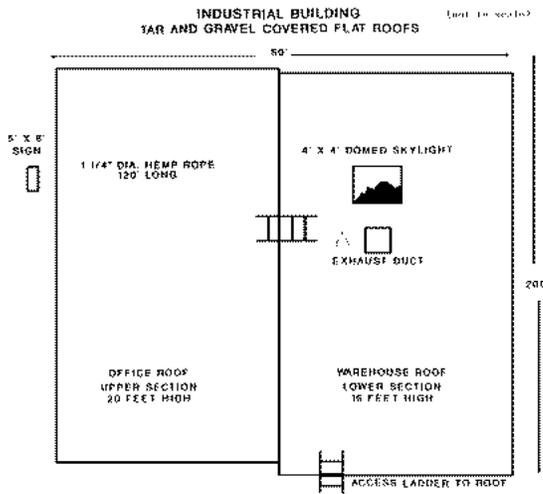
Figure 1.

The victim, apparently untied the rope from the ladder, and either tripped, stepped, or possibly sat on a 4-foot-square smoke dome type skylight located near the work area. The skylight broke and the victim fell 16 feet to a concrete floor (see Figures 1, 2, 3). A 1-foot length of rope was found hanging through the broken skylight following the incident.

Recommendation #3: Skylight manufacturers and owners of buildings where skylights have been installed should voluntarily affix accident prevention signs on the skylights, and at or near points of access (e.g., roof hatches, fixed ladders, stairways, doors, etc.) to areas containing these skylights.

Recommendation #4: Designers/manufacturers of skylights should evaluate current designs with a view toward increasing load capacities and/or incorporating safeguards.

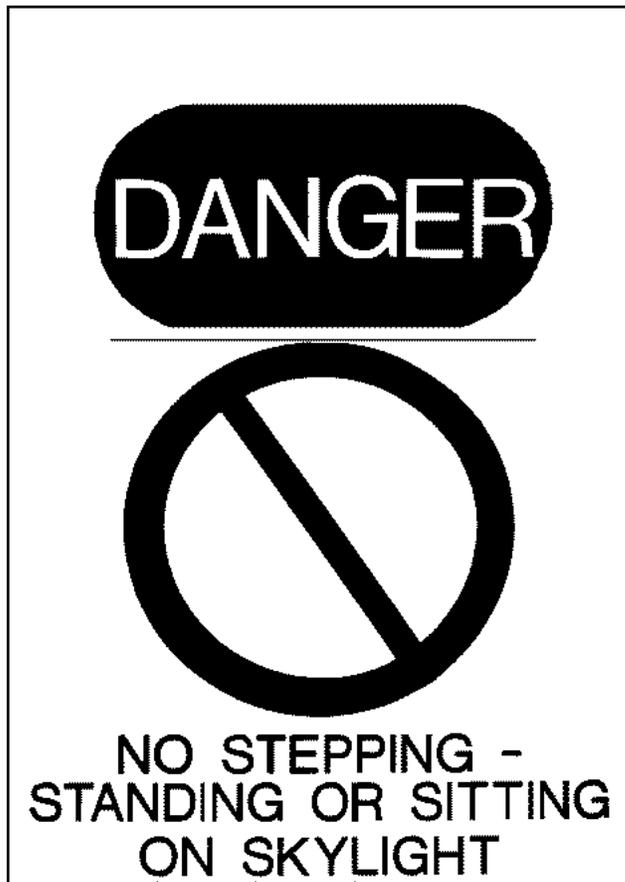
Figure 5. Recommended accident prevention sign to be applied to skylights.

Signs should be easily visible to anyone approaching the area, should contain specific information on procedures, should be inspected on a regular basis, and should be printed both in English and in the predominant language of non-English-reading workers. Also, workers unable to read posted signs should receive instructions regarding hazardous area.
