Stucco Mason Dies in Fall from Scaffold

FACE 8935

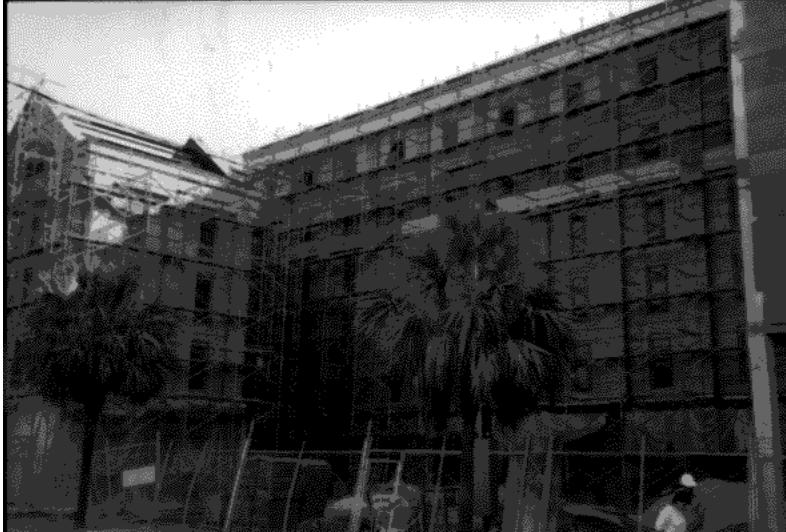
Figure.

Although the incident was unwitnessed, it is assumed that the victim started to climb to the next level of scaffolding by stepping onto the bottom guardrail. (The victim had been previously observed climbing from level to level of the scaffolding without using the built-in scaffold ladder.) The guardrail, which may have been loosely secured or not secured at all to the scaffolding uprights, gave way allowing the victim to fall approximately 48 feet to the ground. Another employee saw the victim strike the scaffold planking at the first level before he struck the ground (see [Figure](#)).

The loose or unsecured guardrail may have been identified and corrected had proper installation, initial inspection, and/or periodic inspection procedures been used.

Recommendation #1: Where the potential for a fall from an elevation exists, employers should ensure that fall protection equipment is provided and used by workers.

Recommendation #2 Employers should conduct initial and periodic inspections of erected scaffolding.
