Distribution Line Technician Electrocuted by Conductor in Contact with 7200-volt Power Line

FACE 89-36

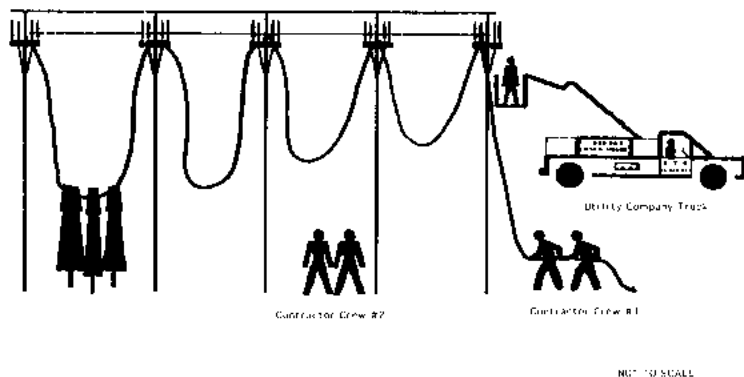
Figure 1.

The two utility company employees were located in a bucket at the top of the pole at the end of the fourth span preparing to “dead-end” (attach) the second new conductor to an insulator on the final crossarm (see [Figure 1](#)). One contractor crew (the victim and co-worker) was located at the base of the pole, at the end of the fourth span, preparing to pull the slack out of the new conductor by hand. The second contractor crew was directing traffic near the first pole of the fourth span, which was 216 feet from the end pole.

The victim, because of his seniority, was the supervisor of the contractor employees. When the utility company employees were ready to dead-end the conductor to the crossarm, they called down to the victim to take up the slack. The victim grasped the conductor and began to pull but was not able to take up any slack. The co-worker, seeing that the victim was having a difficult time, grasped the conductor behind the victim and also began to pull. At this time one of the crewmen directing traffic saw that the conductor had become snagged in the topped-out cedar trees in the first span. Before he could yell for the victim to stop pulling, he heard a loud buzz and saw a flash at the midpoint of the first span above the topped-out cedar trees. The two workers had pulled on the new conductor with enough force to cause it to flip up into the energized conductor. The crewman also noticed the new conductor swaying back and forth. The utility company employees heard the victim and his co-worker yell and turned to see both men fall to the ground. They immediately lowered themselves to the ground and began to administer cardiopulmonary resuscitation (CPR) to the victim. The co-worker received electrical burns to his left arm and right side. Two nurses passing in a car stopped and assisted with CPR until the emergency medical service (EMS) rescue squad arrived. The EMS personnel transported the victim and co-worker to a local hospital where the victim was pronounced dead by the attending physician. The injured co-worker was transferred to a burn center where he was listed in serious condition. At the time of the NIOSH investigation, the co-worker had been released from the burn center, but had not returned to work.
