Foundry Laborer Electrocuted While Loading Electric Induction Furnace

FACE 89-43

On June 5, 1989, a 22-year-old male foundry laborer was electrocuted when a piece of scrap metal he was loading into a damaged electric induction furnace became energized.

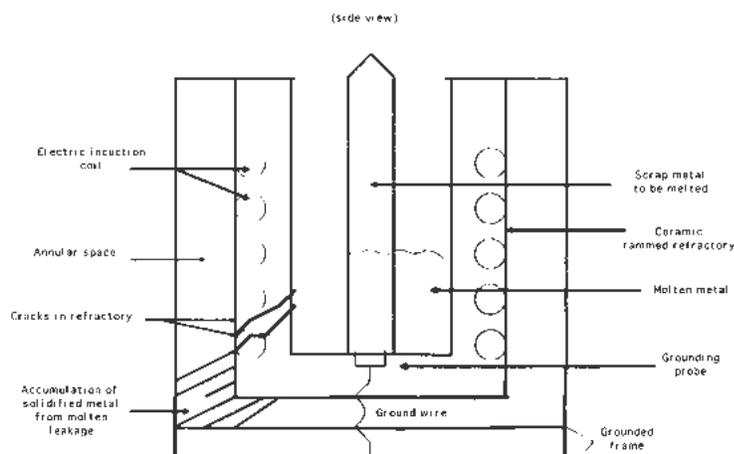
Figure. Electric Induction Furnace

The foundry uses electric induction furnaces for melting aluminum, brass, stainless steel, and iron. The furnaces are powered by a 3-phase, 1250-volt electrical system. The outside dimensions of the furnaces are 32 inches in diameter by 4 feet high. The inside of the furnaces are lined with a ceramic material which leaves a mold cavity (i.e., the space in which the metals are melted; also called a rammed refractory) that is 12 inches in diameter by 3 feet deep. A copper tube (electric

induction coil) is coiled around the outside of the ceramic refractory. Water circulates inside the copper tube for cooling. The frame and sides of each furnace are constructed of steel. A dead air space exists between the induction coil and the furnace frame. The inside of the refractory is electrically grounded with a metal probe which protrudes up through the base of the refractory. The probe is attached to a flexible grounding wire directly under the furnace that leads to a steel grounding rod. The furnace frame is also grounded (see [Figure](#)).

Company standard operating procedures require that after approximately 100 to 120 furnace heats, the ceramic refractory and grounding probe be replaced (due to expected wear on the refractory after repeated heatings). One month prior to the incident, the refractory on one of the furnaces was replaced and the old grounding probe removed, but a new grounding probe was inadvertently left out. The furnace was heated approximately 100 times during the weeks that followed. As a result the refractory began to wear, and developed cracks. (A certain amount of wear is considered “normal.” However, the cracks which developed in this instance are not considered normal wear). Molten metal seeped through cracks between the coil and gradually solidified in the space between the coil and furnace frame. A mound of the metal formed and was in contact with the frame, but not in contact with the coil.

Discussion: Although the company had a written procedure for changing out furnace refractories (which included installing a new grounding probe with each new refractory), the installation of the new grounding probe after removing the old grounding probe in this instance had been omitted. This resulted in an ungrounded furnace refractory. If it had been properly grounded, when the molten metal leaked through the crack in the refractory and came in contact with the energized coil the current would have gone to ground, causing the breaker to trip, thus greatly reducing the possibility of electric shock to the workers.

Recommendation #1: The employer should ensure that all electrically powered equipment is adequately grounded (according to the National Electric Code 250-112).
