Two Workers Electrocuted by 23,000 Volt Power Line While Erecting a Steel Support Structure

FACE 85-07

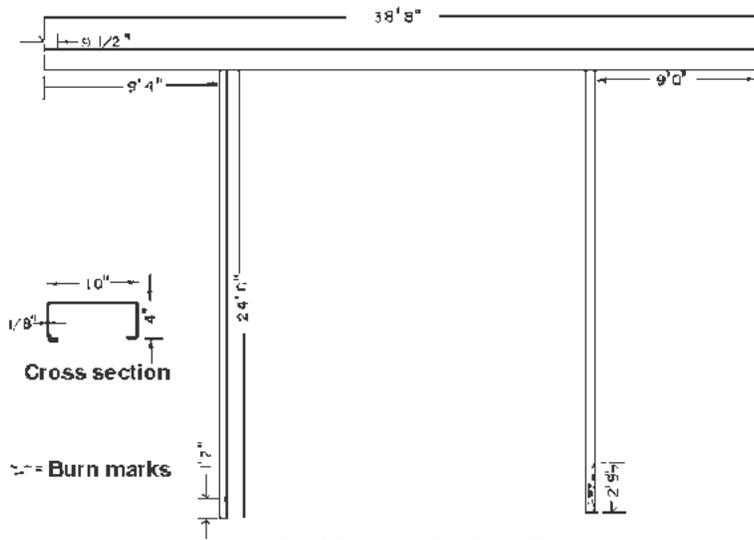
Figure 1 Steel Framing Configuration

At the time of the accident, the major steel framework had been erected except for the end sections. After the south end was erected, the workers discovered that an incorrect roof beam had been installed (Figure 1). To replace this beam, a decision was made to use a crane to lower the south section to the slab (Figure 2). The incorrect beam was unbolted from the two corner columns, but was left connected to the two intermediate columns. These intermediate columns were disconnected from the anchor bolts on the slab. A lifting sling was placed around the incorrect beam with the intention of raising the whole assembly (beam and support columns) off the anchor bolts, tipping it in a northward direction, and laying the whole assembly on the slab. Then the columns would be unbolted and the correct beam installed.

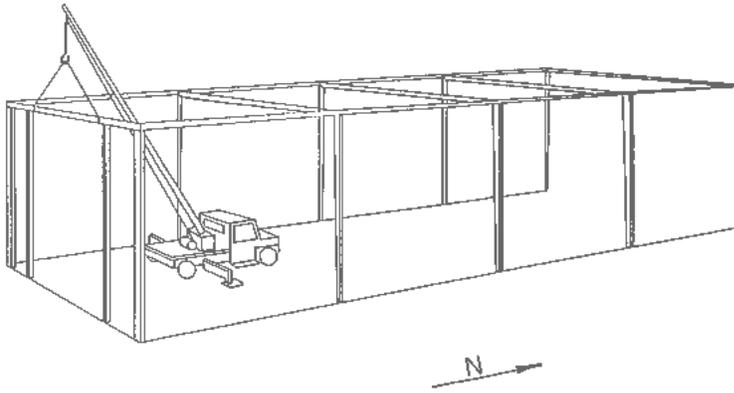
Figure 2.

As the co-owner (standing on the running board and operating the hydraulic crane controls) raised the steel section, two workers attempted to pull the base of the west column towards the north while the third worker tried to pull the east column likewise. Due to unbalanced forces, the east end of the incorrect beam rotated and/or tipped into the inside phase of the east-west powerlines. The phase to ground voltage was approximately 13,200 KVA. Two workers (one on each of the support columns) were electrocuted. The remaining worker, pulling the west column, sustained extensive electrical burn injuries on his left hand, left arm, and both feet and was in the burn unit of a local hospital when the field activities were conducted. It is surmised that he was still alive because he had only one hand in contact with the column. The electrocuted workers had both hands on the columns and this probably facilitated the path of current through vital organs. The co-owner who was operating the crane was not injured.

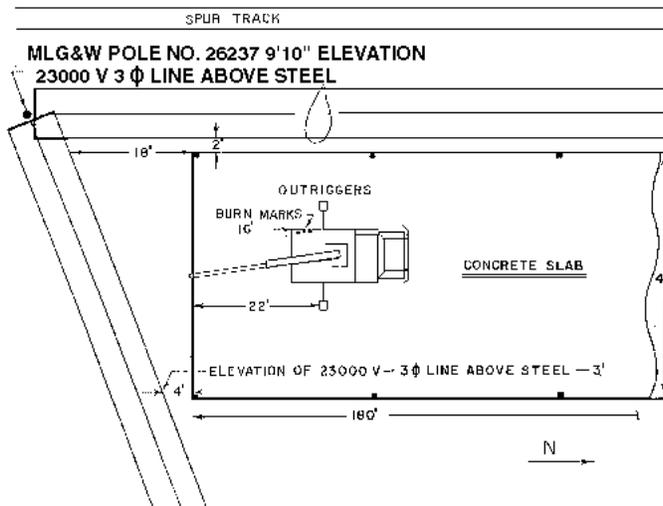
A plan view of the building layout and the proximity of the two sets of 23 KVA overhead power lines to the work area are shown in Figure 3. One set of power lines ran in an east-west direction. This set came from a corner pole (outside the fence) on the west side of the slab and steel uprights. These powerlines fed a transformer bank consisting of 3, single phase, 23 KVA transformers which supplied power to the facility. One of these lines was approximately a five foot diagonal distance from the structural section which was to be lowered. The second set of power lines ran on the west side of the structure along its entire 180' length. The inside phase of this set appeared to be approximately 10 feet diagonally from the upright columns of the structure's west side.

1. Initial approval for construction was granted by the city building inspector. It is recommended that in the future, the issuing body of construction permits should incorporate rules and regulations requiring all known electrical lines (both overhead and underground) be referenced on building application drawings.

2. Apparent insufficient safety awareness by the general contractor prior to issuing a subcontract and during steel erection.
3. The electrical lines were neither de-energized, insulated, nor moved away from the construction activity.
