# Carpenter's Helper Dies in 24-Foot Fall from Building Under Construction

FACE 8914

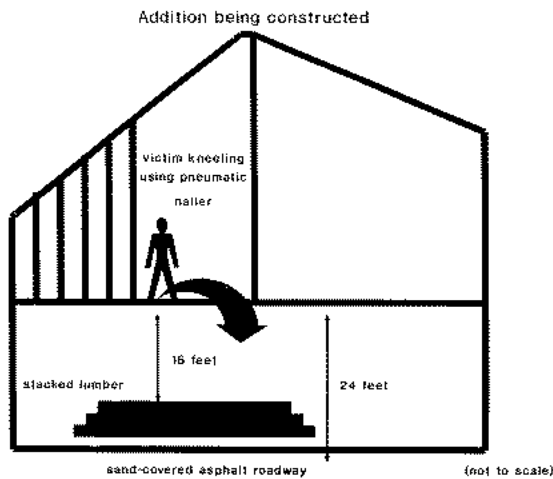
Figure.

At the time of the incident the victim was kneeling on the floor, nailing the outside bottom of a stud to the frame. After the stud had been nailed the victim began to reposition the pneumatic nailer to the side of the stud when he unintentionally hit his left leg above the knee with the nose (i.e., the cylinder that discharges nails) of the nailer. The nailer discharged a 3-inch nail into the victim's leg. The victim called to the foreman and told him what had happened. The foreman descended the ladder, went to the victim, and tried to remove the nail from the victim's leg using the claw hammer. The foreman could not extract the nail with the hammer, so he decided to go to the floor below and borrow a pair of pliers from an electrician. When the foreman returned to the area of the incident he noticed the victim still kneeling but slumping over toward the open end of the building. Before the foreman could reach him, the victim fell head first out of the opening onto an 8-foot-high stack of lumber that had been piled next to the addition, and then fell the remaining distance to a sand-covered asphalt road. (See [Figure](#)).

**Recommendation #1: When the potential for a serious or fatal fall exists, the employer should provide fall protection equipment and ensure that it is used by all employees working at elevations.**

Discussion: The victim was working 24 feet above ground level in an area where the potential for a fall existed. According to 29 CFR 1926.28 (a), "the employer is responsible for requiring the wearing of appropriate personal protective equipment (PPE) in all operations where there is an exposure to hazardous conditions." If the employer had provided and required the use of fall protection (i.e., safety belt, lanyard, and lifeline) this incident may have been prevented.
